Australian Quarantine and Inspection Service

CATERPILLAR & KOMATSU DUMP TRUCKS

The Dump Truck series cleaning/inspection guide have been segmented to facilitate the process and the segments are as follows:

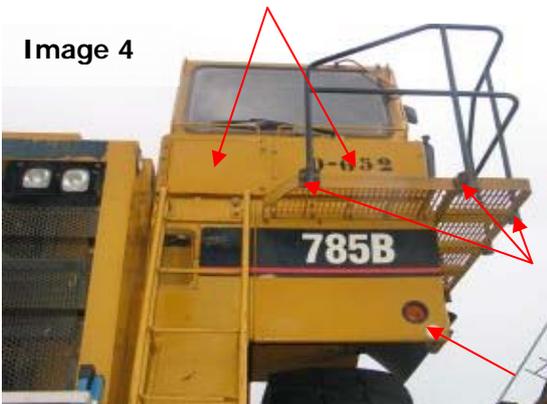
Image 4: The panels in front of the cabin, which house the air-conditioning and electrics, must be removed. All hollow handrail tubing must be flushed in the presence of the inspecting officer. Check all light covers for damage – it is not unusual to find contamination inside light covers.

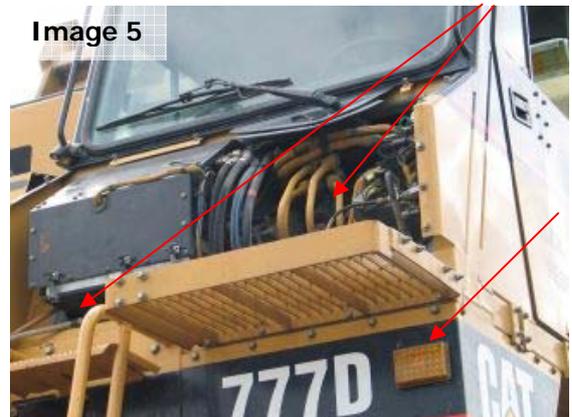
Image 5: This photo shows the front cabin panels removed, allowing access to the air-conditioning and electrics. Best to use a telescopic or flexible mirror to inspect all areas inside. All light covers must be checked.

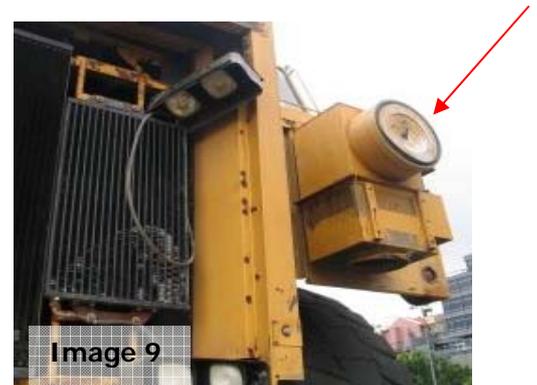
Image 9:

On some models the air-filters are found in a variety of locations. This one is below the cabin and has several hollow channels as highlighted by the two arrows above. Filters must be removed and blown with air to verify cleanliness. Have any other non-affixed panels dismantled to allow full access.

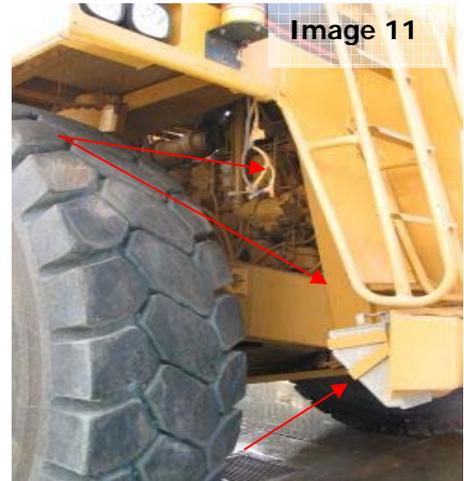
Image 12:

Vertical chassis support found either side of the radiator. Note the drainage hole on the underside – must be flushed in the presence of the inspecting officer. Note the small drainage hole seen towards the bottom of the photo – another box channel, which also requires flushing.

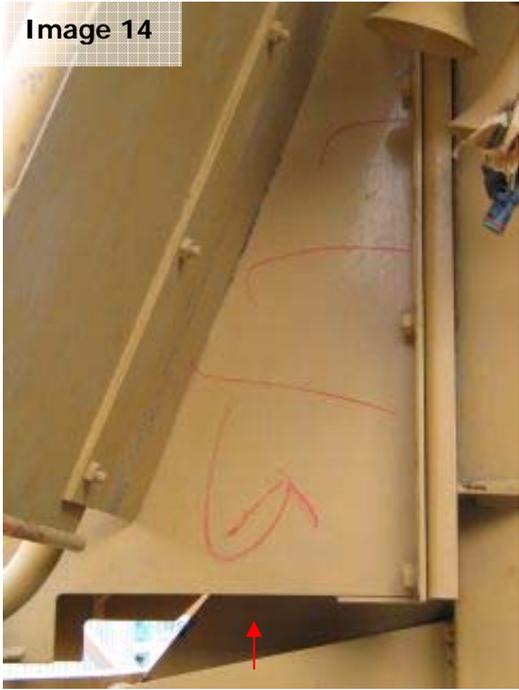
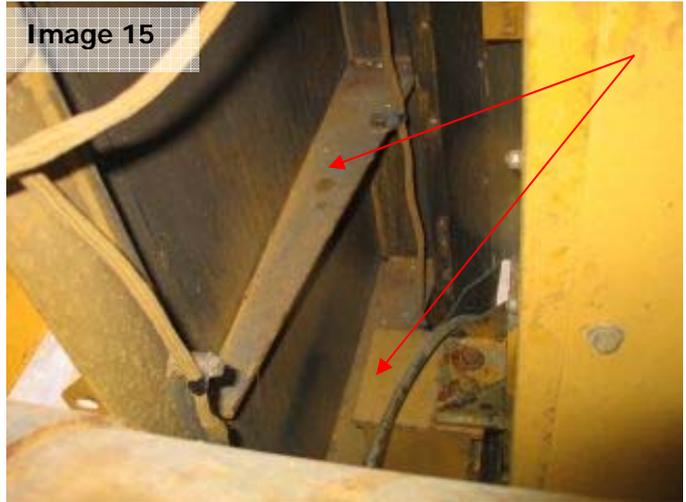
Images 14 & 15:

These pictures show both the external and internal view of the where the horizontal fins are located on each side of the radiator. These can be accessed from either the front (pull back black rubber sheets from either side of the radiator) or from in the engine bay, as seen in the view on the right.

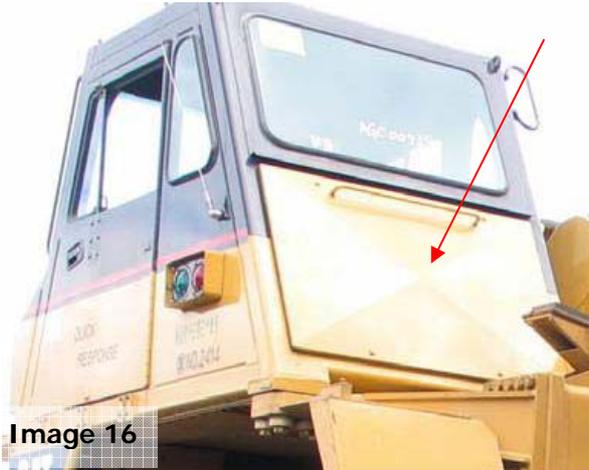
Image 16

Landscape shot of a Dump Truck cabin. There are generally two doors to allow access to the cabin.

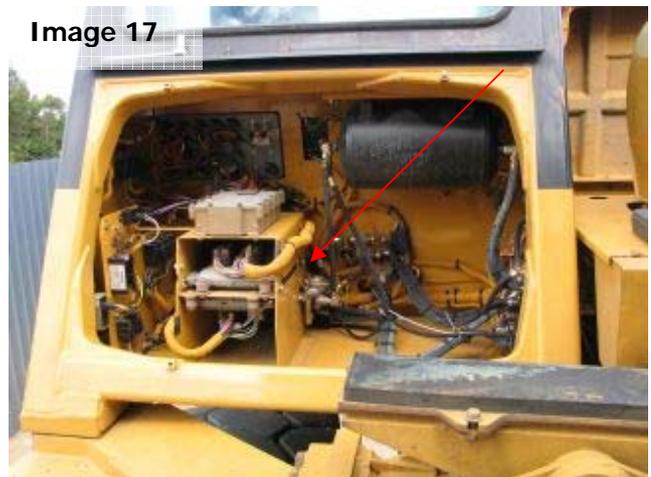
Image 17

This photo shows the rear panel removed. This area can contain the computer chips so cleaning can be difficult and best to clean with a damp rag. This area is usually well sealed, however contamination has been found in these areas.

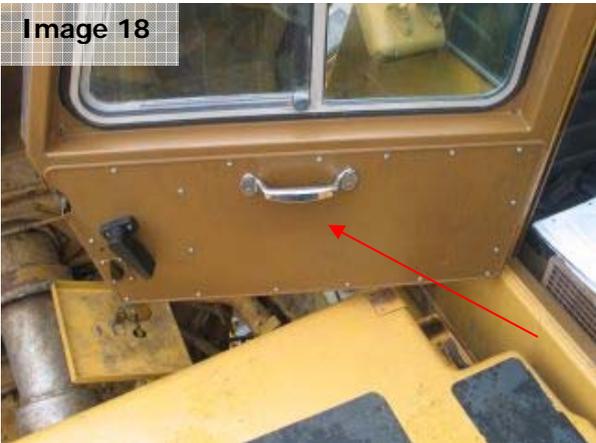
Image 18

Depending on the configuration, the internal door void (red arrow) may harbour contamination and be of interest to AQIS.

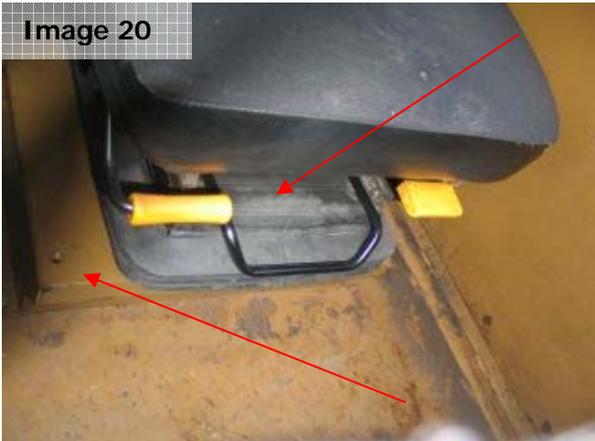
Image 20:

All seats need to be removed to allow proper inspection of the underside of the seat and the rubber shroud. Below the seat, like in the illustration above, there is a small hollow box section, which also needs to be inspected. Without removing the seat, access may not be possible.

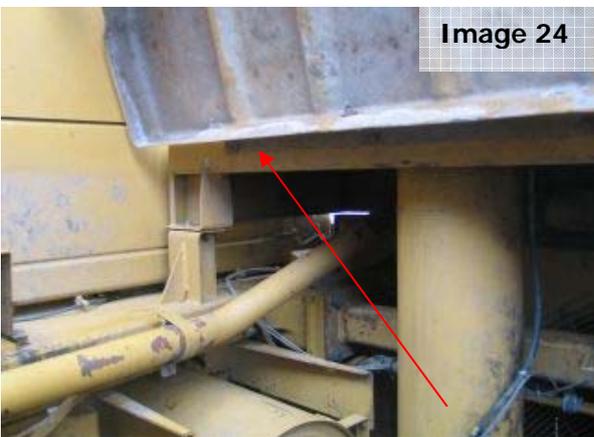
Images 24 & 25:

Where the engine cover hinges attach to the frame, this box section is hollow and has been known to harbour numerous kilograms of contamination. It appears to be solid, sealed section, however there are access points, which cannot be seen from this view. On the opposite side, on each end, there are small triangular openings, which allow access for flushing.

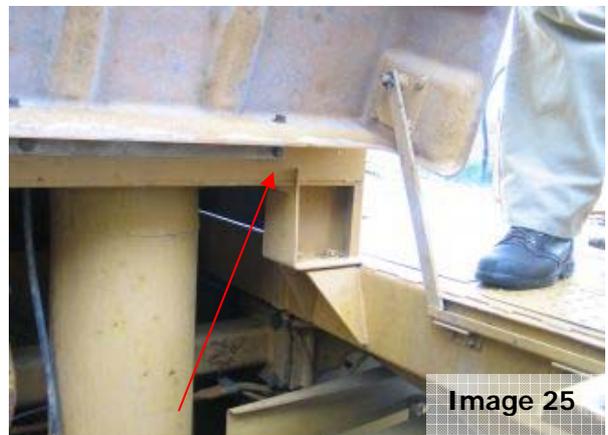
Image 26:

Opposite view of box channel where engine cover hinges attach. Note the small triangular access point, located at either end of this box section. This must be flushed in the presence of the inspecting officer.

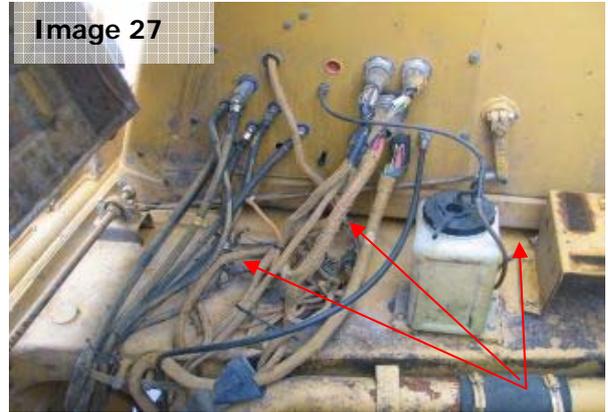
Image 27

The myriad of electric cables exiting the side of the cabin wall to various parts of the machine. All need to be checked for cleanliness. The two arrows on the right show the small gap under the cabin, which also requires flushing.

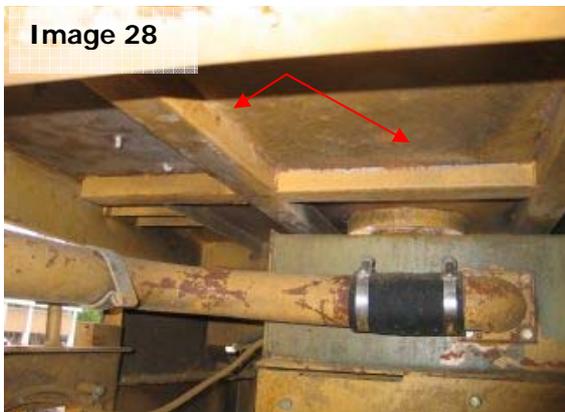
Image 28

Images 28 & 29:

The housing above the radiator. These hollow box sections are only spot welded into place and therefore contamination may be present. All individual box sections require flushing – a needle jet is best for gaining access.

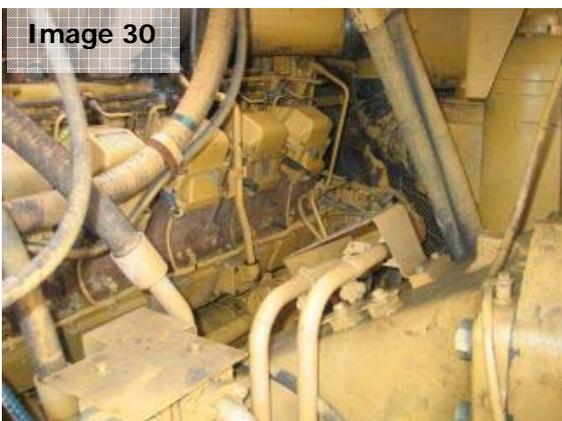
Image 30

Image 30:

Side view of the RH side of the engine block. As well as checking all other areas, the gap between the tappet covers can harbour contamination. Some flushing in this area is required.

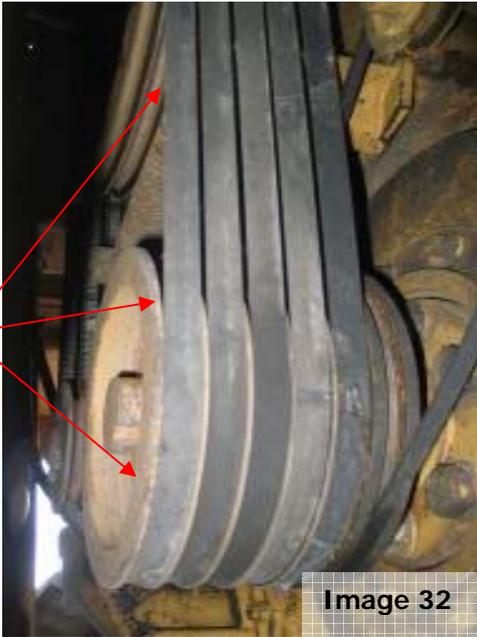
Images 32 & 33:

The harmonic balancers must be cleaned as well as the small opening below the block as seen in the picture on the right.

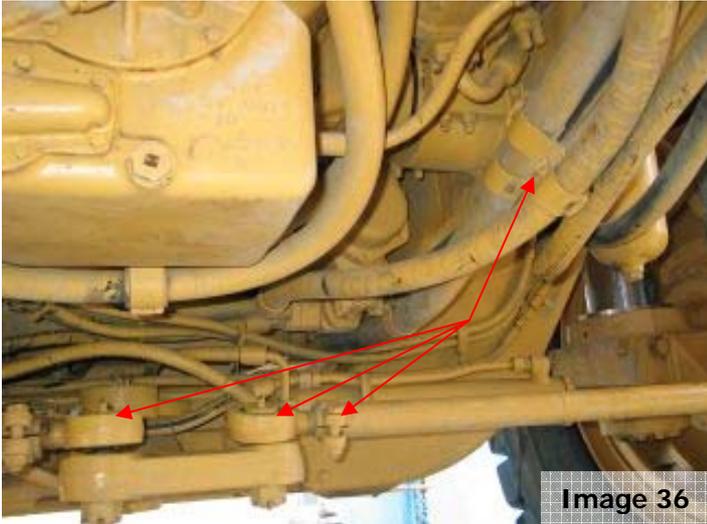
Image 37:
The small openings at the end of the pivot points are often overlooked when cleaning. Above: Areas above belly plate (along front of wishbone) that requires thorough inspection.

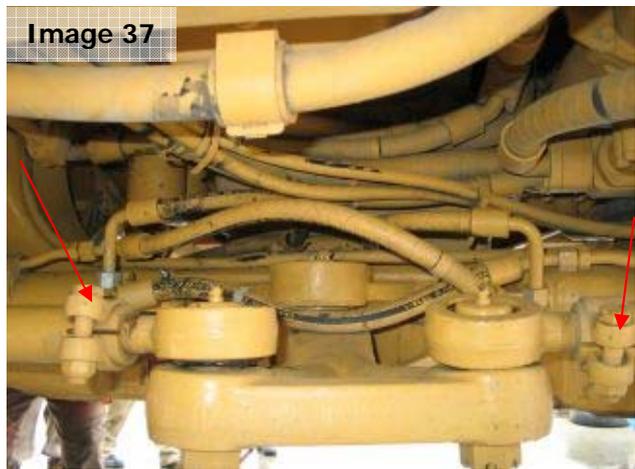
Images 38 & 39:
Areas above belly plate (along front of wishbone) that requires thorough inspection.

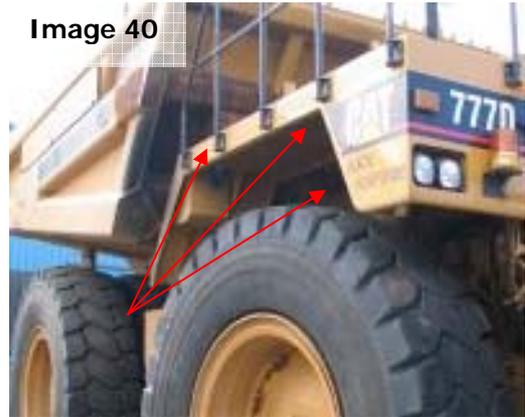
Image 40

Image 40:

The RH wheel arch on most dump trucks is the most difficult to clean and inspect. These wheel arches consist of a myriad of box channels, most of which has small triangular openings at the ends. These opening are further demonstrated in this series of photographs. Check all open ended hand rail tubing (will require flushing) and circular tubing around the wheel arch for any drainage points (if present, they will also require flushing).

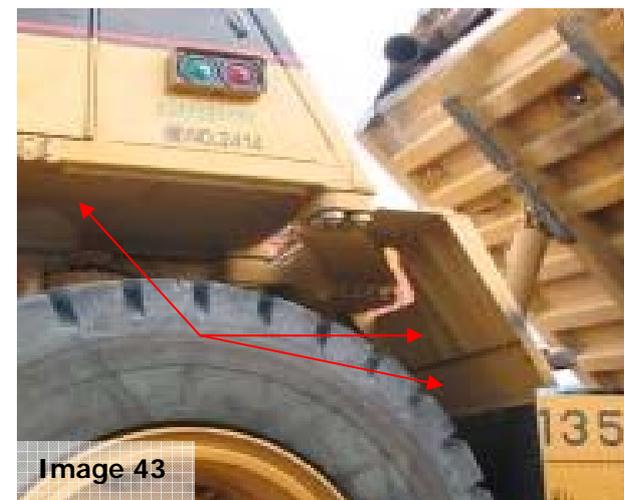
Image 43

The LH wheel arch is not quite as complicated, but still requires that the panelling from under the cabin is removed. Check the ledges behind the tyre for contamination. On some Komatsu models, these ledges are covered but still have access and flushing points.

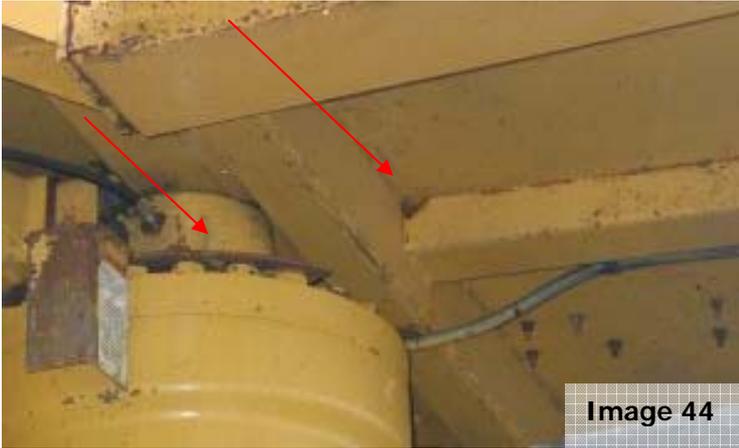
Image 44:
Arrow indicates the small triangular openings that are found at the ends of these box sections.

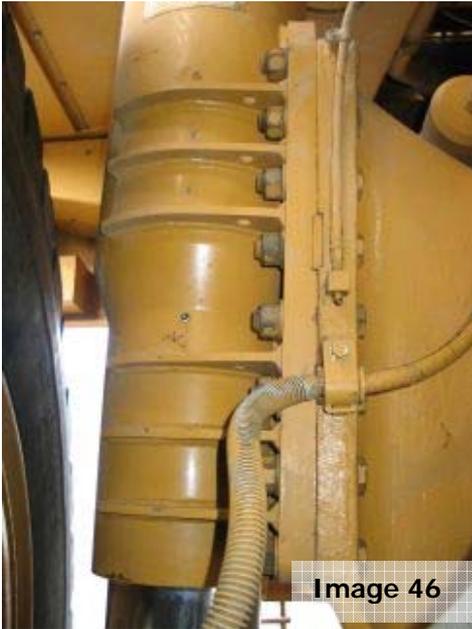
Images 46 & 47:

Located just inside each front tyre and rim are two vertical struts. These struts attach to the wishbone, which on the CAT series of Dump Trucks is a hollow and accessible area that needs thorough flushing to ensure it is clean.

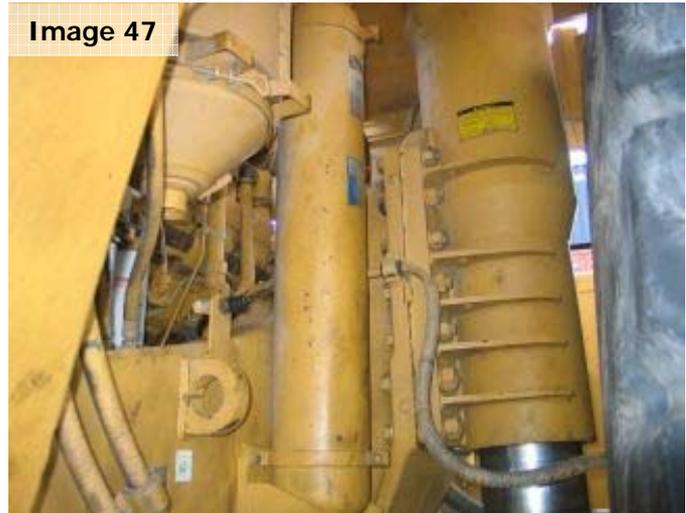
Image 48:

Contamination can enter the wishbone via these holes, located just inside either strut. The wishbone (blue arrow) appears to be a solid mass, but inside is hollow and contains a series of ribs, which can make removing contamination difficult. To enable these areas to be properly flushed and cleaned, a long lance with a 90-degree tip is required and is inserted up the area indicated by the red arrow.

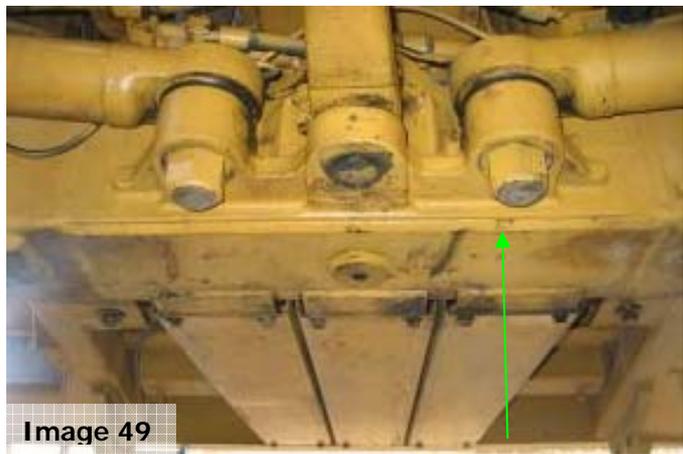
Image 49

Just right of centre at the rear of the wishbone is a small drainage hole. Flushing via the two entrance holes located below either strut will result in water draining from this hole.

N.B. It can literally take hours to flush this wishbone clean.

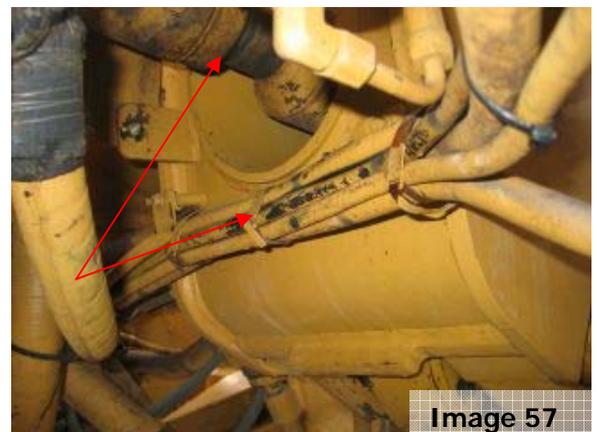
Image 58

Image 58:

Area just forward of the fuel cell. Again this area consists of numerous hydraulic lines and cylinders, all requiring careful attention.

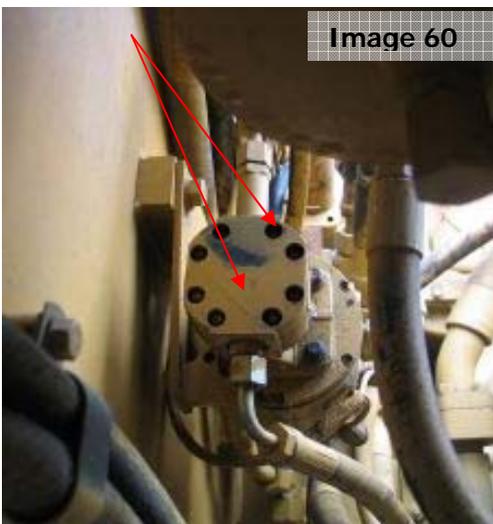
Image 60

There are numerous structures such as the one highlighted above, all requiring inspection from various angles to ensure cleanliness.

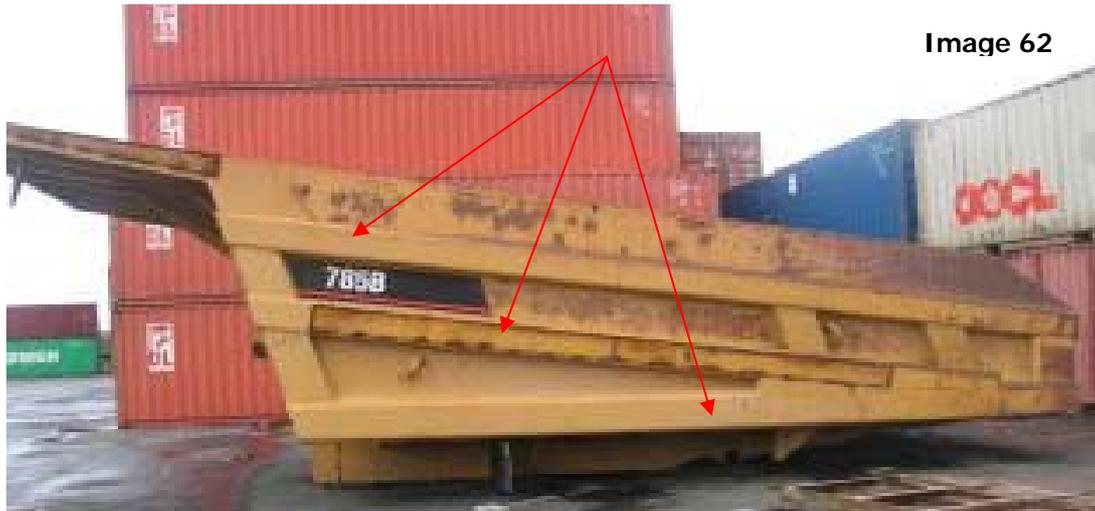
Image 62

Dump Truck trays such as the one illustrated above can be one of the major areas that harbour contamination and none may be visible. These trays possess an internal lining or 'skin', which hides a hollow area, capable of harbouring hundreds of litres of contamination.

The gussets or ribs along the sides and across the bottom also have the potential to harbour significant amounts of contamination. Dump Trays are prone to damage simply due to the size and weight of the cargo that they carry. If there is any evidence of hairline cracks, splits, new welding or evidence of repair, then all these areas need to be investigated. Trays with suspected contamination inside cannot be released until completely verified.

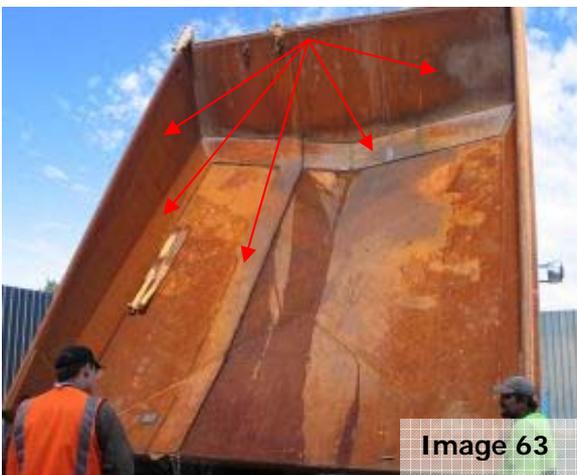
Image 63

This tray comprises of two segments that are bolted together. Once apart, the ribs along the underside are open and exposed to contamination.

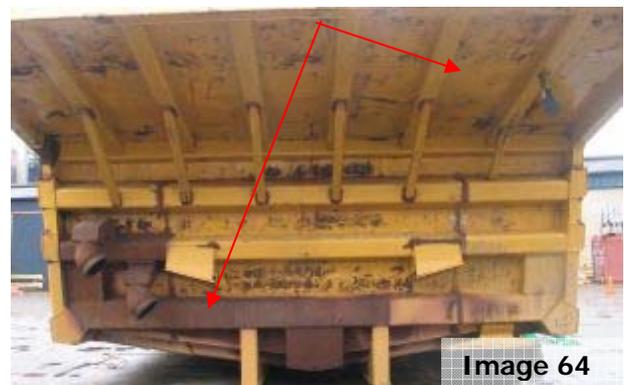
Image 64

This Tray shows evidence of repair and therefore requires investigation of the gussets and ribs.

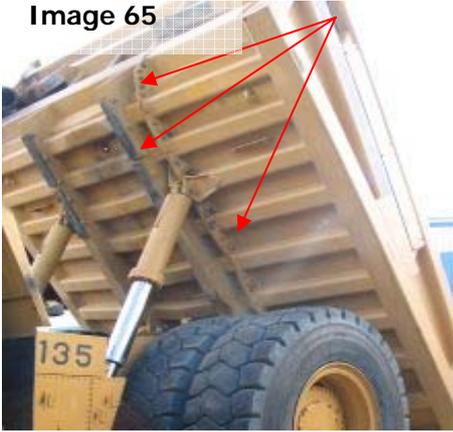
Image 65

Image 65:

Arrows indicate where the tray has been bolted together. The black rubber pads on the underside of the tray require thorough flushing to ensure clean.

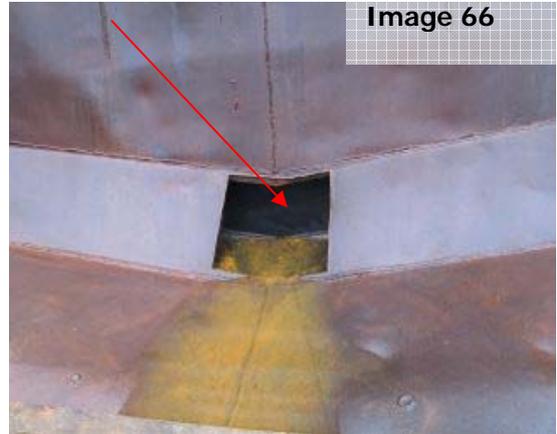
Image 66

The front of this tray showed signs of damage and prior to import the contamination was removed. AQIS is not in a position to order the cutting of any part of any imported machine. If there is evidence of cracks, splits or repair, then it is the responsibility of the importer to prove that these areas are free of all contamination.

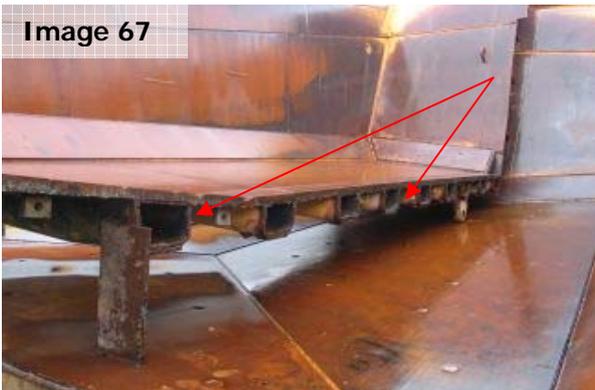
Image 67

Images 67 & 68:

Tray cut prior to import, highlighting the hollow ribs/gussets on the underside of the tray.

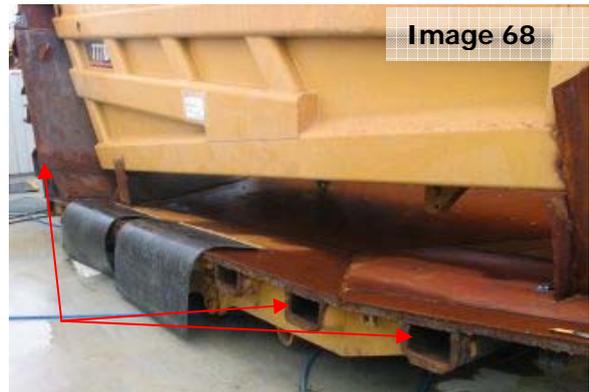
Image 69

Image 69:

This tray showed signs of damage prior to import and as a result holes were placed at the rear of the ribs/gussets running along the sides.

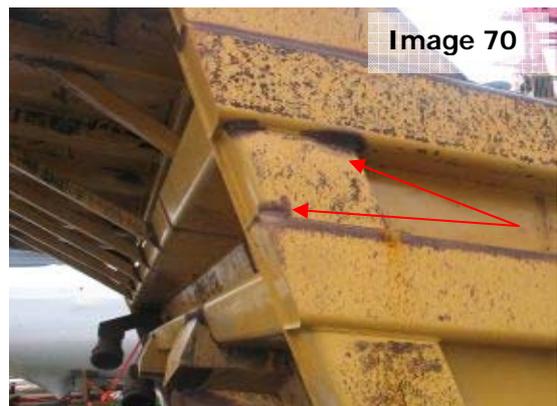
The outside front of the Tray. Note the vertical line indicating and opening. The right arrow shows evidence of new welding. Although not clear in this photo, the blue arrow indicates a crack in the rib/gusset, which requires further investigation.

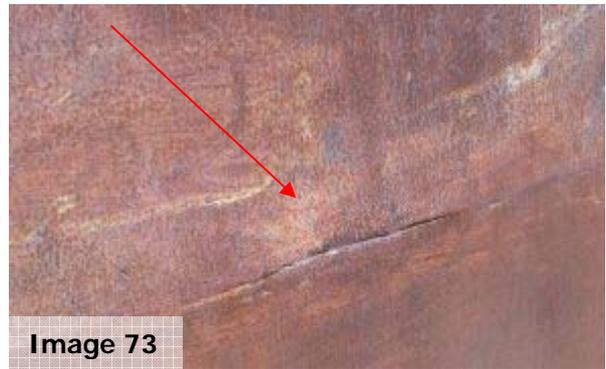
Images 73 & 74:

Crack in the 'Skin' and damage along the top of the side.

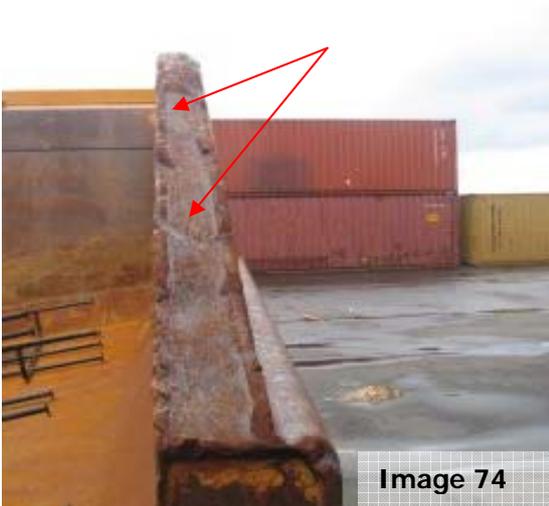
An example of a crack in the tray of a dump truck. If areas like this are found, then they need to be investigated.

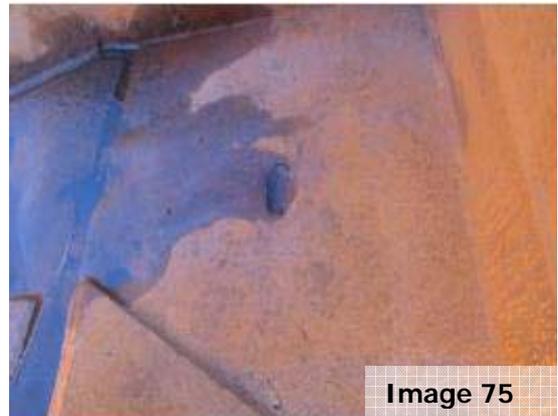
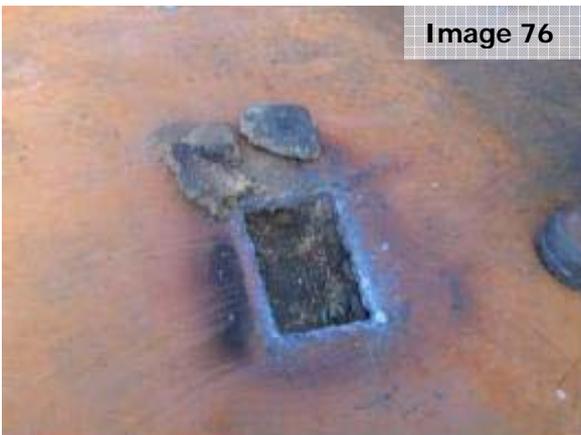
Image 76

Once this crack was investigated, it revealed an inch of contamination between the two 'skins'. AQIS does not direct any cutting, however if any cracks, splits or evidence of repair is evident, then that machine cannot be released until these areas are verified clean. It is the responsibility of the importer to demonstrate that these areas are free of all risk material.

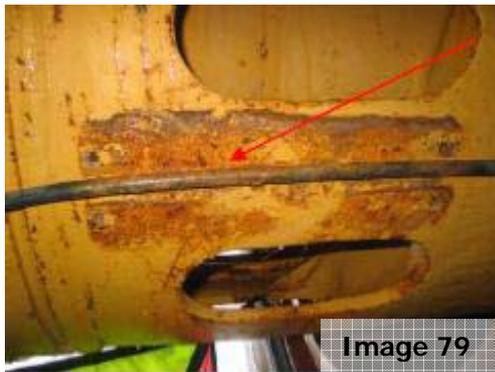
Image 79:

The protective cover on the rim has been removed, revealing contamination.

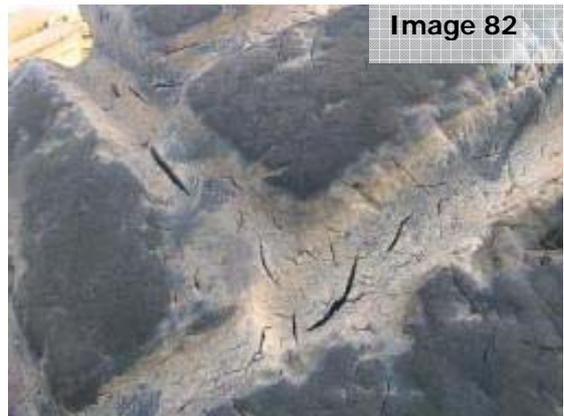
Images 81 & 82

Examples of crack in tyres that all need to be verified clean.

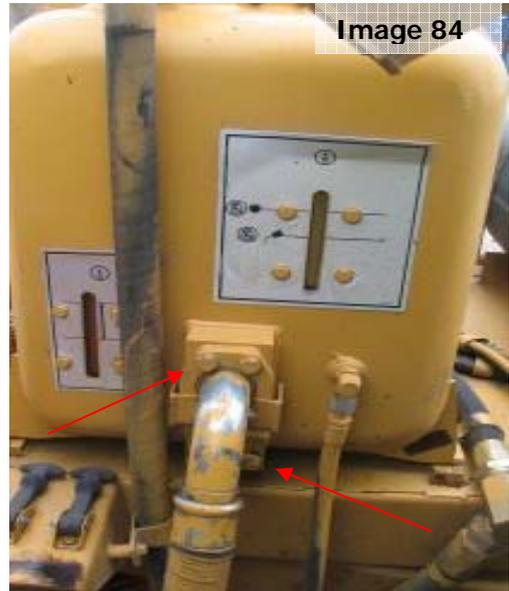
Image 84:
The oil tank situated above the engine is easy to access, however the underside difficult to inspect and may require the use of a mirror. The coupling also requires inspection.

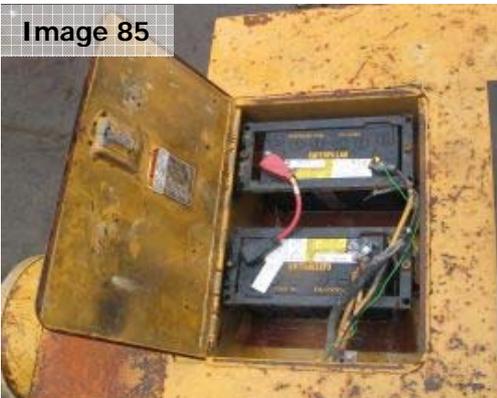
Image 85:
To enable a thorough inspection of the battery box, ensure that the batteries can be lifted and flushed underneath.

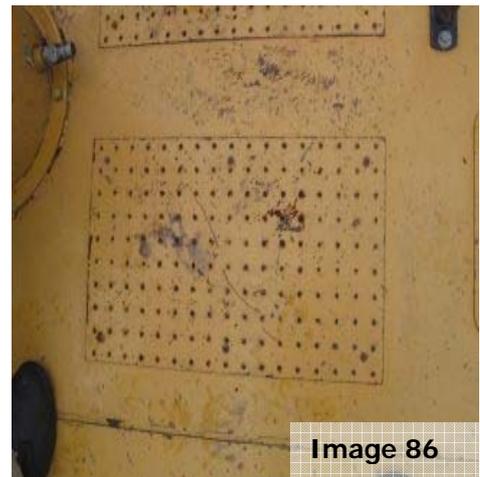
Image 86:
All non-slip checker plate needs to be verified by flushing with high pressure water (some importers have chosen to completely remove).

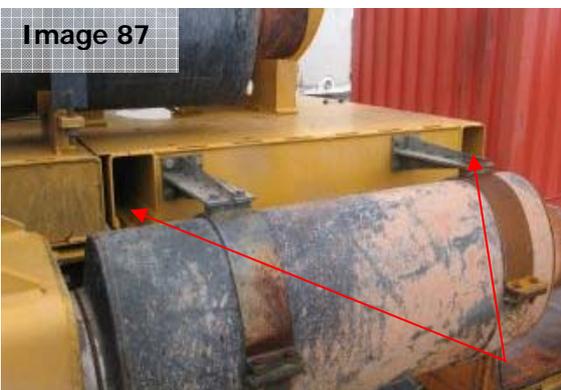
Image 87:
The RH wheel arch from behind. On some models the box channels are open ended such as the ones illustrated above. These require flushing in the presence of the inspecting officer to verify cleanliness.

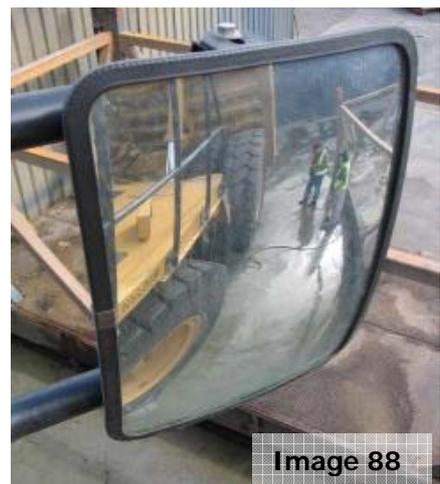
Image 88:
Check all mirrors. If cracked or pieces missing, best to check behind.
