EXCAVATORS

The following cleaning/inspection guide has been segmented to facilitate the process.
The segmentation is as follows:

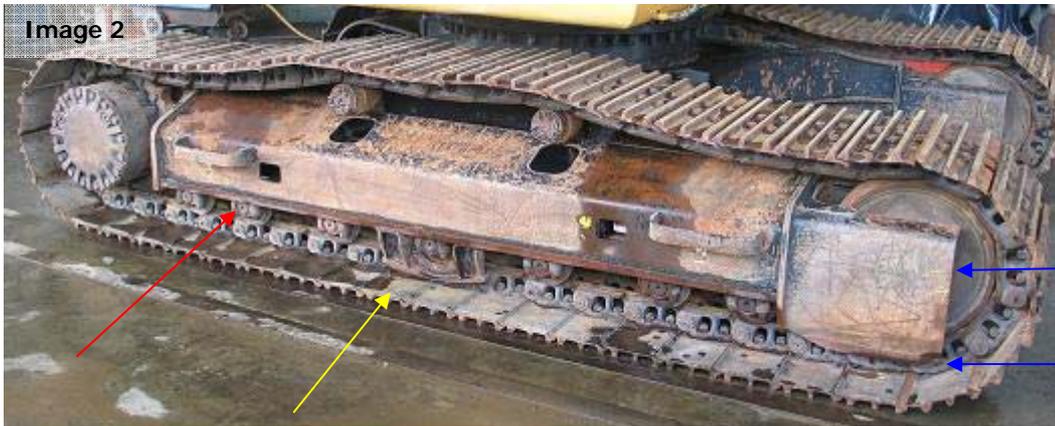
Image 2:

The tracks on any excavator are the main area that comes into contact with soil and other Quarantine risk material. Thorough cleaning and inspection techniques are required. In order to facilitate the cleaning and inspection process, all non-affixed panels, rock guards and motor covers must be dismantled. The yellow line indicates a small rock guard, which may not require dismantling. The red line indicates the rollers and the blue the hollow channels on the idler wheel frame.

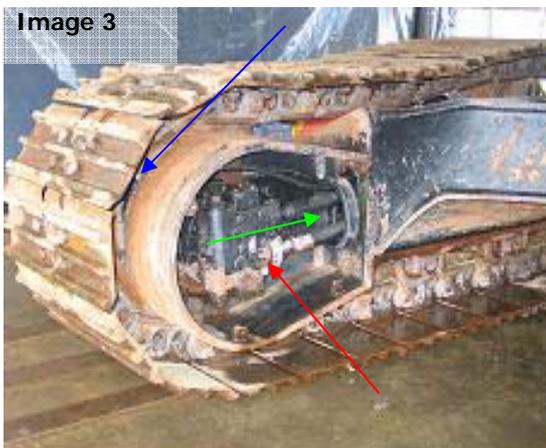
Image 3:

Red line indicates that the motor cover has been removed, allowing access to the drive motor. The green arrow indicates the hollow channel, which extends up through the frame into the turret or slew ring. These hollow areas on each side need to be thoroughly flushed to ensure cleanliness. The blue arrow indicates the area at the rear of the motor cover, which can be easily overlooked.

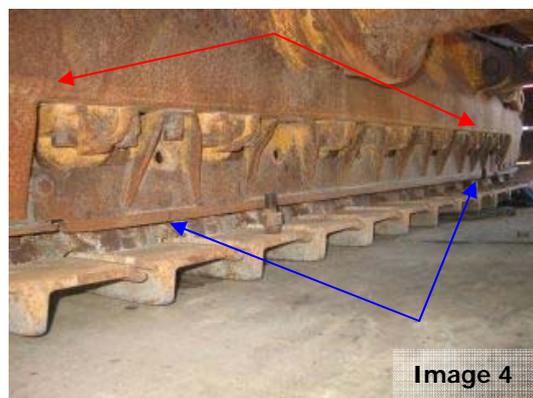
Image 4

Illustration of rock guards (red arrows) on a track frame. The frame to which these rock guards is attached (blue arrows), is hollow and must be verified clean. To verify this hollow area and around each roller, the rock guards must be dismantled.

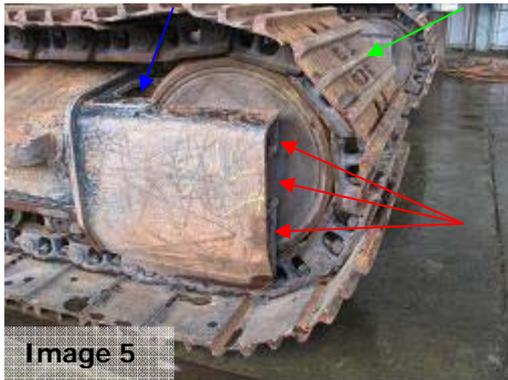
Image 5:

This picture indicates the hollow sections that can be found supporting the idler wheel. All these hollow areas require thorough flushing to remove all contaminants. These hollow sections can also be found on the inside of the idler wheel – green arrow.

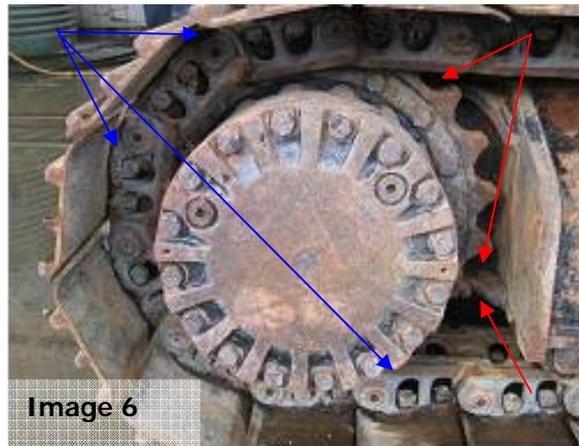
Image 6

This picture indicates the outside of the drive motor. The red arrows highlight the rear of the motor cover and the blue arrows highlight each track nut.

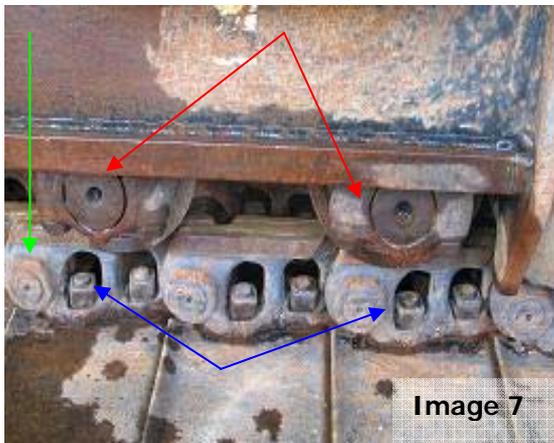
Image 7:

The blue arrows highlight the small gaps either side of each nut where contamination is commonly found. The red and green arrows highlight small hollow areas where contamination can become compacted.

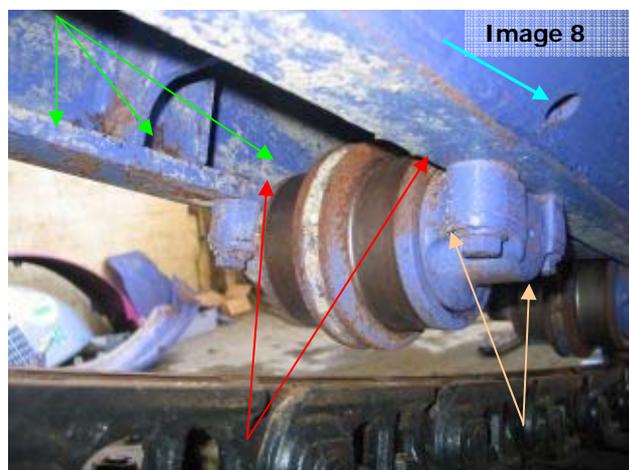
Image 8:

This picture highlights the roller inside the track frame. Not the horizontal ledge inside the frame highlighted by the green arrows. The red arrows highlight the small gap either side of the roller while the aqua line shows a drainage hole, sometimes found on the turret of some excavators.

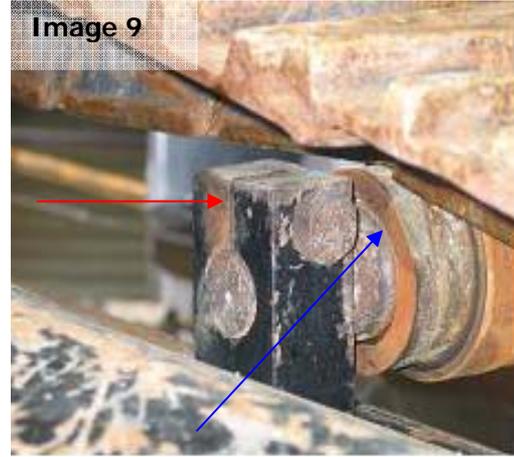
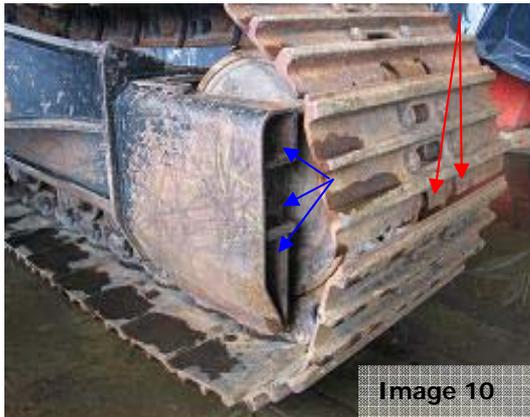
Image 10:

Indicates the top roller above the track frame. The red arrow highlights the small gap at the rear, which must be flushed while the blue highlights the small gap at the rear of the roller.

Blue arrows again show the hollow framework that requires thorough cleaning and the red highlight where the track pads connect to the chain. All tracked machines undergo one full revolution to ensure cleanliness. The picture below highlights the track pads opening slightly at the apex, allowing this area to be cleaned.

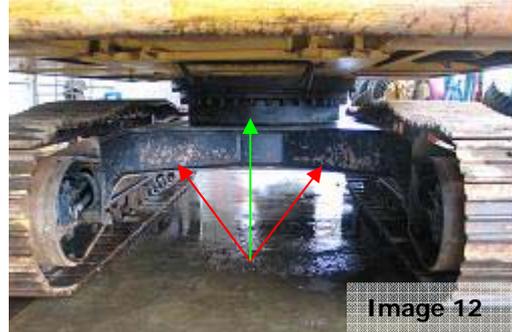
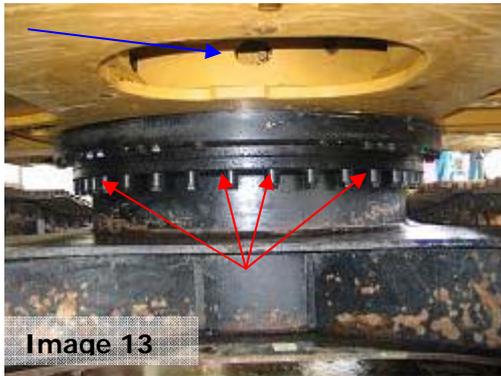
Image 13:

A closer view of each nut/bolt that attaches the carbody to the turret. The blue arrow highlights just one of the plates which has been removed, allowing access to the underside of the engine.

The red arrows highlight the various ledges that can be found inside the turret/slew ring, each ledge requires thorough cleaning. The green arrow points to the hollow channel where the hydraulic hoses run down through the turret housing to the drive motors (yellow line demonstrates the path of the hydraulic hoses). This area must be flushed in the presence of the inspecting officer to verify cleanliness.

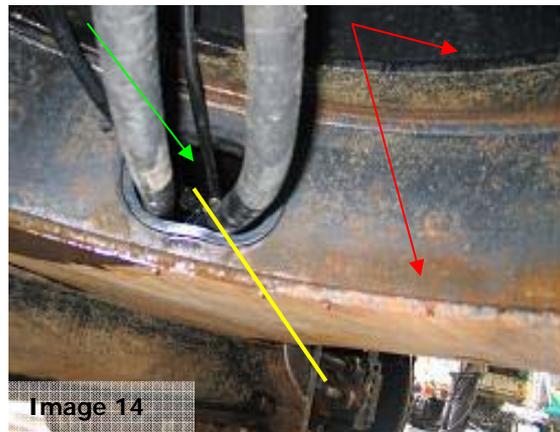
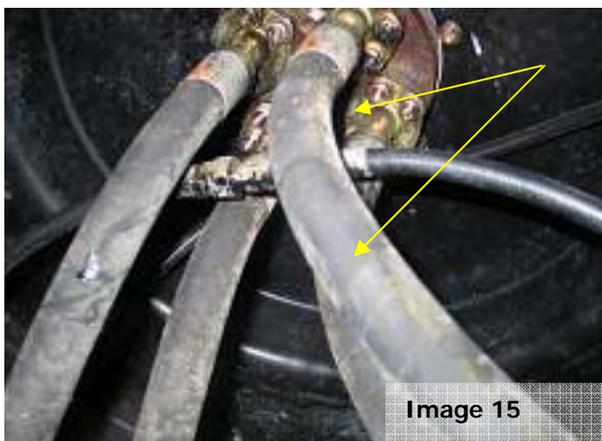
Image 15:

The hydraulic hoses inside the turret/slew ring. Each hose must be individually cleaned.

The RH side of the engine bay. On some models the horizontal blue line highlighted in this picture indicates a hollow channel while the red arrow on the left indicates the entrance to this area. On other models this area is completely sealed. If this channel is open ended, it will require flushing in the presence of the inspecting officer.

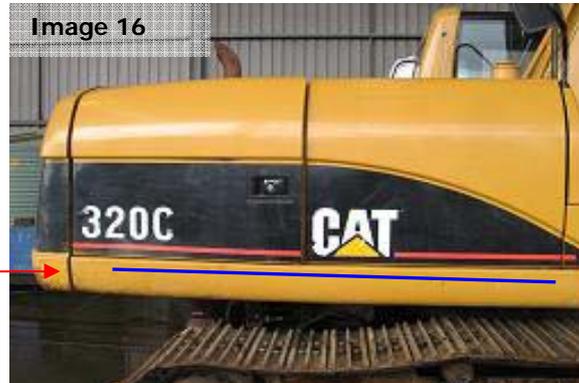
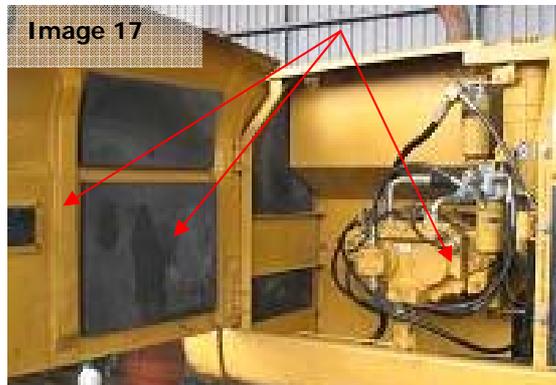
Image 17:

Check all engine doors for hollow support channels. Check for drainage holes or if only spot-welded – will require flushing if not completely sealed. Check all foam insulation and hydraulic hoses.

Check all surfaces and hydraulic hoses for cleanliness as indicated by the red arrows. The blue line indicates an accumulation of hydraulic hoses, bound together by zip-ties. These hydraulic hoses need to be separated to allow cleaning and inspection.

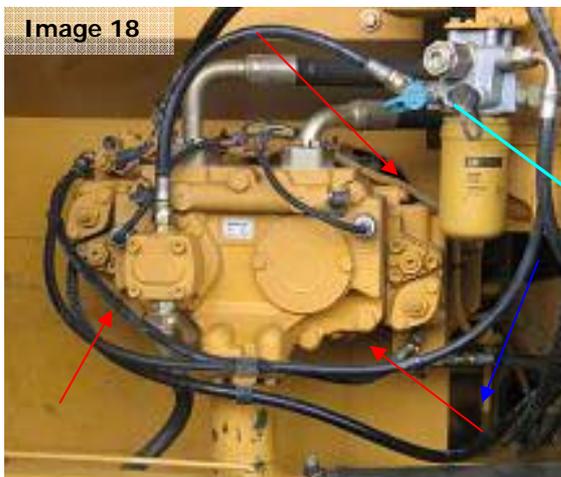
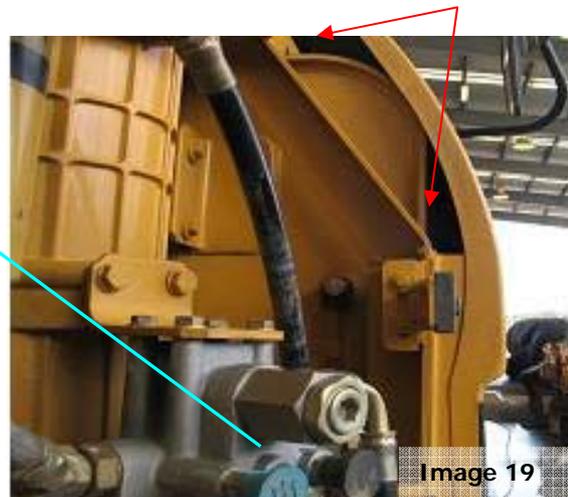
Image 19:

The small blue cap seen on the left is also the one seen in this picture. It highlights the fuel cell, located forward. The red arrows show the gaps at the side and above where contamination may accumulate.

Image 20:
The battery box located just in front of the fuel cell on the RH side of the excavator. Ensure the hollow, open-ended sections in the battery-box cover are flushed. Check handrail for openings at either end – flush if open-ended.

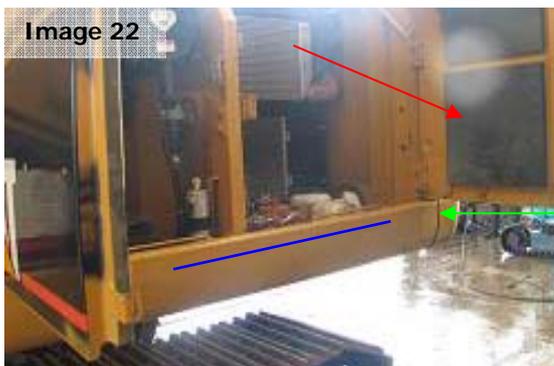
Image 22:
A view of the LH side of the engine bay. Check all insulation foam (red arrow). The blue line again indicates that this section may be a hollow channel while the green line highlights the opening to this hollow section. This hollow section is not applicable on all models.

Image 23:
The red arrow highlights the air-filter, which needs to be removed and checked for cleanliness. An air hose is the best way to verify cleanliness. The blue line highlights the fuse-box. This area is generally well sealed, however an internal cleanliness check is required. The green arrows highlight the oil coolers. Each must be flushed to ensure cleanliness.

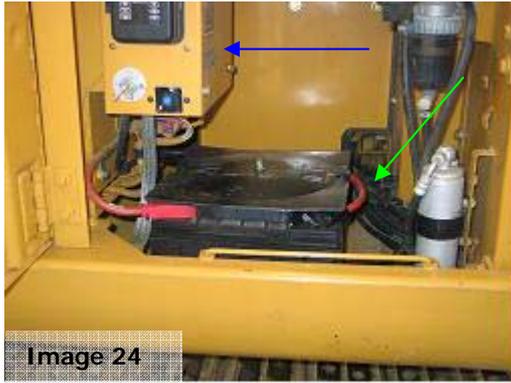
Image 24:

Another view of the LH side of the engine bay. The blue arrow again indicates the fuse-box (access is required), while the green arrow shows an accumulation of hoses that are held together by zip-ties. Each hose must be cleaned and inspected.

Another view of the oil-coolers and radiator core. All require flushing to verify cleanliness. To allow access to the radiator at the rear, the oil cooling fins may have to be dismantled to allow thorough flushing.

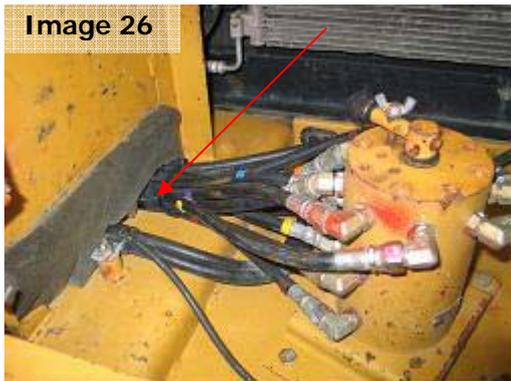
Image 26:

An accumulation of hydraulic hoses bound together with zip-ties.

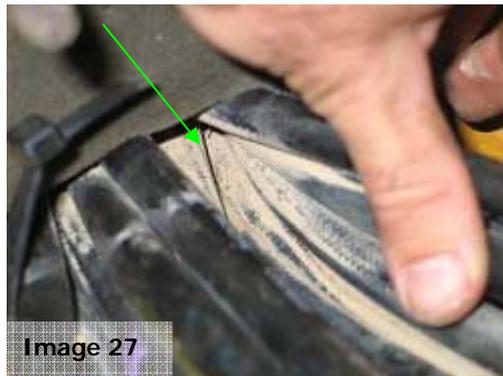
Image 27

The zip-tie removed, allowing the hoses to be moved and highlighting contamination between the hoses.

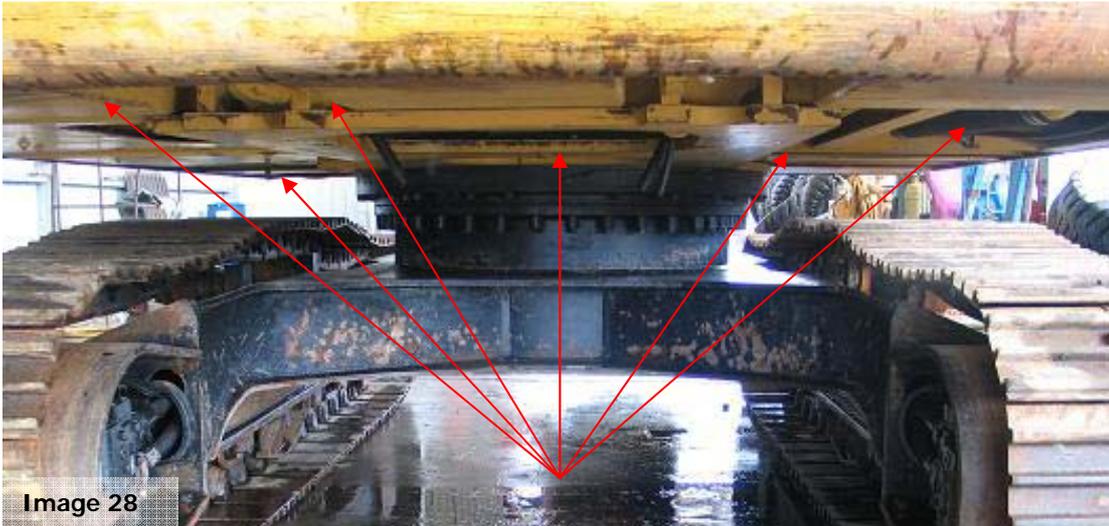
Image 28:
All non-affixed panels on the underside of the carbody have been removed allowing access for cleaning and inspection.

Image 29:
When the non-affixed panels on the underside of the carbody are dismantled, this allows access to cleaning and inspection staff. Areas like the one highlighted above requires careful attention and a mirror may assist the inspection process.

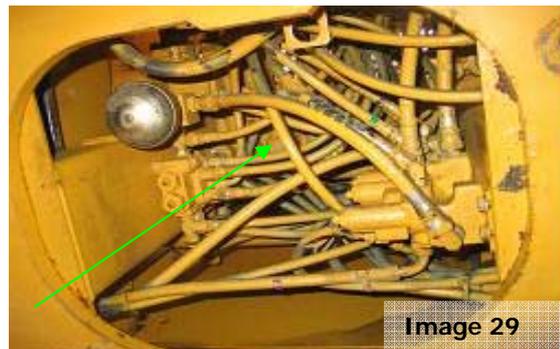
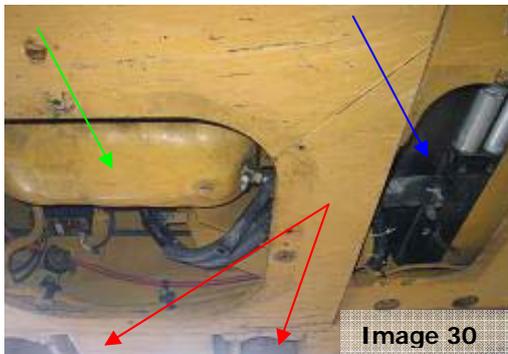
Image 30:
The bottom of the sump (green line) is visible with the non-affixed panels removed. All contaminated grease and oil residues must be removed during cleaning. The blue line shows the bottom of the radiator, while the red lines show where the counterweight attaches on some models.

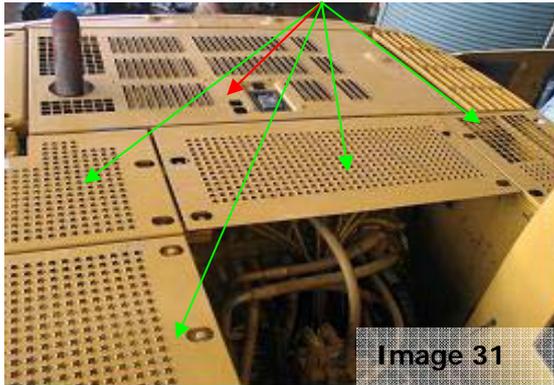
Image 31:
The topside of the engine bay. The red arrow highlights the engine cover that opens, allowing access to the topside of the block. The green arrows highlight the remaining engine covers that are non-affixed and can be dismantled to allow for cleaning and inspection.

Image 32:
The engine cover open, allowing access to the topside of the engine block (red) and radiator (blue).

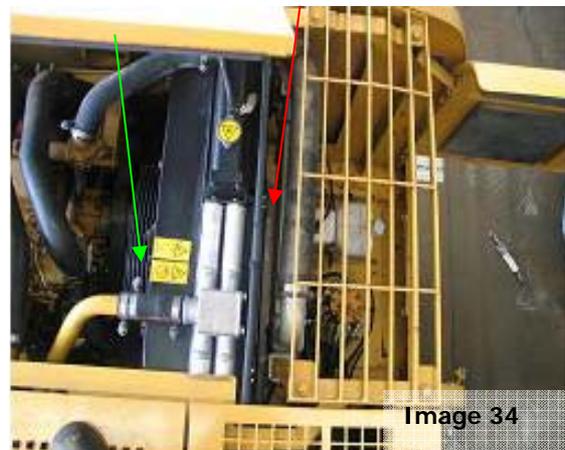
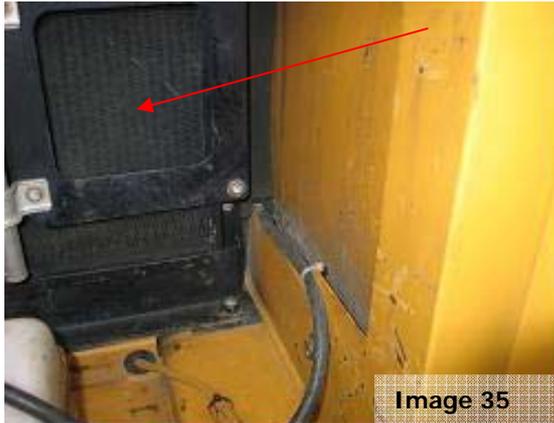
Image 35:
On some models, a mesh grill protects the radiator core. These mesh grills need to be removed as the gauge is small and prevents contamination caught in the radiator fins from being successfully removed.

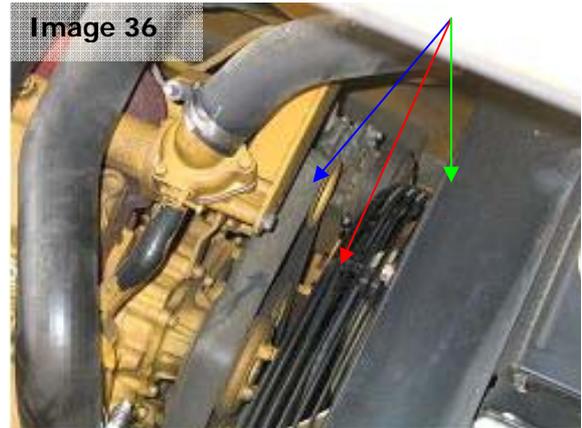
Image 36:
Check the sides of the block, including the harmonic balancers (blue line) as contamination can become caught in front of these open ended flywheels. The red line indicates the radiator grill, which if still present, prevents access to the bottom of the radiator shroud (green line).

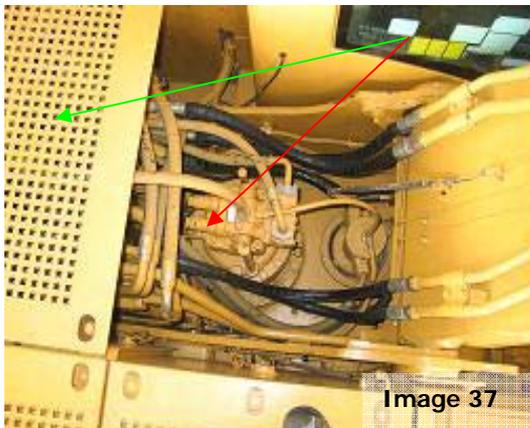
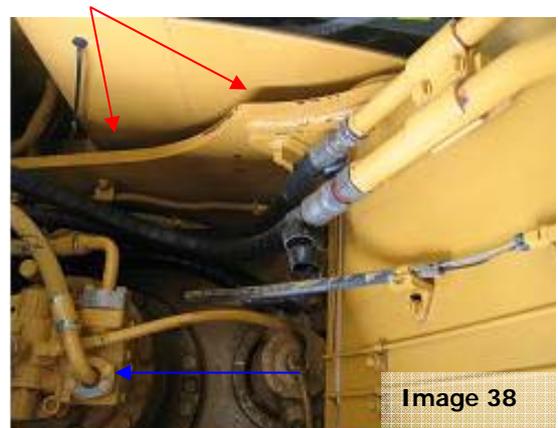
Image 37:
The accumulation of hydraulic hoses (red line) situated just behind the boom stick. Sometimes this area may be covered by a non-affixed panel, which will need to be dismantled to allow access. Other non-affixed panels (green line) can also be dismantled to facilitate the cleaning and inspection process.

Image 38:
Ensure that the small gap between the cabin wall and the base of the boom stick is cleaned and inspected. Contamination can often accumulate inside the small gaps where the hydraulic hoses connect, indicated here by the blue arrow.

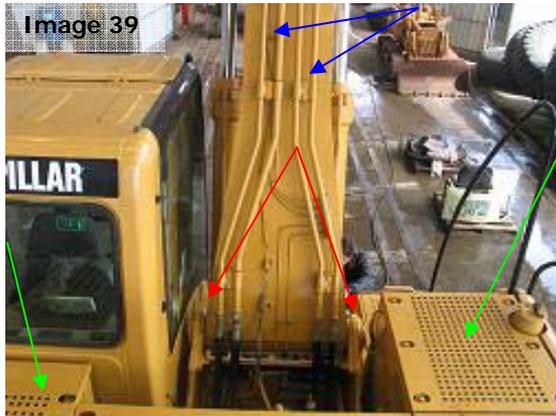
Image 39:

The base of the boom stick and checker-plate above the engine. Ensure all contaminated grease is removed from the pivot –points (red arrows). Flush under all the checker-plate as indicated by the green arrows. Check all hydraulic lines and mounting points (blue arrows). The boom can be extended and lowered to address occupational health & safety concerns (otherwise use scaffolding or cherry picker).

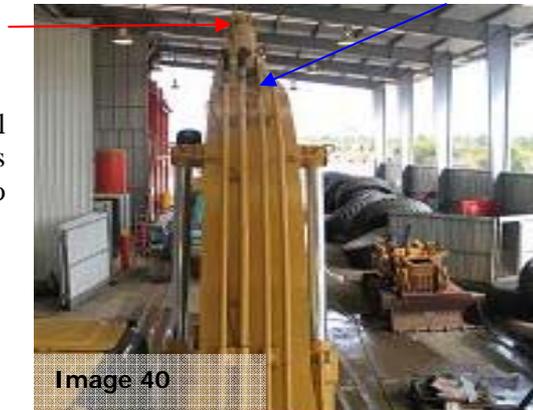
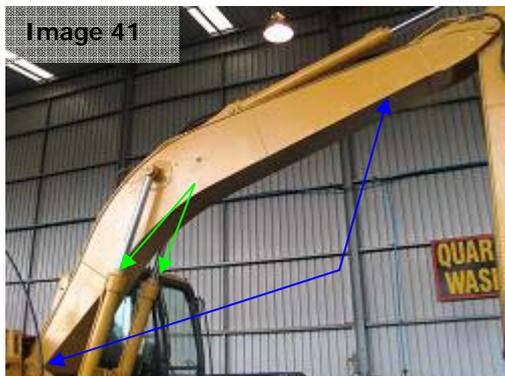
Image 40:

Check along the length of the boom, ensuring all risk material including contaminated grease is removed (red line). All hydraulic lines need to be cleaned and inspected (blue line).

Check along all surfaces, hydraulic rams (green arrows) and for the presence of any drainage holes or openings in the boom stick (blue lines).

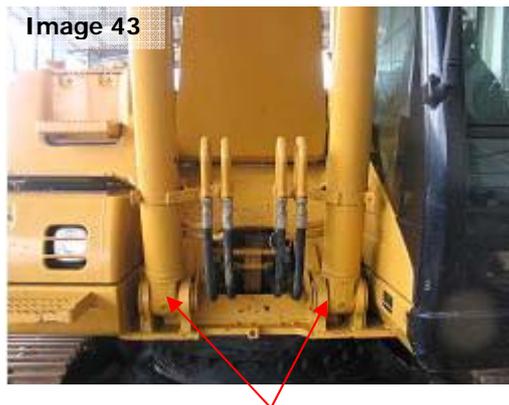
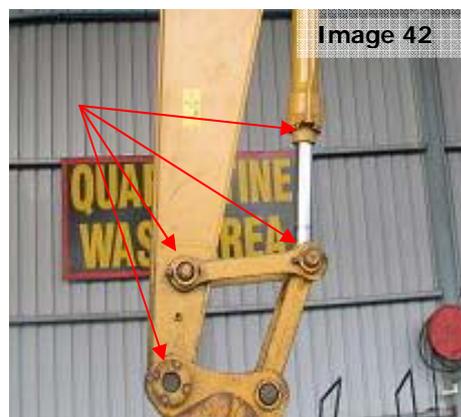
Images 42 & 43:

Ensure all rams and pivot points are clean and free of contaminated grease.

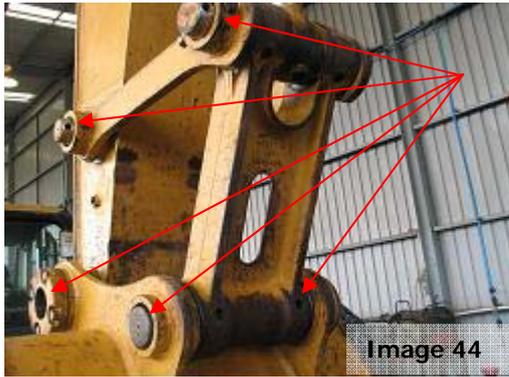
Image 44:
Check all pivot points above the bucket and ensure all contaminated grease is removed.

Image 45:
The wear plates (red arrows) either side of the bucket must be either dismantled or at the very least loosened off and flushed behind. All cutting teeth (blue arrows) must be removed and the teeth can be seen here in the bucket (green line).

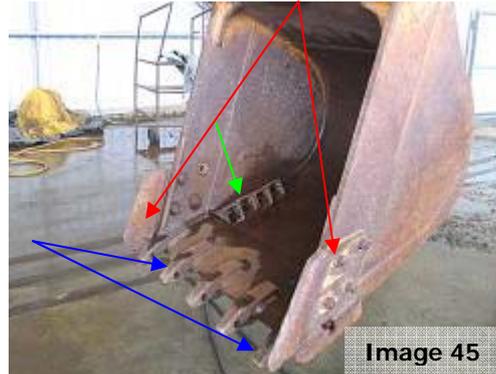
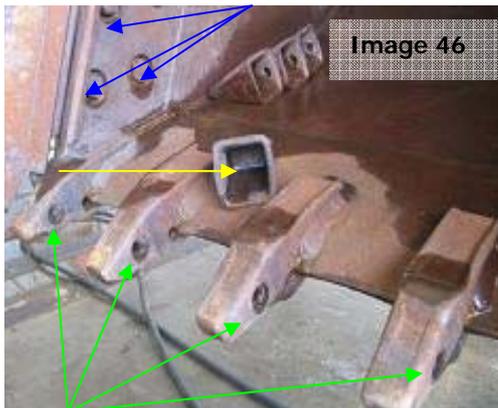
Image 46:
The cutting teeth have been removed, exposing the hole through the centre (green line), which cannot be verified while the teeth are still in place. Ensure the countersunk holes (blue line) where the wear plates attach are free of all contamination. The yellow line shows the inside of the cutting teeth – quick and easy to verify if presented in this manner.

Image 47:
A close up of the boots and which the cutting teeth are mounted. Ensure around each pinhole is clean. The blue arrows highlight a narrow opening that tends to become compacted with risk material and can be overlooked if the cutting teeth are still attached.

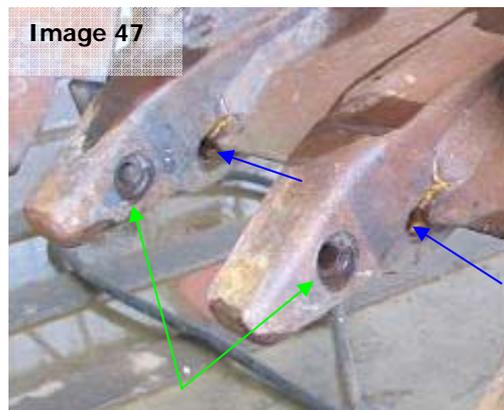
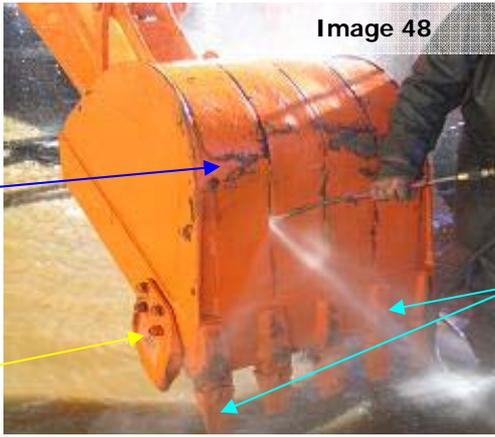
Image 48

Evidence of a crack/split (blue line) in the wear plate on the underside of the bucket. Side wear plates (yellow line) need to be either removed or loosened and flushed. Cutting teeth (aqua lines) must be removed at the time of inspection.

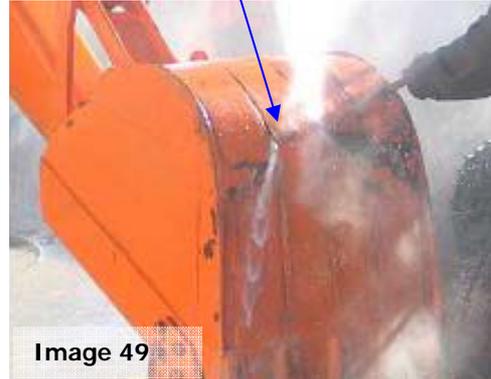
Image 49

If wear plates are only spot-welded as seen in the examples above, ensure that these are verified. E.g. by witnessing high-pressure water being flushed through.

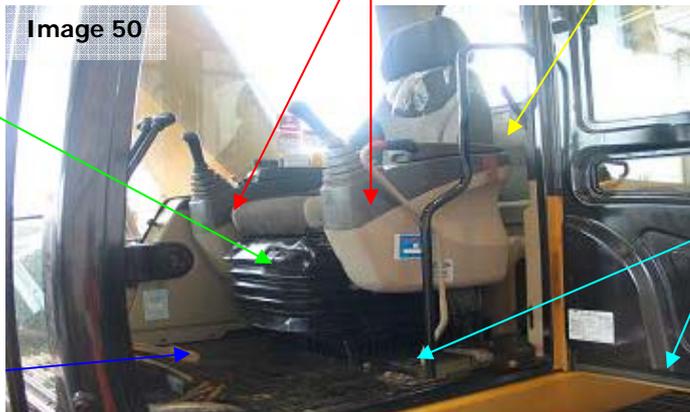
Image 50:

Landscape shot the inside of a typical cabin. Access is required to verify the cleanliness of the internal workings of the joystick controls (red arrows). The seat shroud (green arrow) must be internally and externally cleaned and inspected. If rubber or plastic foot pedal covers are in place, remove and clean. The yellow line highlights the air-conditioning unit, which will be highlighted later. The door rubbers (aqua arrows) can be contaminated and the internal door panelling, depending on the configuration may be harbouring internal contamination.

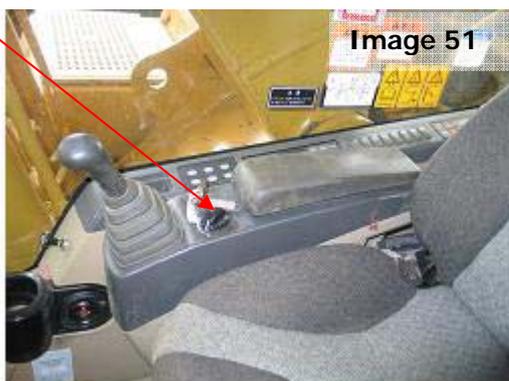
Image 51

Access will be required to check the internal workings of the joystick control panels.

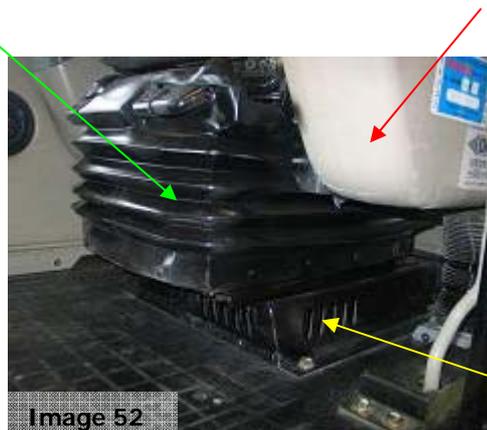
Image 52

The box section below the seat needs to be thoroughly cleaned. Proper access can only be achieved once the four bolts are removed and the seat moved. Access into the joystick control panels (red line) is required. Inside the seat shroud must be cleaned and inspected.

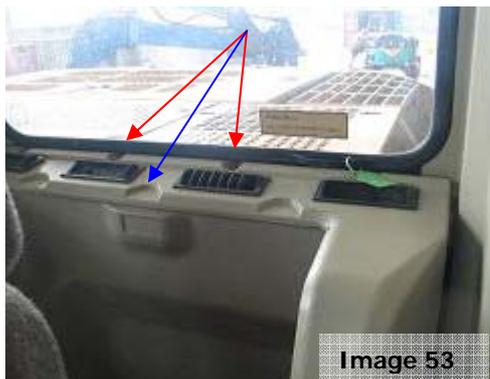
Image 53

Contamination has previously been found in some air-conditioning vents and therefore an area of interest to AQIS.

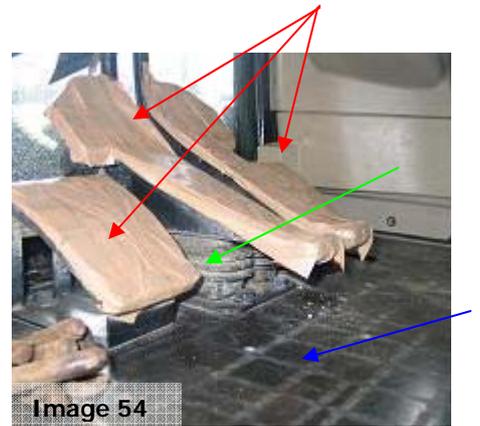
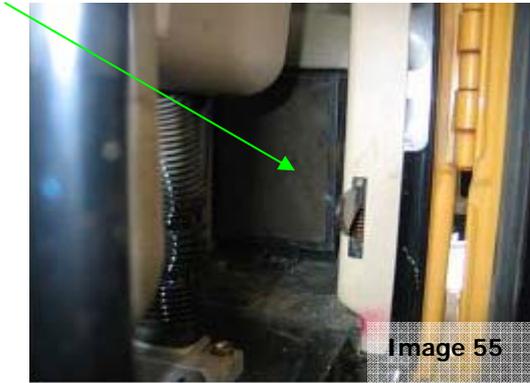
If rubber or plastic foot pedal covers (red lines) are in place, remove and clean. Rubber shrouds below pedals (green line) must also be verified clean inside. Under the floor mat must be clean (blue line).

Located behind the seat in some models is the air-conditioning filter. The filter must be removed, the filter and surrounding area cleaned and verified.

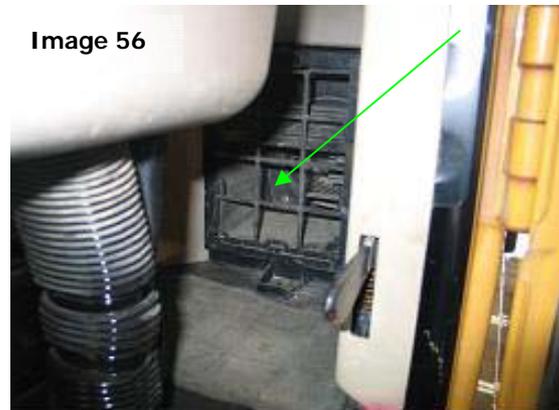
The filter has been removed, revealing contamination inside which must be removed.

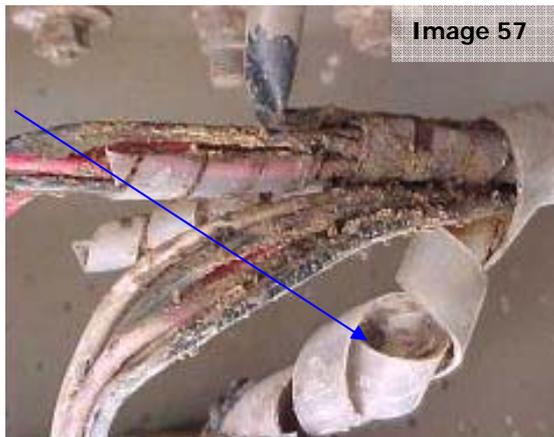
Image 57

Ensure that all looming (blue line) around hydraulic hoses and lines is free of all contamination. Flushing these areas with the looming still in place rarely removes all contamination as can be seen in this illustration.

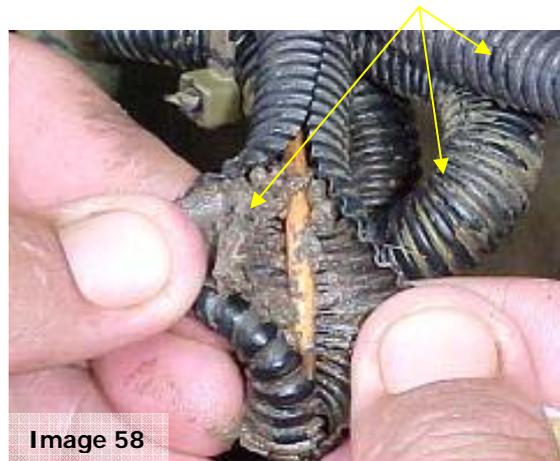
Image 58

All wiring harnesses (yellow lines) must be thoroughly inspected for internal contamination as seen above.

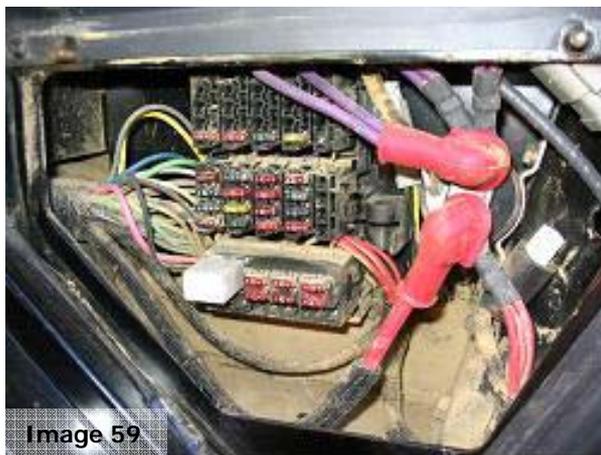
Image 59

Contamination inside the fuse box – must be removed.
