Australian Quarantine and Inspection Service

MEDIUM SIZED DOZERS

Small and Medium Dozers

The following cleaning/inspection guide has been segmented to facilitate the process. The segmentation is as follows:

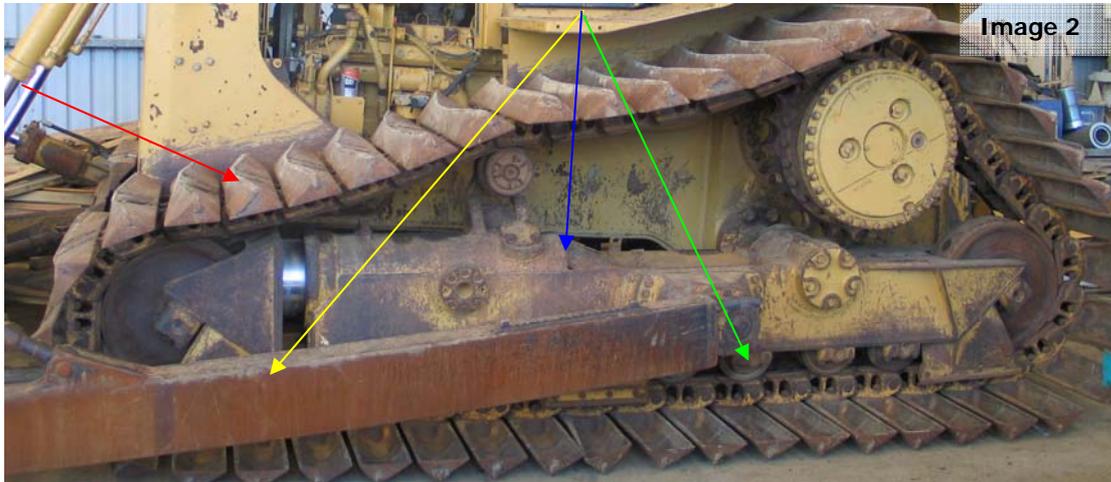
Image 2:

The track pads (swamp tracks – red arrow) on a small model dozer. The track frame (blue arrow), push arms (yellow arrow) and rollers (green arrow) will all be highlighted in the flowing illustrations. To allow a complete inspection, all tracked machinery must undergo one full revolution to verify all track pads and countersunk holes in the rollers and idler wheels.

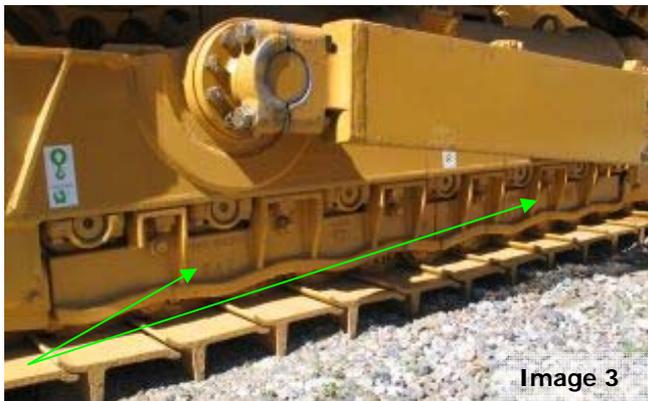
Image 3:

To enable thorough cleaning and inspection, all rock or stone guards (green arrows) which are commonly found on smaller model dozers, must be removed.

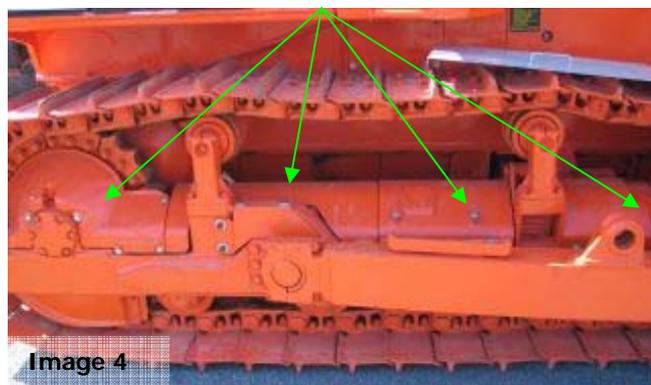
Image 4:

On other small models the topside of the track frame may have numerous non-affixed panels (green arrows) which all must be removed for cleaning and inspection.

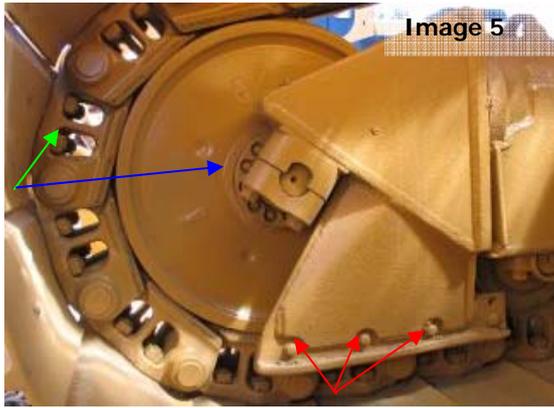
Image 5

The idler wheel on the track frame. The protective plate on the bottom of the track is hollow and will require flushing via the openings (red arrows) to verify cleanliness. All countersunk bolts (blue arrow) on the idler wheel require verification. Each nut (green arrow) holding the track pads must be verified.

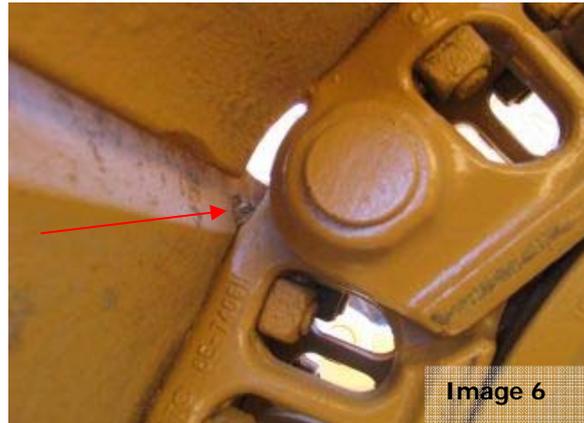
Image 6

The green arrows highlight the small gap either side of the nut, while the blue arrow highlights the rear of the outside nuts, which can be verified from the inside. The red arrow highlights where the track pads attach to the chain. See next illustration

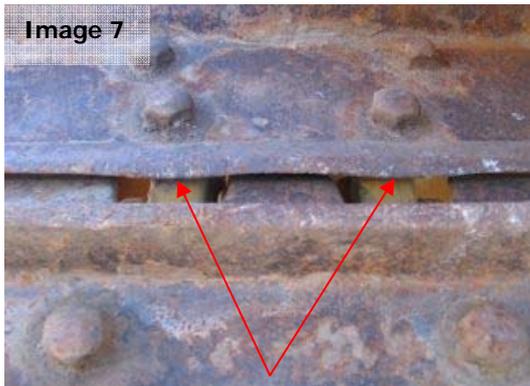
Image 7

When the tracks are rolled, the track pads will open when they pass around the idler wheel, opening the pads so the area highlighted by the red arrows can be cleaned and inspected.

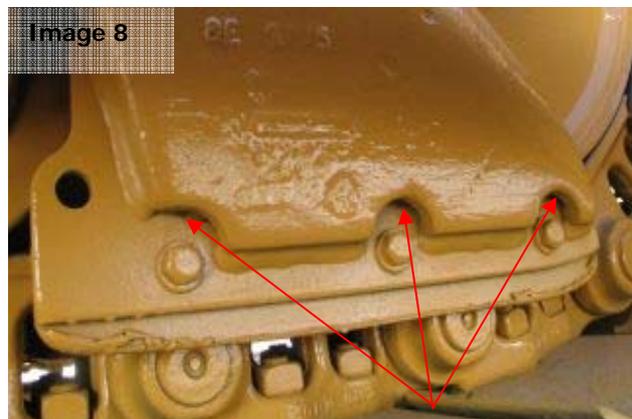
Image 8

The protective cover at the end of the track frame, which is hollow. Flushing via the access points (red arrows) will verify internal cleanliness.

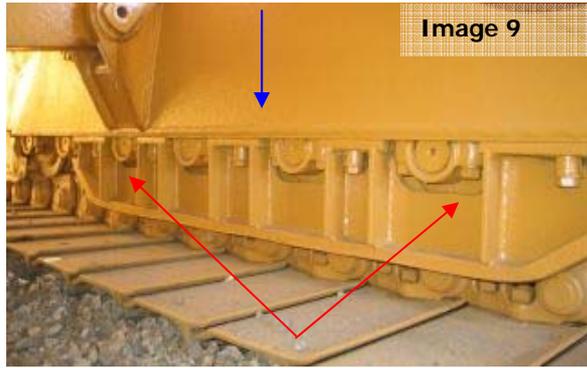
Image 9:

The rock or stone guards (red arrows) in place on a small dozer. These must be removed to allow cleaning and inspection access to the inside of the track frame, but also to allow the hollow track frame (blue arrow) to be flushed, once the bolts have been removed. See next illustration.

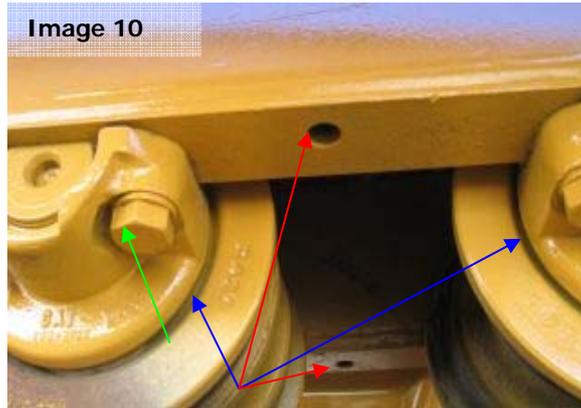
Image 10:

Once the rock or stone guards have been removed, the hole (red arrows) vacated by the bolts allows an access point to the hollow frame for flushing. The rock guards from both sides of the track frame must be removed. Check around each roller nut (green arrow) and flush around the small recess around each individual roller (blue arrows).

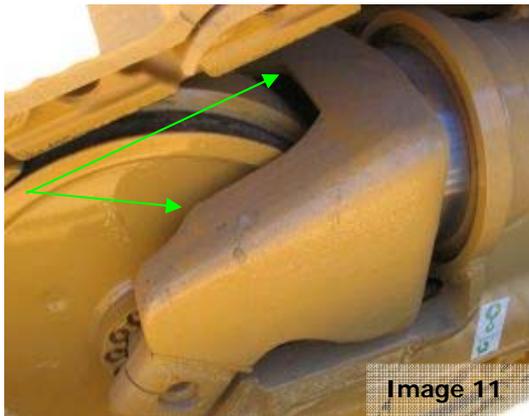
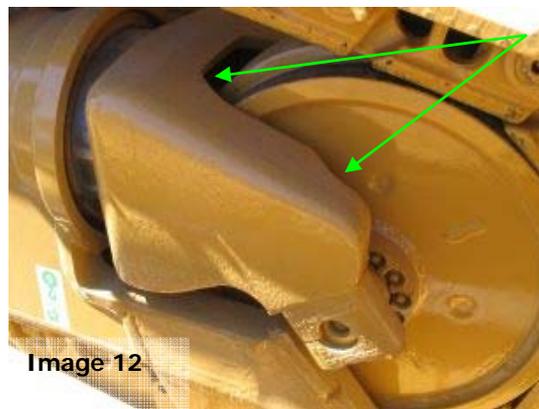
Images 11 & 12:

These illustrations highlight the adjuster ram and the rear idler wheel. There are usually ledges inside the frame (green arrows) that must be thoroughly cleaned and inspected.

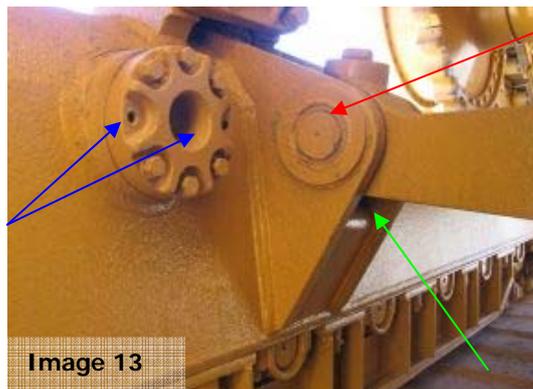
Image 13:

The sway bar pivot point (red arrow) must be free of all contaminated grease. The green arrow highlights the bottom access point for cleaning and inspection, while the blue arrows highlight a number of countersunk holes that must be clean and free of all contamination.

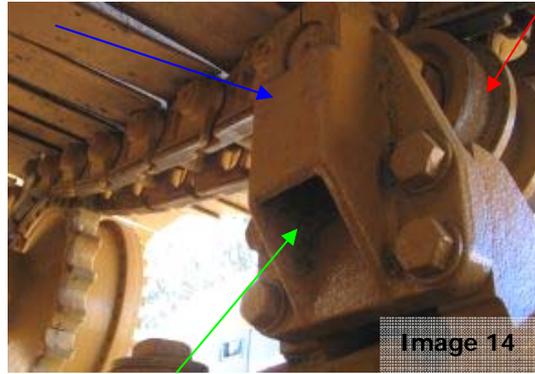
Image 14:

The carrier roller (red arrow) support arm. In this illustration the support arm is open ended (green arrow) and on other models the opening may be topside or at the rear (blue arrow).

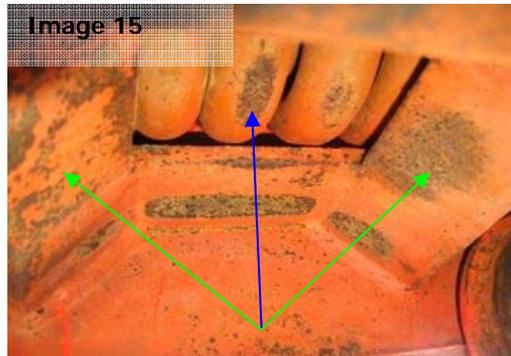
Image 15:

Inside some small dozer track frames, small V-shaped gussets may be found. These V-shaped gussets may be sealed units, however verification if open or spot-welded is required. The blue arrow highlights the track adjuster spring that, due to limited access requires flushing to verify cleanliness.

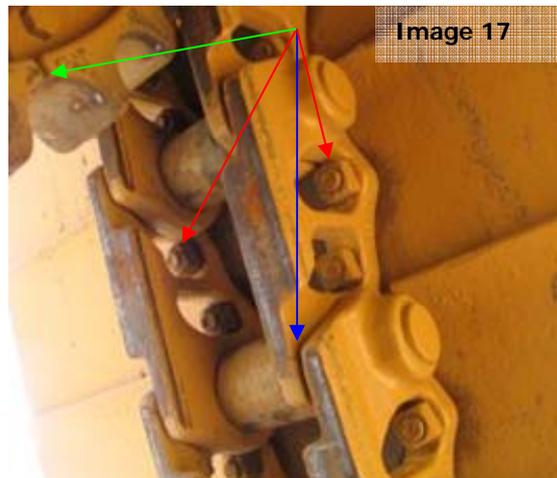
Image 17:

Another view of the track chain, highlighting the track pad nuts (red arrows), the small recess in the drive wheel (green arrow) and the gaps between the track chains (blue arrow). All must be thoroughly cleaned and inspected. In some cases flushing will be required.

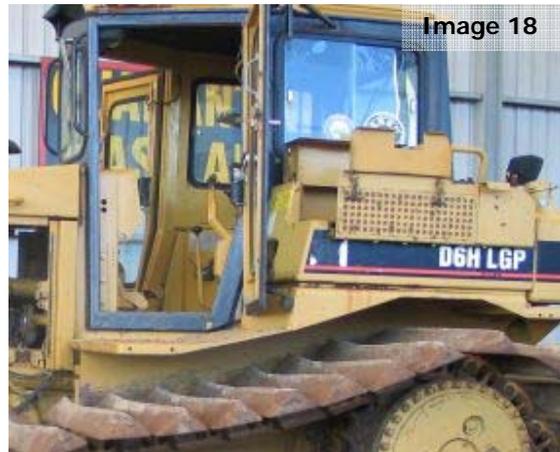
Image 18:

A typical dozer cabin as seen on the D6 model. All cabins require dismantling and through cleaning and inspection.

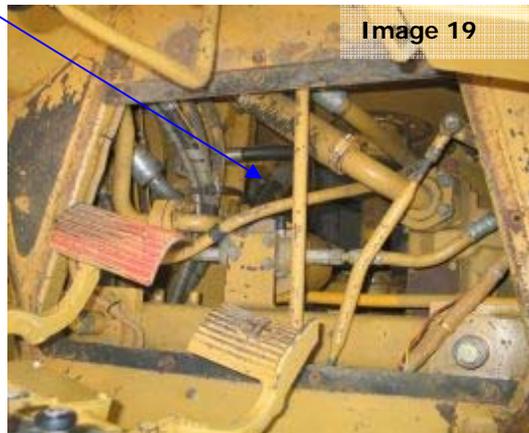
Image 19:

The floorpan immediately below the footpedals has been removed, allowing access to the top of the transmission, bell housing, rear of the engine block and the base of the roll over protection system (ROPS). All will be highlighted in the following illustrations.

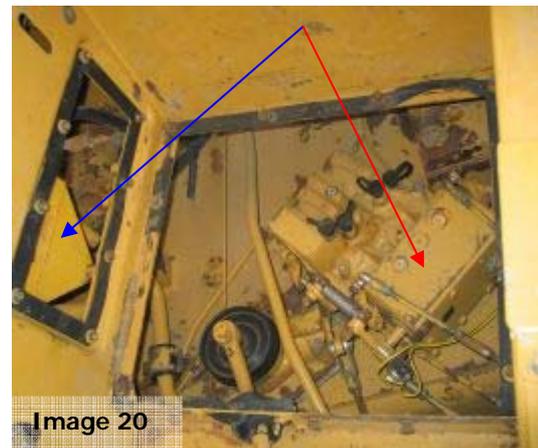
Image 20:

The seat and floor panel below have also been removed allowing access to the topside of the differential and steering box (red arrow). The

non-affixed panel on the side of the joystick control (blue arrow) has been removed for internal cleaning and inspection.

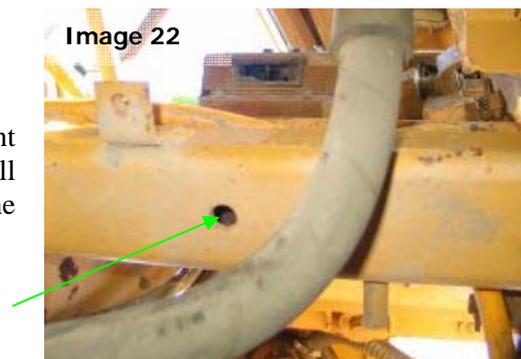
Image 23

The red arrows highlight the base of the roll over protection system (ROPS). These ROPS do not sit flush against the sidewall of the dozer and the small recess must be flushed to verify cleanliness. The bolt heads (blue arrows) at the rear of the ROPS also requires cleaning and inspection.

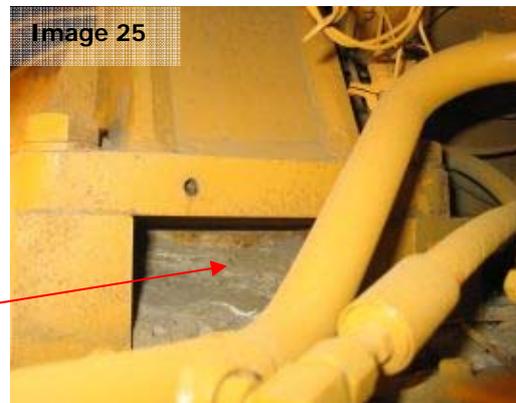
Image 25

Image 25: Some ROPS have large recesses underneath and can be full of contamination as highlighted by the red arrow.

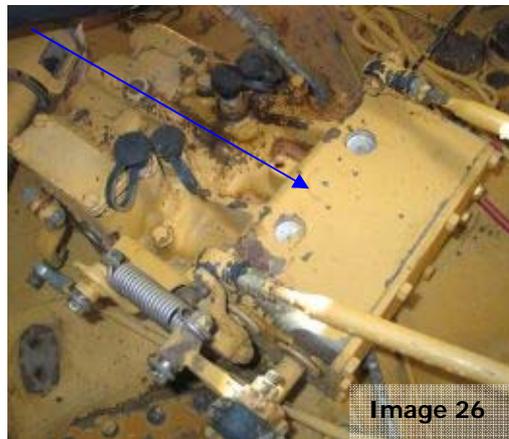
Image 26

The topside of the steering box (blue arrow) as seen under the seat. This requires careful cleaning and inspection due to the undulating surface, bot topside and bottom. Also see next illustration.

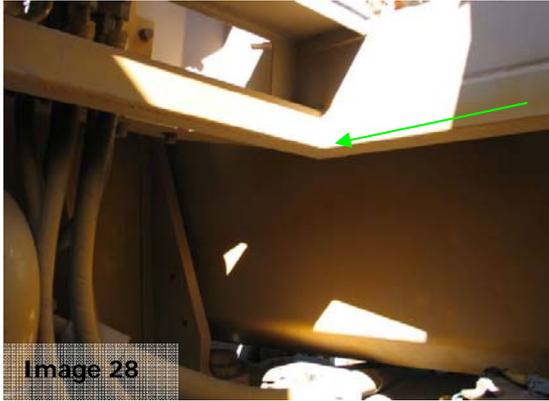
Image 28:
Check all framework under the cabin floor. On some models this has open ends (green arrow), which will require flushing to verify cleanliness.

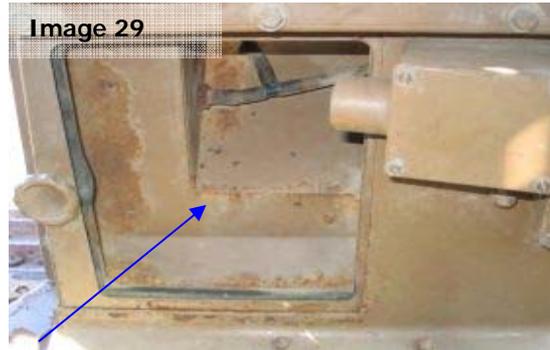
Image 29:
The air-conditioning vent under the instrument panel has been removed for cleaning and inspection.

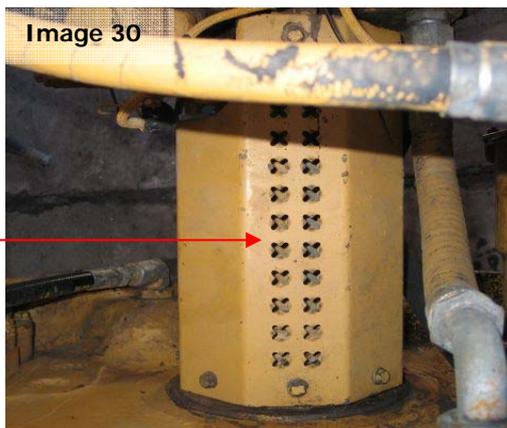
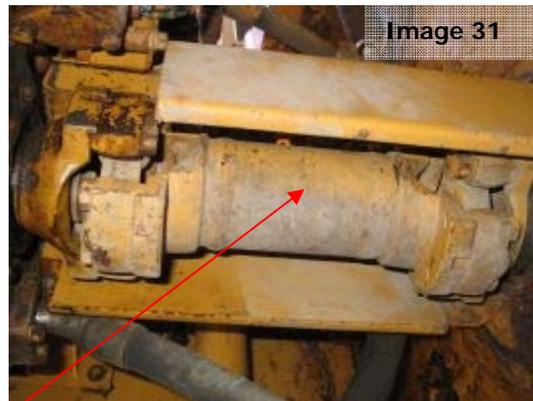
Images 30 & 31:
The protective plate around the universal joint under the floorpan must be removed to facilitate the cleaning and inspection process. The second illustration shows the bottom half of the protective cover removed, allowing access to the universal joint.

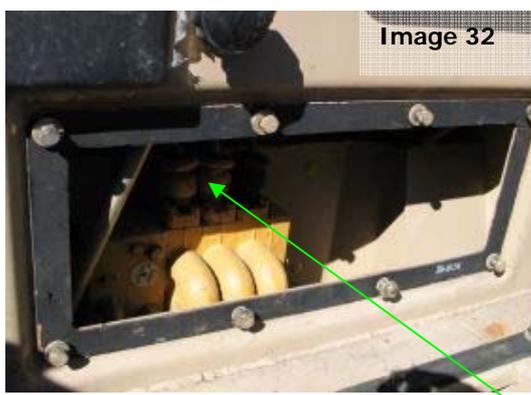
Image 32:
The internal of the right hand joystick control panel. Removing this panel allows cleaning and inspection access to the ledges and hydraulic hoses found inside and require verification.

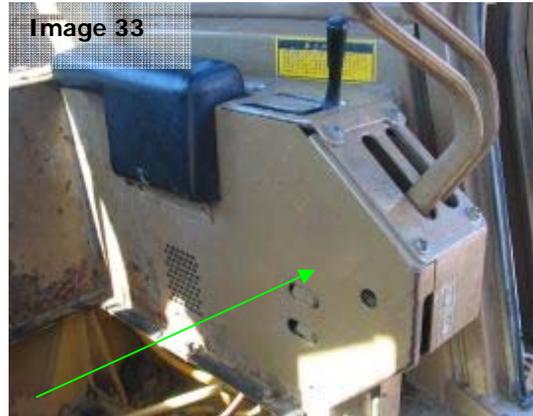
The left hand joystick control panel. Like the right hand panel, internal cleaning and verification will be required.

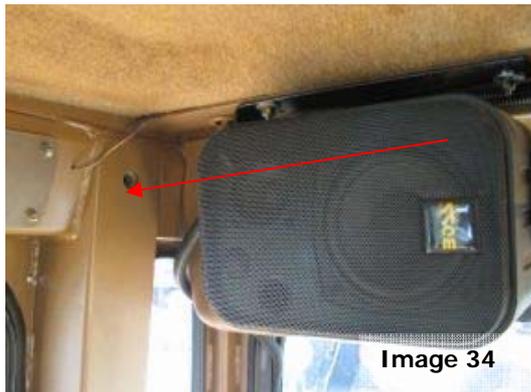
Image 34

Check all internal cabin framework for small holes like the one illustrated. If, present, flush to verify cleanliness.

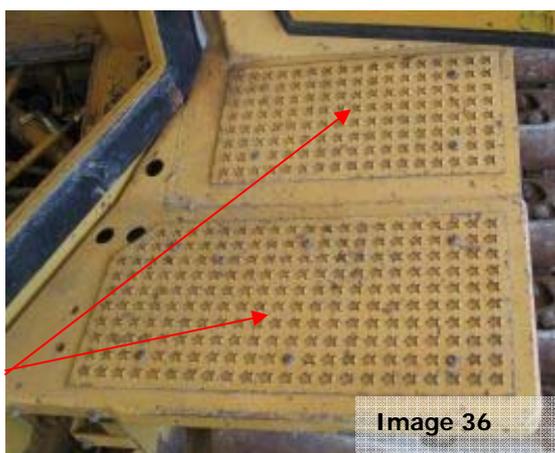
Image 36

The checker plate (red arrow) outside the cabin door which requires flushing to verify cleanliness.

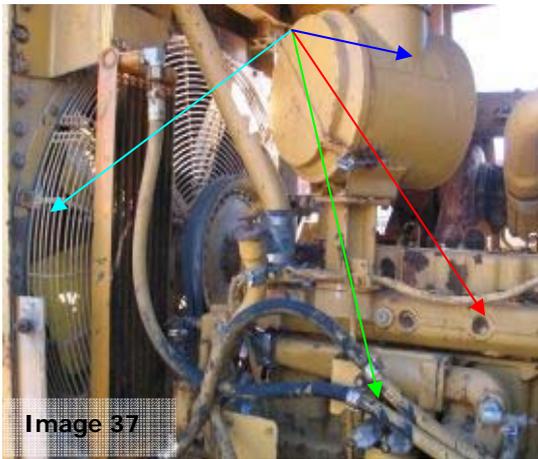
Image 37

The left hand side of the engine block. This illustration highlights the air-filter (blue arrow), the block (red arrow), hydraulic hoses (green arrows) and the radiator (aqua arrow). All must be thoroughly cleaned and inspected. The internal radiator grill (aqua arrow) must be removed for internal access to the radiator shroud.

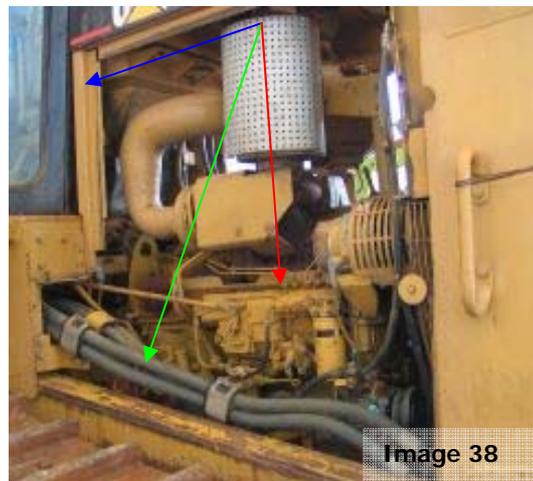
Image 38

The right hand side of the block also highlighting the side of the block (red arrow), hydraulic hoses (green arrow) and part of the engine housing (blue arrow) which must be checked for hollow or open-ended channels.

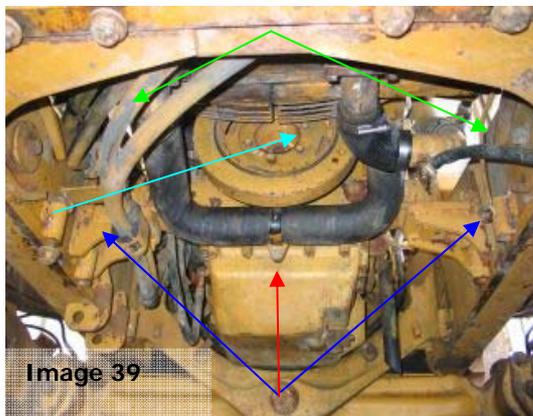
Image 39

The underside of the block of a medium sized dozer. The belly plates have been removed, allowing cleaning access to the sump (red arrow), engine mounts (blue arrows), hydraulic hoses (green arrows) and harmonic balancer (aqua arrow).

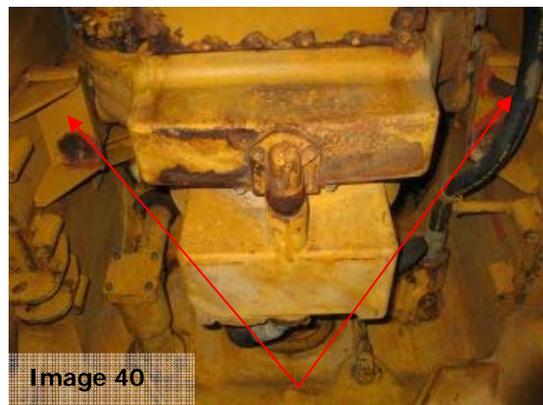
Image 40

The rear of the engine block and bell housing. All surfaces, including rear engine mounts (red arrows) require thorough cleaning and inspection.

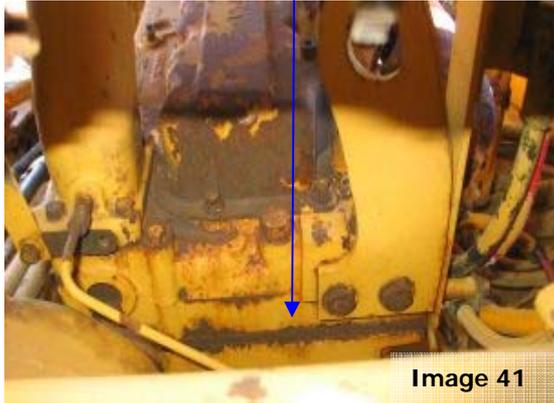
Image 41:
The topside of the block as seen from below the floorpan. From this angle, the rear end of the block can be accessed for cleaning and inspection.

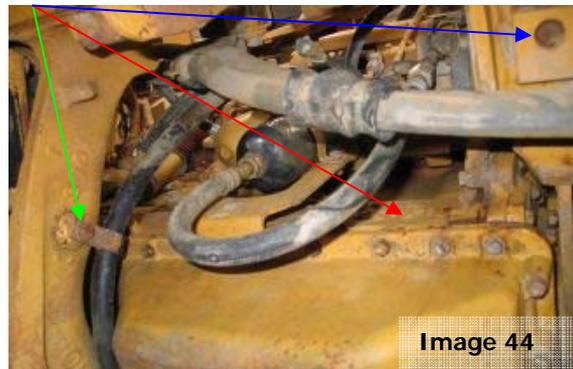
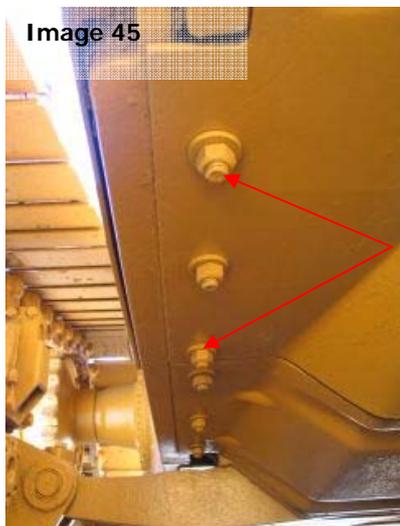
Images 45 & 46:
Once the belly plate bolts (red arrows) have been removed, these may provide access holes to the hollow chassis rails (These chassis rails are sealed on all small models).

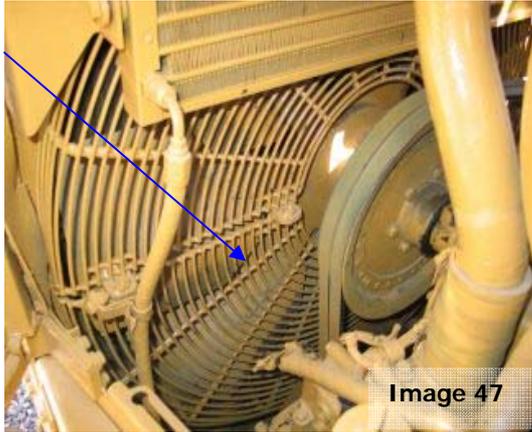
Image 47:
The internal radiator grill (blue arrow) which must be removed to allow cleaning and inspection access to the radiator shroud.

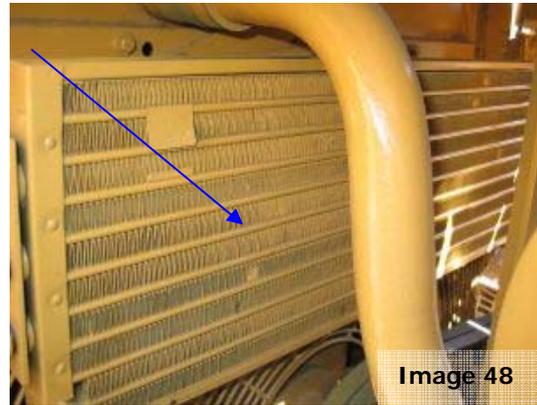
Image 48:
The oil cooler (blue arrow) located behind the radiator. To verify cleanliness, this and the radiator core must be flushed in the presence of the inspecting officer.

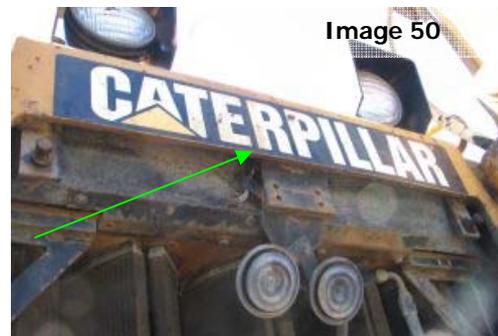
Image 50:
Check along the topside of the radiator for any ledges or channels that will require cleaning and inspection. Flush the radiator fins to verify cleanliness.

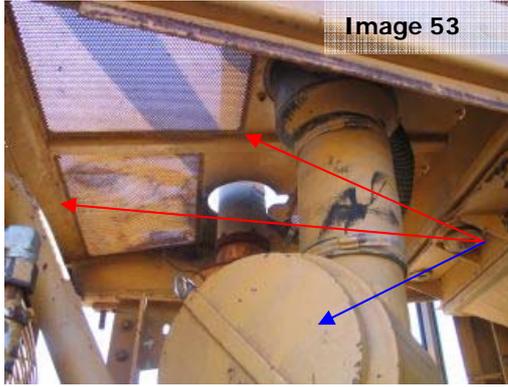
Image 53

Image 53: Check all internal engine housing support framework (red arrow) for hollow, open-ended or spot welded channels. Flush to verify internal cleanliness if present. Remove the air-filter (blue arrow) had verify clean.

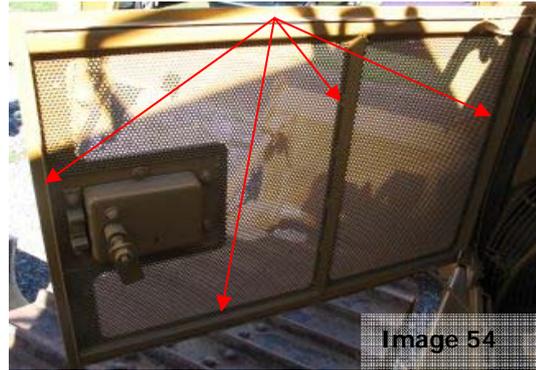
Image 54

Image 54: Check all engine cover doors for hollow, open-ended or spot welded channels (red arrows). Flush to verify internal cleanliness if present.

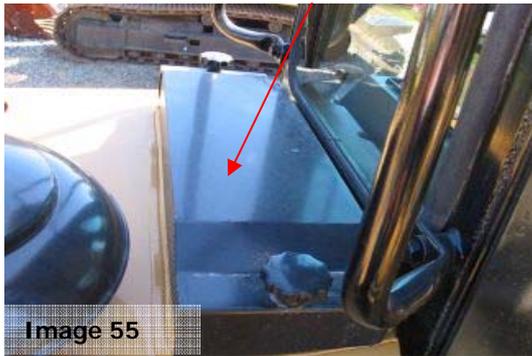
Image 55

Image 55: The air filter located just in front of the cabin windscreen (red arrow), must be removed to verify the cleanliness of the filter and the housing.

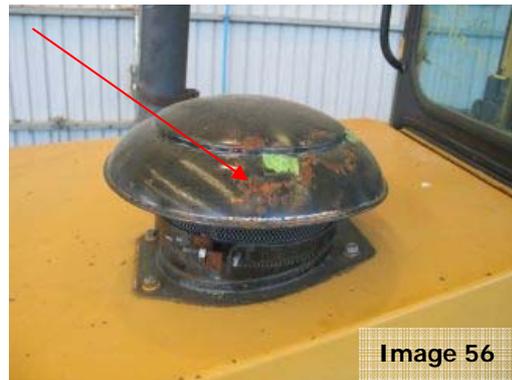
Image 56

Image 56: Remove the dust collector cover (red arrow) and verify internal cleanliness.

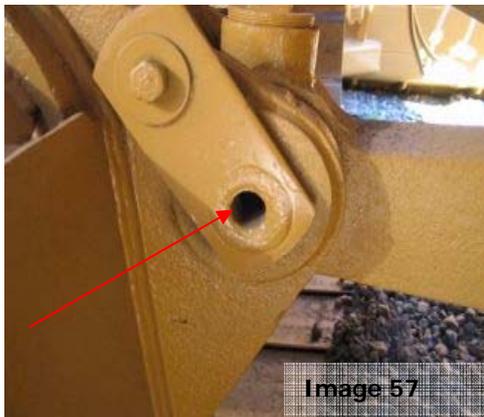
Image 57

Image 57: The sway bar joints attachment point to the track frame. Check all recesses (red arrow) and ensure all contaminated grease is removed.

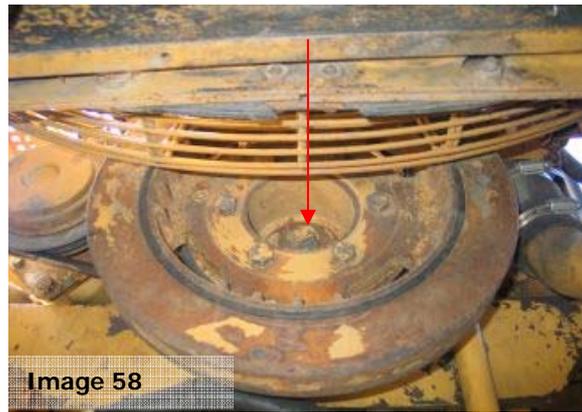
The front view of the harmonic balancer (red arrow) at the front of the engine block. Like many harmonic balancers, they are concave and can harbour significant amounts of contamination and must be verified clean inside.

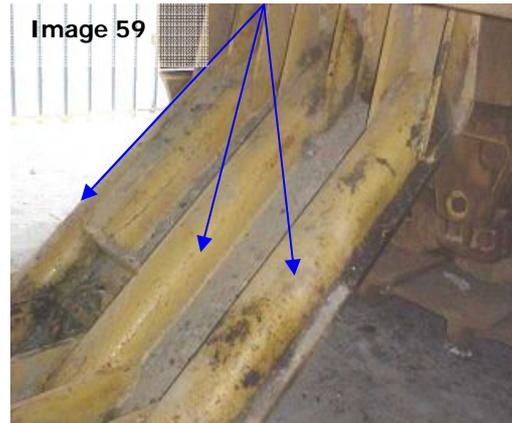
The inside of a typical belly plate. Check along each of the gussets (blue arrows) as on some models these are open-ended and require flushing in the presence of the inspecting officer in order to verify cleanliness.

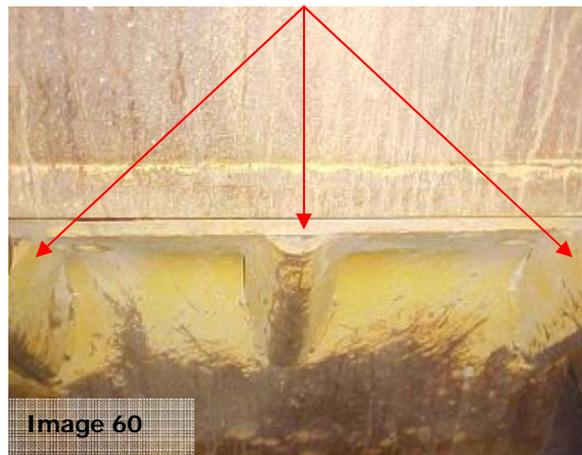
On some belly plates, gussets can be found on the outside of the belly plate, as highlighted by the red arrows. These need to be flushed to verify clean.

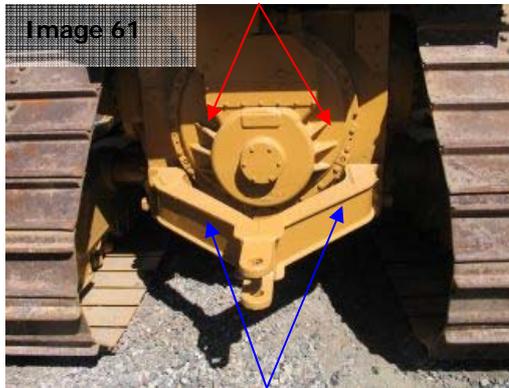
Image 61:
The rear of the small dozer (red arrows) and drawbar (blue arrow). Check all surfaces of the drawbar for drainage holes for cracks, splits or evidence of repair.

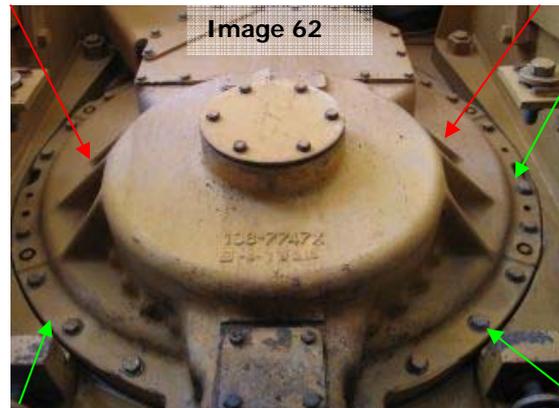
Image 62:
All ledges (red arrows) and recesses (green arrows) around the rear of the dozer must be clean and free of all contamination.

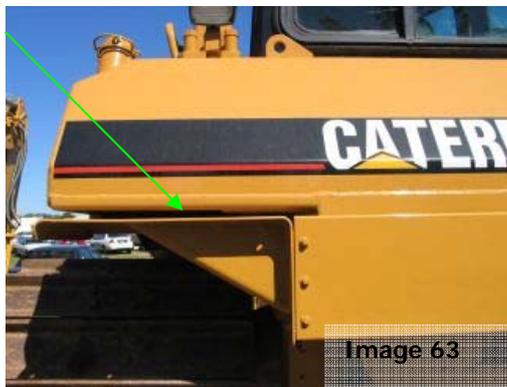
Images 63 & 64:
All surfaces of the fuel cell need to be carefully cleaned and inspected, particularly the back and underside (green arrows).

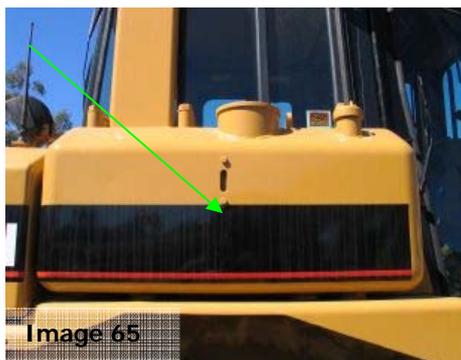
Image 65:
The oil tank outside the right door of the cabin. All surfaces must be thoroughly cleaned and inspected.

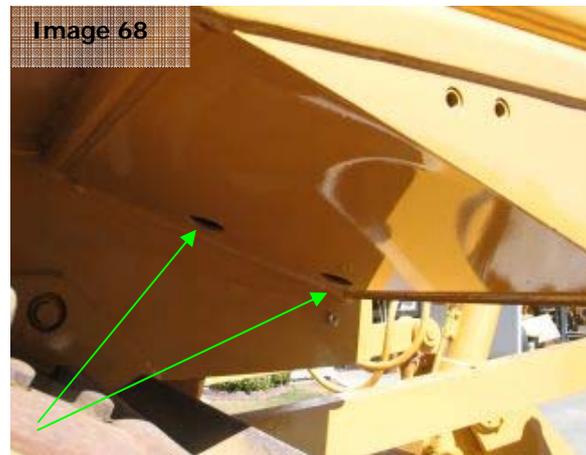
Image 68

The area illustrated in the previous picture may also have drainage holes on the underside as highlighted by the green arrows).

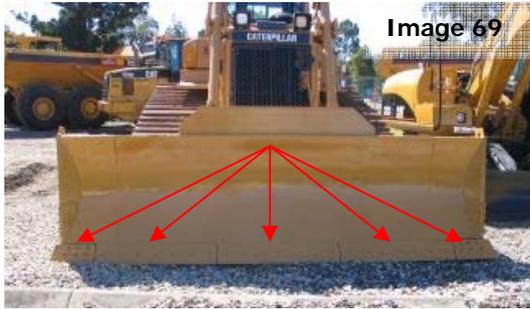
A typical blade on a dozer. All cutting teeth (red arrows) must be loosened and flushed to verify cleanliness. Check all surfaces for cracks, splits or evidence of repair to all surfaces. If detected, these will require investigation to verify internal cleanliness.

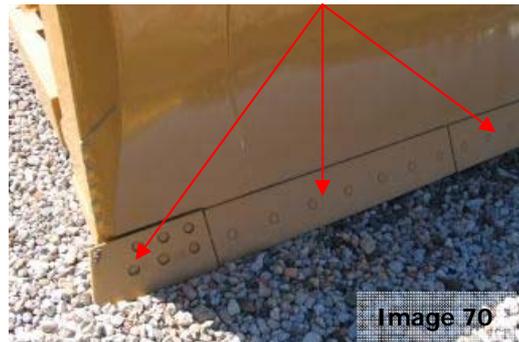
A close up of the cutting teeth on a blade that need to be loosened and flushed to verify cleanliness.

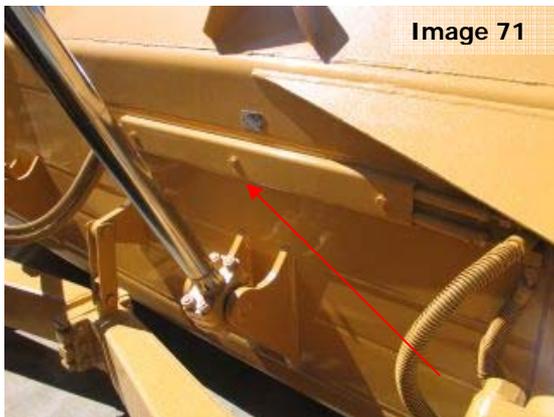
On the rear of some blades, gussets or protective plates may cover hydraulic hoses. These must be removed for cleaning and verification.

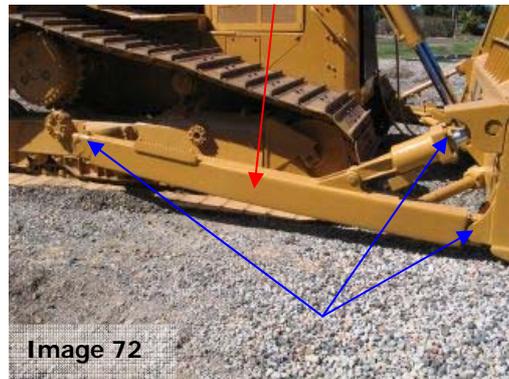
Image 72

The push arms (red arrow) on a dozer. These are generally sealed units, but need to be checked for any cracks, splits or evidence of repair. Ensure all contaminated grease is removed from pivot points (blue arrows).

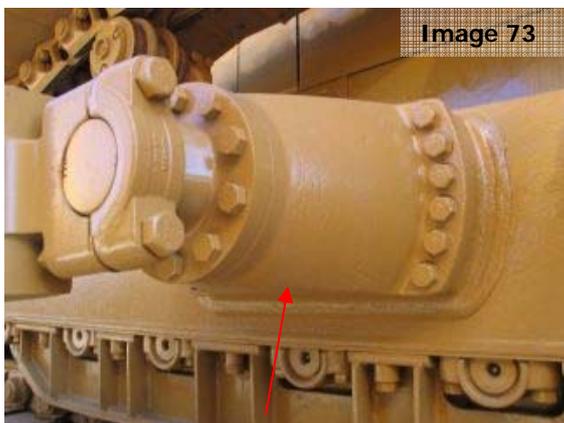
Illustrates where the push arms attach to the track frames. These units are hollow and may have drainage holes on the underside (red arrow), which will require flushing, if present to verify internal cleanliness.

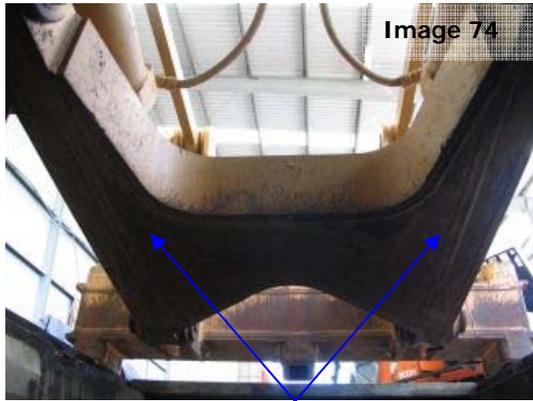
Image 74

The underside of a typical ripper cradle. On this illustration, there are no drainage holes, but if present, these must be flushed to verify internal cleanliness. Check all surfaces for any cracks, splits or evidence of repair.

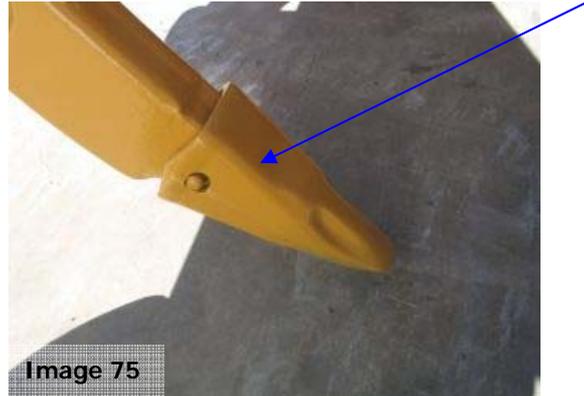
Image 75

All cutting teeth must be removed for internal cleaning and inspection.

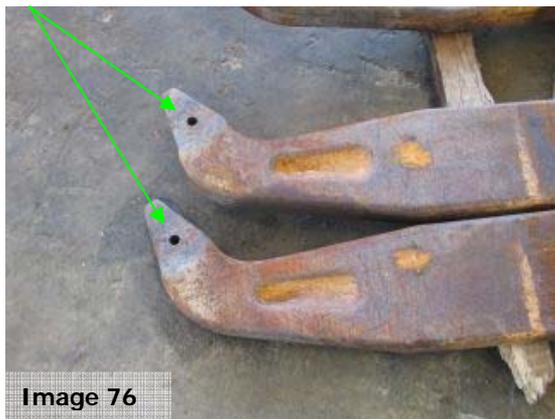
Image 76

The cutting teeth have been removed from the tynes for cleaning and inspection.

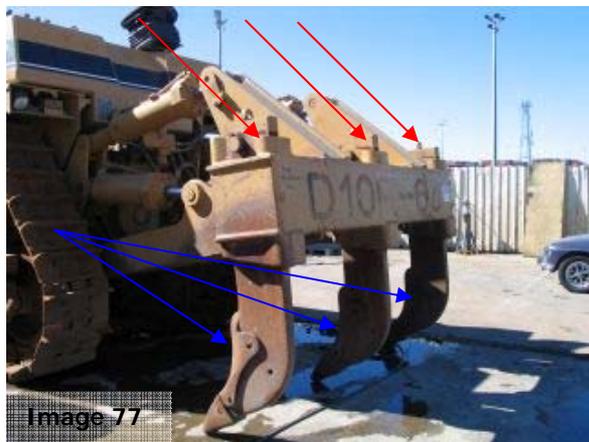
Image 77

In addition to the cutting teeth being removed, all wear plates (blue arrow) must also be removed and the recess (red arrows) between the cradle and tynes must be flushed to verify cleanliness.

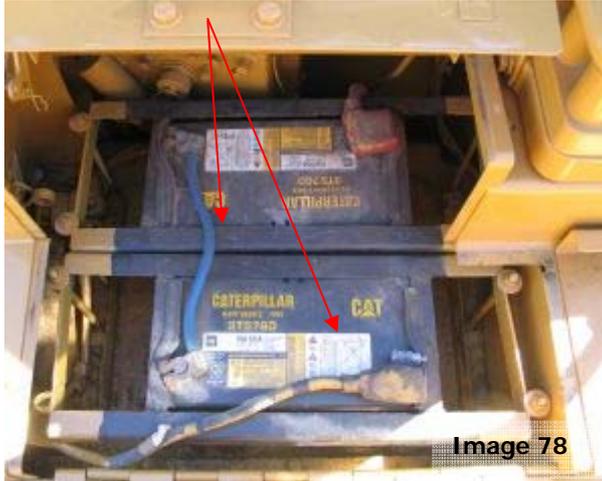
Image 78:
All batteries must be loosened from the tie down points for cleaning and underside inspection.

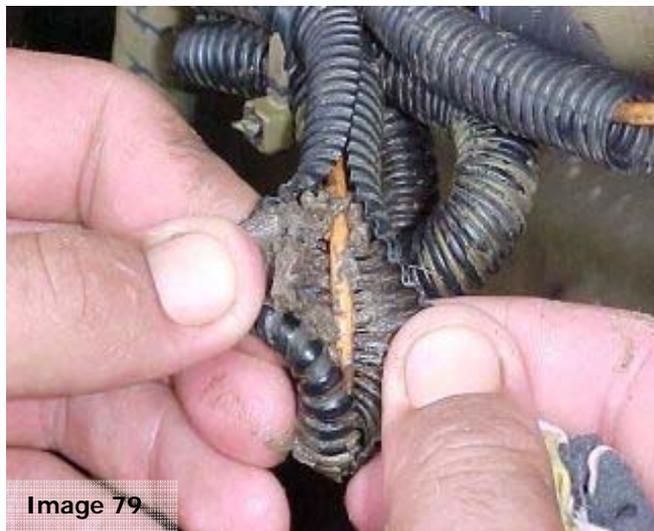
Image 79:
All wiring harnesses are to be carefully cleaned and inspected.

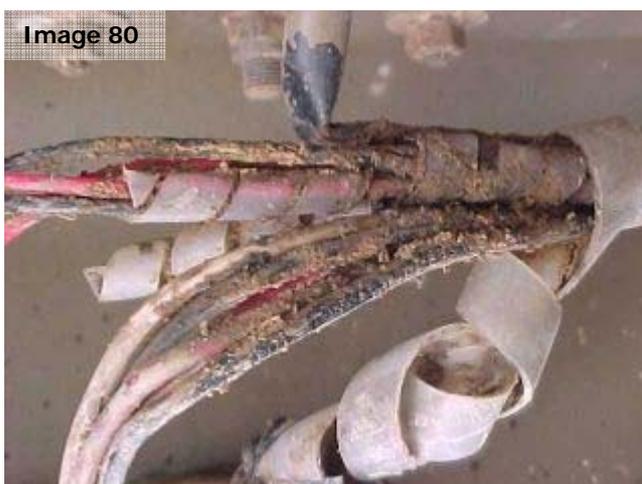
Image 80:
All looming around hydraulic hoses is to be carefully cleaned and inspected.
