Australian Quarantine and Inspection Service

SCRAPERS

The following cleaning/inspection guide has been segmented to facilitate the process. The segmentation is as follows:

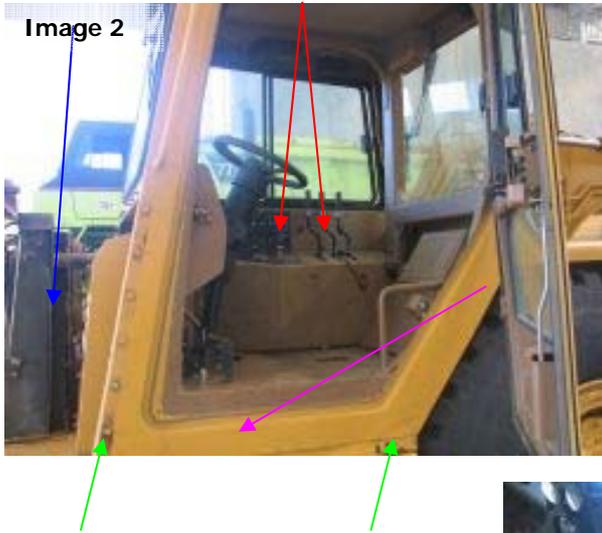
Image 2:

The inside of the Scraper cabin. Note that seat has been removed as well as the rubber floor matting, allowing for cleaning and inspection. Inspection access will be required inside the joystick control panels (red arrows). The non-affixed panel in front of the cabin (blue arrow) has also been removed, allowing access to the air-conditioning unit. Check for drainage holes (green arrows) under the cabin framework. Any non-affixed floorpans are to be removed for cleaning and inspection.

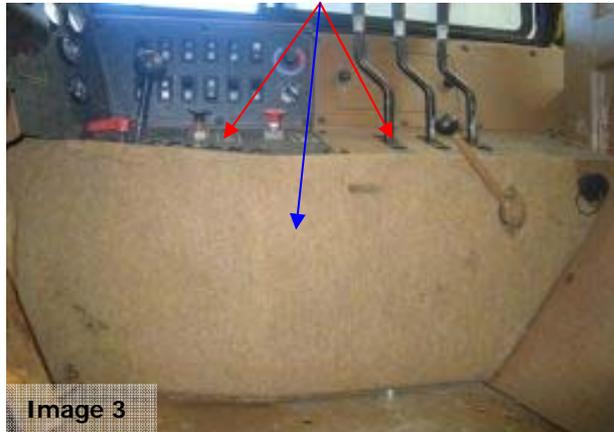
Image 3:

Close up shot of the joystick control panel (red arrows). Access will be required to verify internal cleanliness. The matting still seen on the side (blue arrow) of the joystick control panel will also have to be removed.

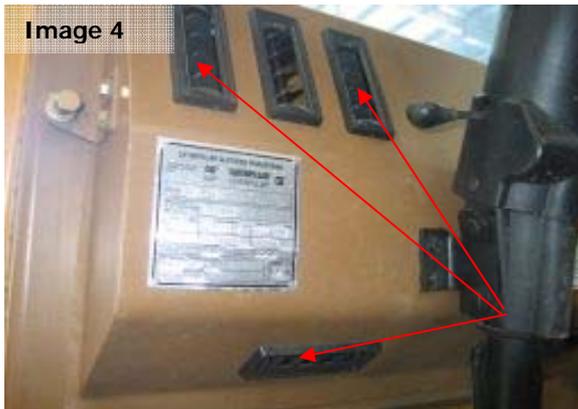
Image 4:

A close up of the air-conditioning vents, which must be internally cleaned and accessible for inspection.

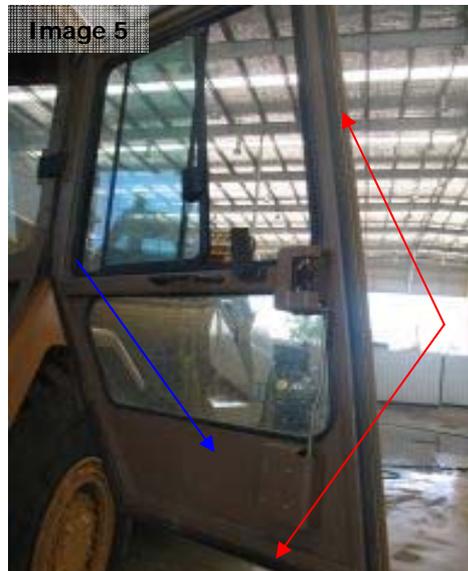
Image 5:

The door rubbers (red arrows) are to be removed for cleaning and inspection, as well as internal door linings (blue arrow).

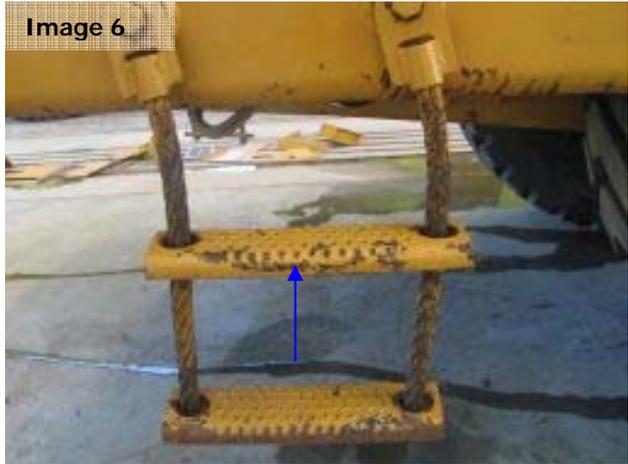
Image 6:
Check the ladder to the cabin. On this model the ladder is made from wire bundles, which must be free of all contamination.

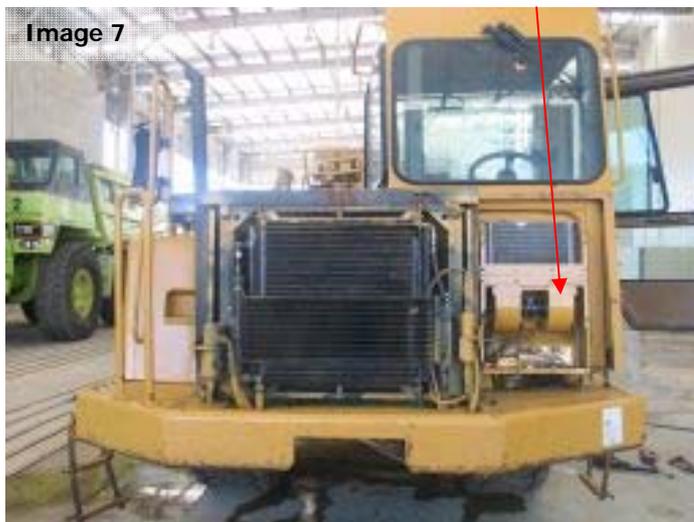
Image 7:
The Front End, highlighting the non-affixed panels removed from in front of the cabin, exposing the air-conditioning unit for inspection.

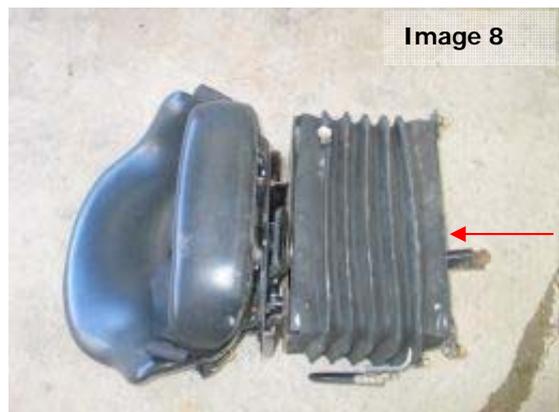
Image 8:
Once the seat has been removed, the internal of the rubber shroud (red arrow) can be easily cleaned and inspected.

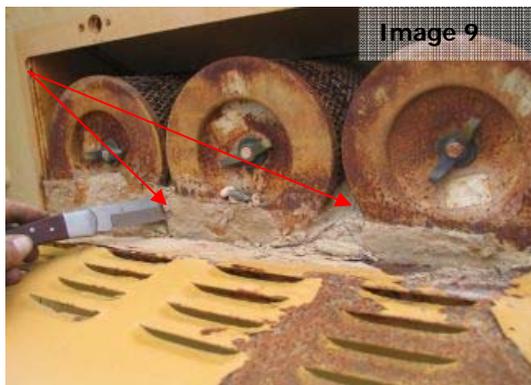
Image 9:
Air-filters in front of the cabin. This illustration highlights the amount of contamination that can be found in this area.

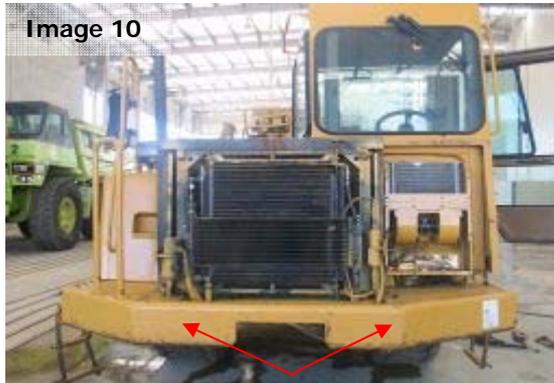
Image 10:

Illustrates the amount of dismantling (numerous non-affixed panels) required to make the engine and front end accessible for cleaning and inspection. The front drawbar (red arrows) is usually hollow, which will be highlighted later.

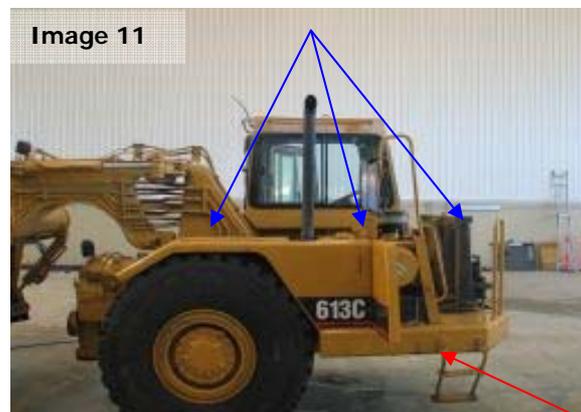
Image 11:

All non-affixed engine covers have been removed, allowing access for cleaning and inspection. The red arrow is highlighting the hollow drawbar.

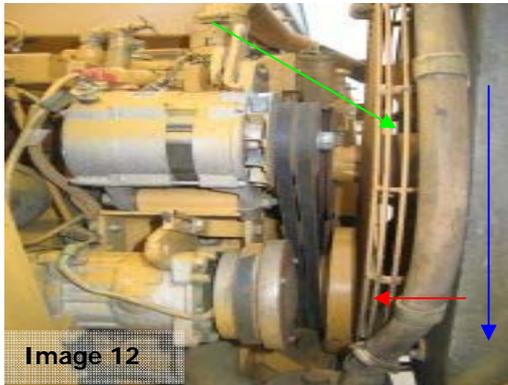
Image 12:

The front of the block and the harmonic balancers (flywheels). These can be concave and harbour contamination inside (red arrow). The internal radiator grill (green arrow) must be removed, allowing cleaning and inspection access inside the radiator shroud (blue arrow). Check all external surfaces of the block, including oil filters, starter motors and between tappet covers.

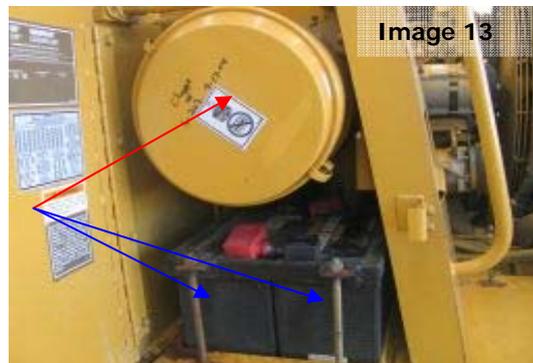
Image 13:

The air-filter (red arrow) is to be removed from the housing and verified clean (usually performed with pressurised air). The batteries (blue arrows) are to be loosened from the tie-down points and inspected underneath.

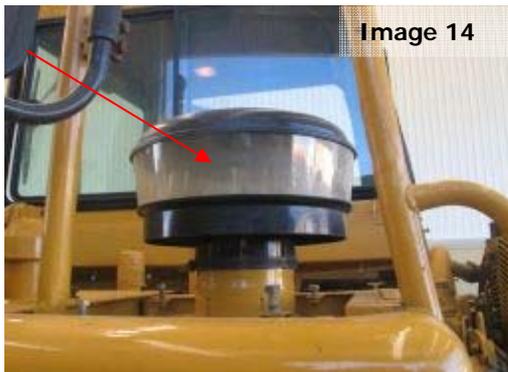
Image 14:

The air-filter pre-cleaner or dust collector (red arrow). The cover must be removed to allow cleaning and inspection.

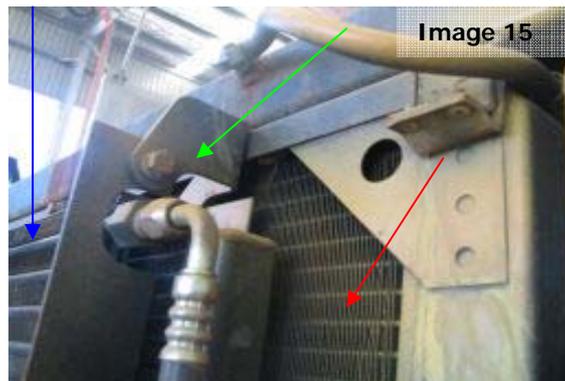
Image 15:

All fins on the radiator (red arrow) and oil cooler (blue arrow) are to be flushed in order to verify cleanliness. Note the small gap between the oil cooler and radiator. On some models, the oil cooler can be unbolted (green arrow), allowing better access for cleaning the fins and inspection.

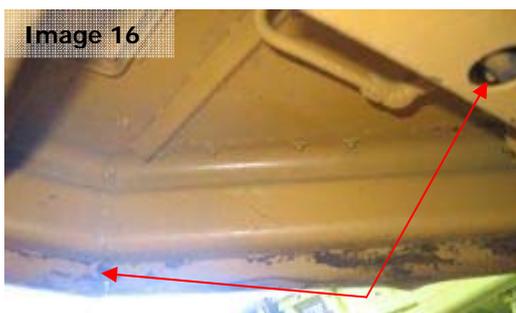
Image 16:

The front drawbar as seen from the underside. These support channels can be hollow, as seen above and can be flushed via the drainage holes (red arrows).

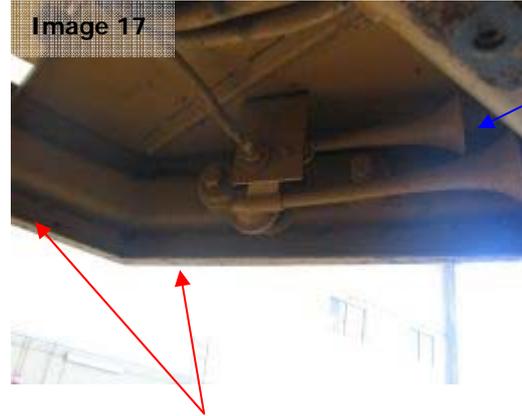
Image 17:

There are other hollow support structures (red arrows) under the front end that will require flushing to verify cleanliness. The inside of the horn (blue arrows), will also require verification of cleanliness.

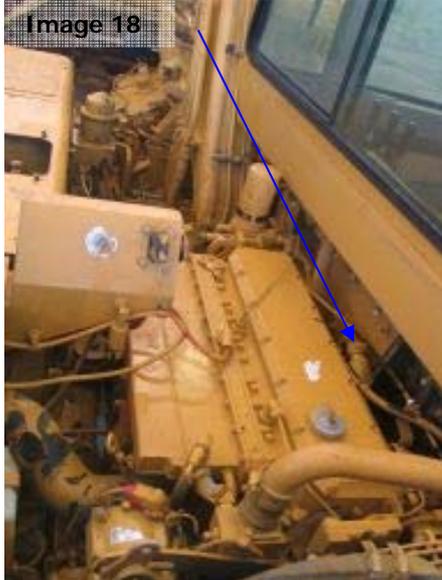
Image 18:

The topside of the block is highly visible for cleaning and inspection once all non-affixed engine covers and panels have been removed. The block and transmission are home to a myriad of hydraulic hoses and cables, which make cleaning and inspection difficult. The area between the cabin and the block (blue arrow) is very confined and the use of inspection mirrors is recommended. Flushing to verify areas that cannot be seen or felt will be required.

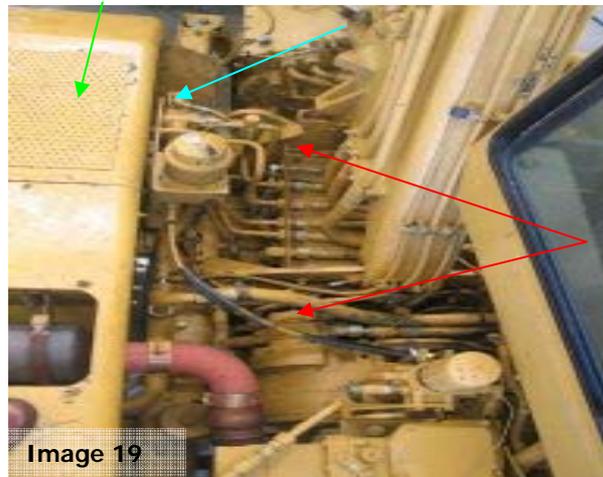
Image 19:

The rear of the block, below the Gooseneck. This area is also characterised by numerous hydraulic and electrical hoses and cables, all requiring thorough cleaning and inspection. All checker plate (green arrow) is to be flushed to verify cleanliness. Flushing to verify areas that cannot be seen or felt will be required. The aqua arrow highlights the access point to the hollow chassis rail, that is highlighted next.

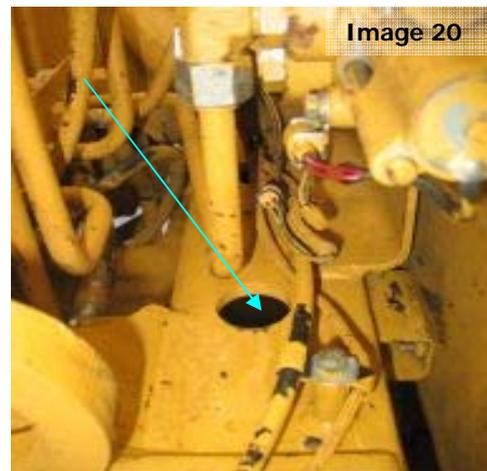
Image 20:

The two chassis rails either side of the engine block are hollow. On most models there will be access points or drainage holes. The one illustrated in this picture is located on the topside of the chassis rail, towards the rear.

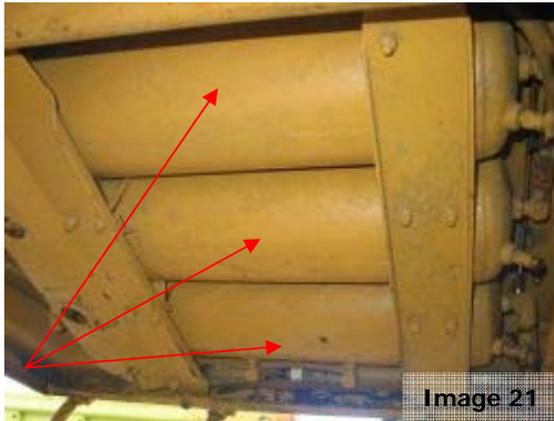
Image 21:
The air tanks that can be located under the front end. The topside of these can be difficult to access and may require dismantling for cleaning and inspection.

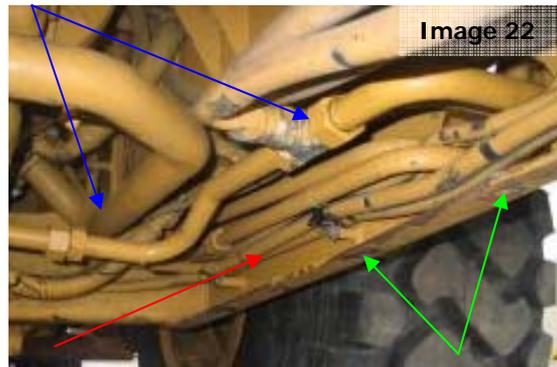
Image 22:
The underside of the front end and hollow chassis rail (red arrow). The belly plates have been removed, allowing access for flushing both channels via the vacant belly plate bolt-holes (green arrows). All hydraulic hoses require thorough cleaning and inspection (especially the non-visible surfaces).

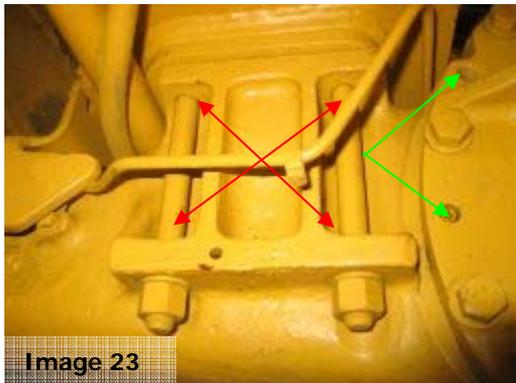
Image 23:
Each axle on either side of the differential has supports (red arrows) for the housing above. Each of these areas requires thorough cleaning and inspection. Check all countersunk recesses (green arrows).

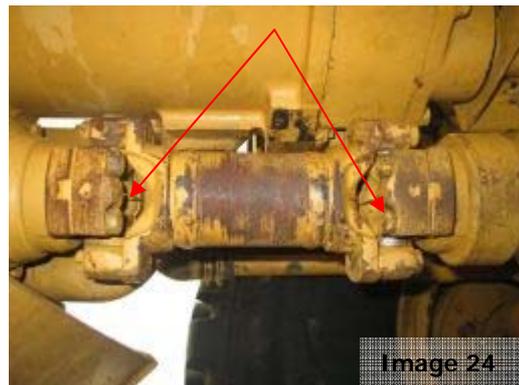
Image 24:
All universal joints must be free of contaminated grease.

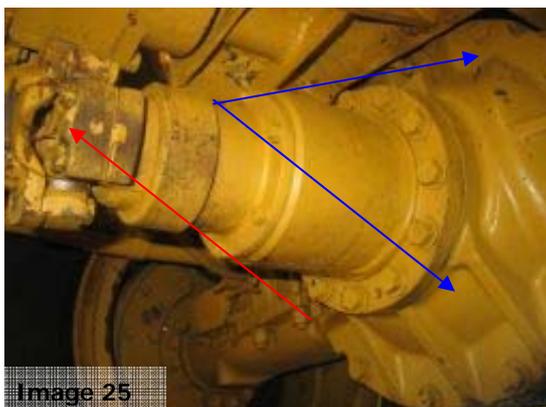
Image 25:
All universal joints must be free of contaminated grease (red arrow). The bell housing (blue arrow) has many nooks, ledges, countersunk holes and hydraulic hoses, all of which require careful cleaning and inspection.

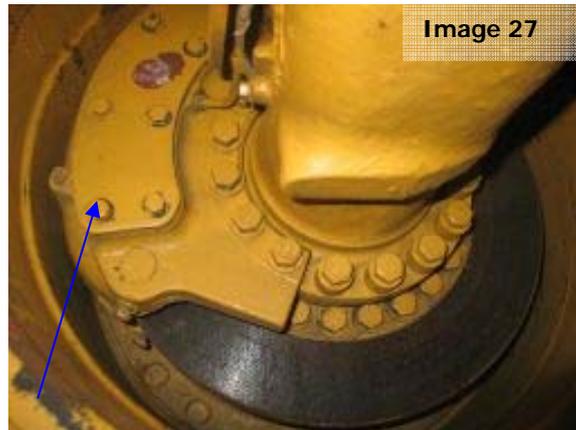
Image 27:
Thoroughly inspect all internal wheel rim surfaces. A mirror is recommended to inspect the backside of the brake drum (blue arrow).

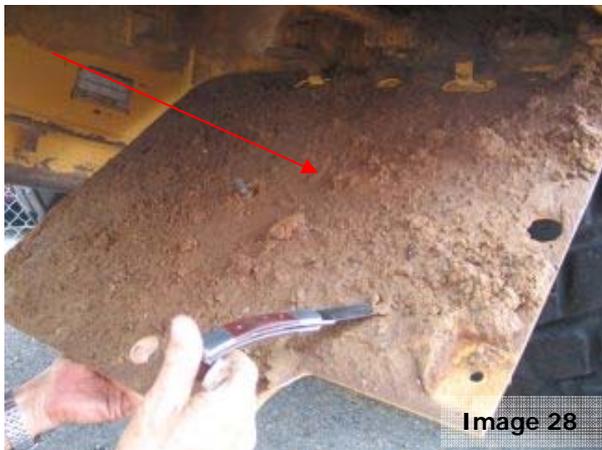
Image 28:
A non-affixed panel removed from under the cabin floor. This illustration highlights the amount of contamination that can be found in these areas.

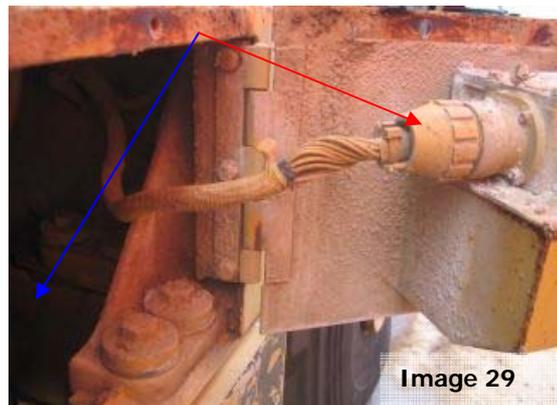
Image 29:
A small door below the cabin, which also provides access to the contamination seen in the last illustration.

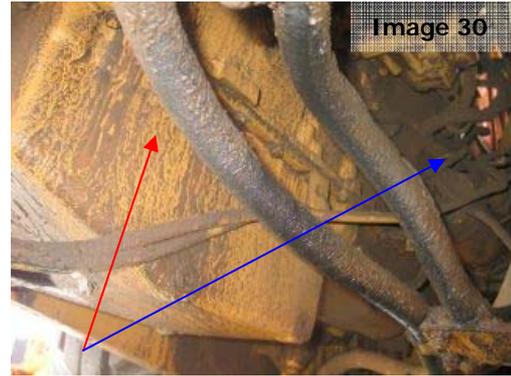
Image 30:

The side of the sump, which can only be accessed once all belly plates have been removed. Note the amount of contamination (blue arrow) that can be seen in the surrounding area. This whole area must be thoroughly cleaned and inspected.

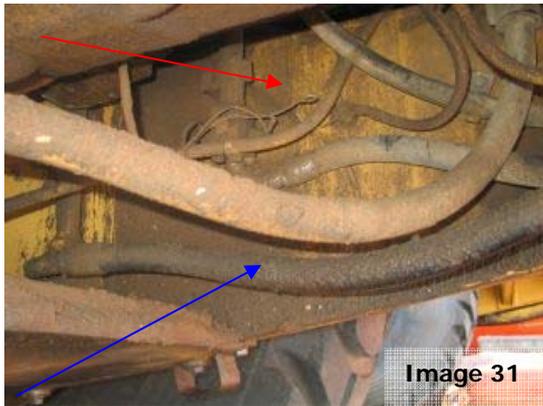
Image 31:

The inside chassis rails, visible once the belly plates have been removed. All hydraulic hoses (blue arrow) must be thoroughly cleaned and inspected.

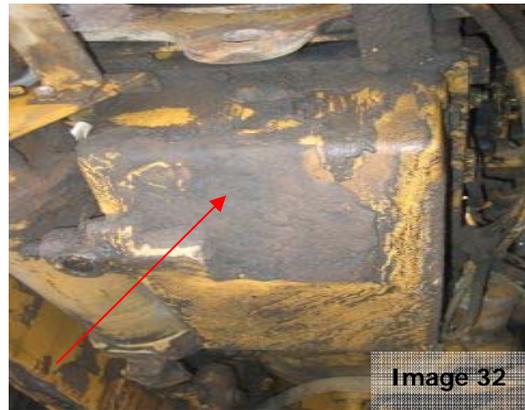
Image 32:

Another view of how contaminated the underside of the engine block and sump can be. All belly plates and non-affixed panels must be removed for cleaning and inspection.

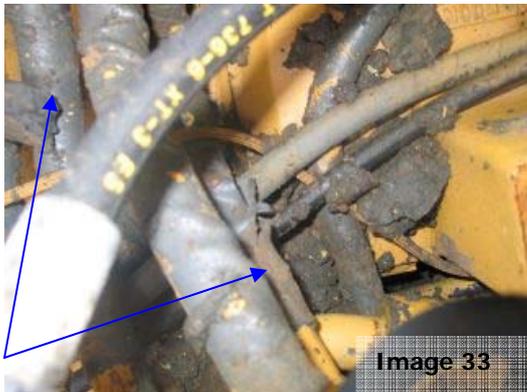
Image 33:

Contamination seen around hydraulic hoses (blue arrows). All surfaces of these hoses must be thoroughly cleaned, including the removal of contaminated grease.

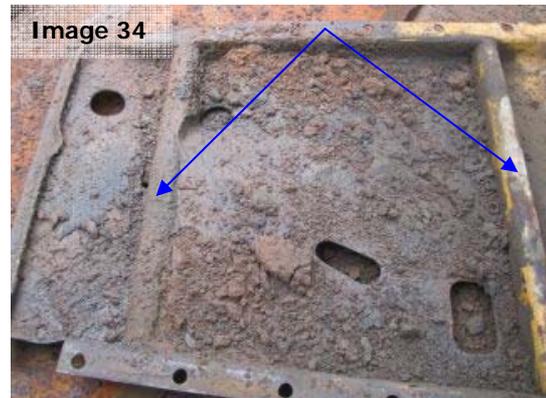
Image 34:

Belly plates must be removed and thoroughly cleaned. Check for openings along the framework (blue arrows). If open, these will require flushing to verify cleanliness.

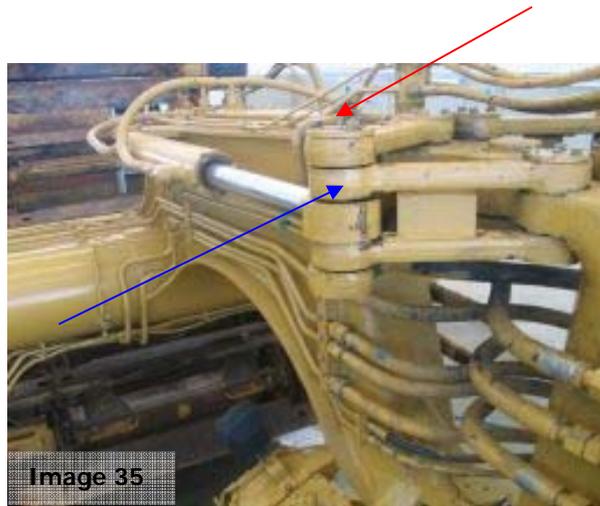
Image 35:

The Gooseneck found on all Scrapers. Check all surfaces of the Gooseneck for any openings or drainage holes. On some models the opening may be topside (red arrow). All hydraulic hoses and lines must be thoroughly cleaned and inspected. Remove all contaminated grease from pivot points and rams.

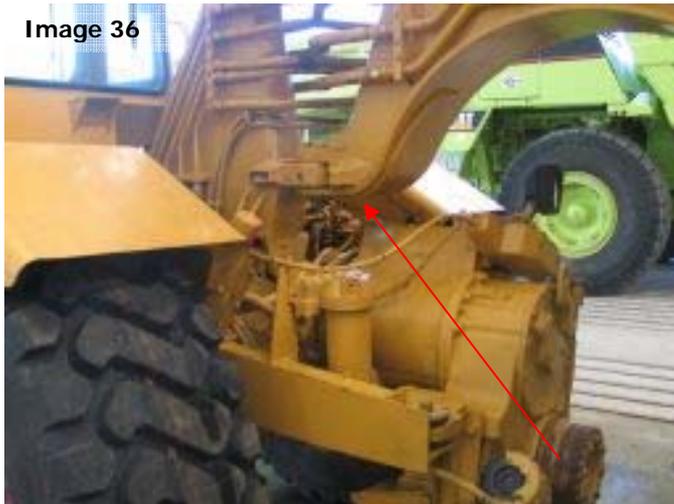
Image 36:

Check all surfaces of the Gooseneck for any openings or drainage holes. On some models the opening may be at the bottom (red arrow).

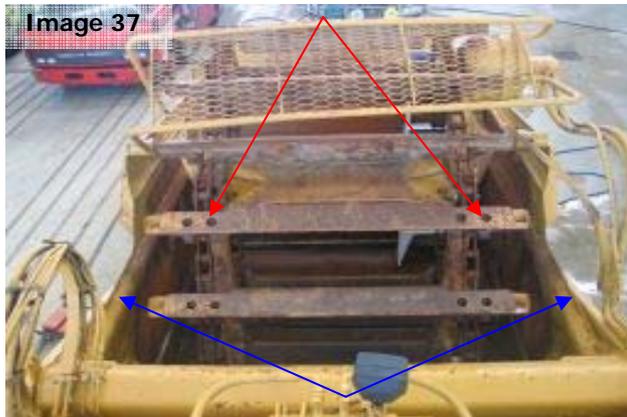
Image 37:

The Elevator as seen from the Gooseneck. This area consists of a series of blades (red arrows) on a chain, used to push the load to the rear of the bowl. The blue arrows highlight the side of the bowl, which will be highlighted later.

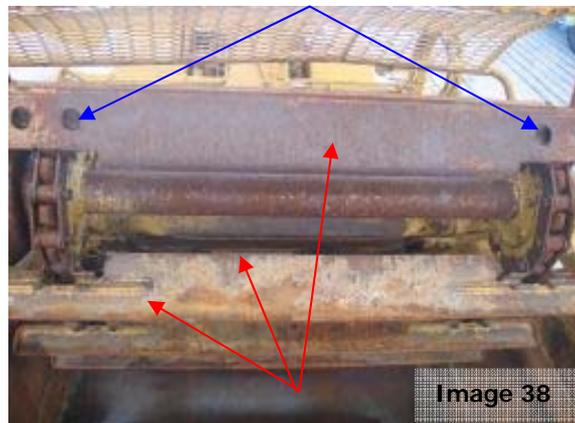
Image 38

The Elevator blades (red arrow) are hollow and need to be flushed via the entrance holes (blue arrows) to verify cleanliness.

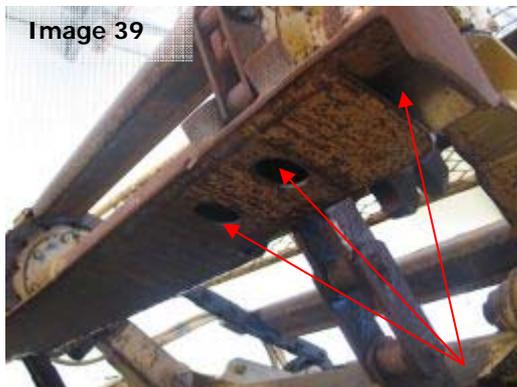
Image 39

Another view of the Elevator blades, highlighting the flushing entrance holes.

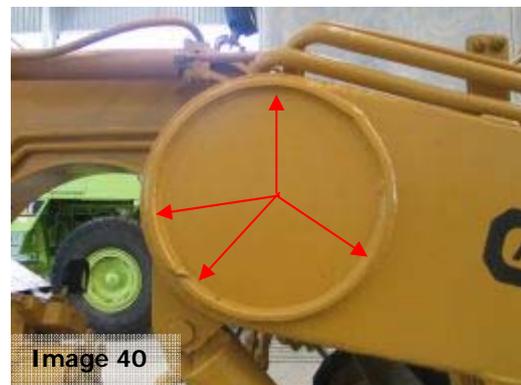
Image 40

An illustration of the Cylinder, located just behind the Gooseneck. This area is hollow and can harbour significant amounts of contamination. Generally a sealed unit as illustrated, however check for cracks, splits or evidence of repair. On this model the ends are completely welded, sealing the unit, but on other models this plate may only be spot-welded. If only spot-welded, flush inside to verify cleanliness.

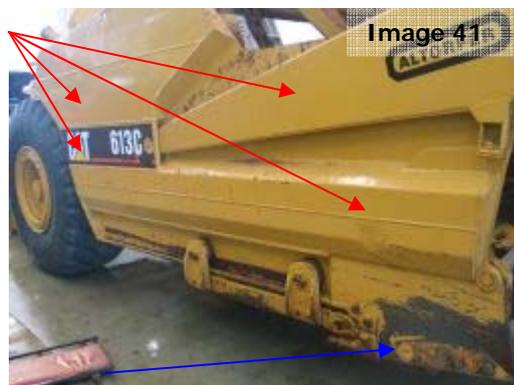
Image 41:

An illustration of the side of a typical Scraper Bowl. The sides, rear and underside of most Scraper Bowls are hollow structures and can potentially harbour hundreds of litres of contamination. The red arrows highlight that there may be separate compartments and the blue arrows show where the wear plates have been removed. Tapping the side of each compartment can assist on determining if these areas are full of contamination (dense sound compared to hollow).

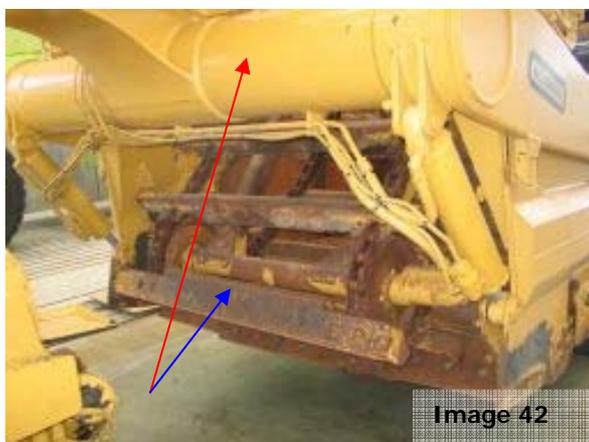
Image 42:

The front of the Scraper Bowl, also showing the Elevator and Cylinder.

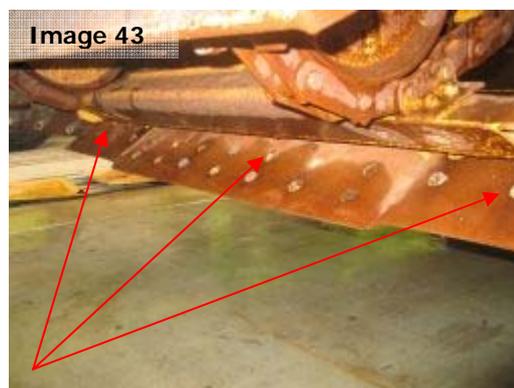
Image 43:

All cutting teeth along the front of the Bowl are to be loosened and flushed behind to verify cleanliness.

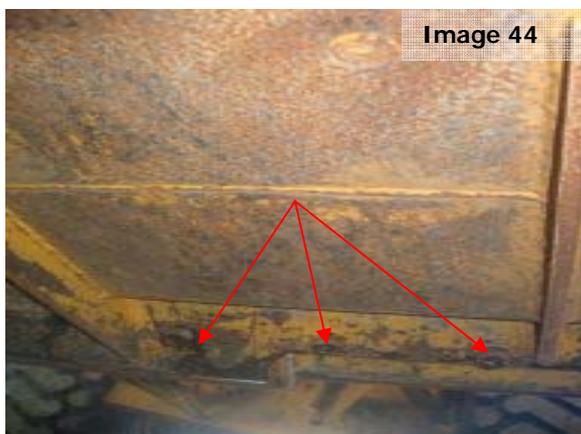
Image 44:

The underside of the cutting teeth. Ensure around each bolt head is clean as well as looking for any cracks, splits or evidence of repair on the underside. The Bowl will have to be supported by chocks at the time of inspection.

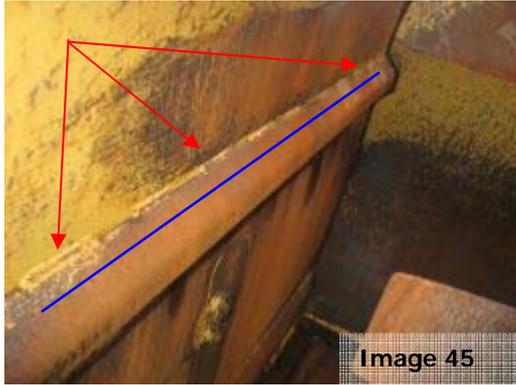
Image 45:

The internal wall of the Scraper bowl may have protective plates, covering the hydraulic hoses as they run from front to back. This area is hollow and may only be spot welded (as highlighted by the red arrows), open-ended (as seen later) and will require flushing to verify cleanliness. The blue line indicates the hollow channel.

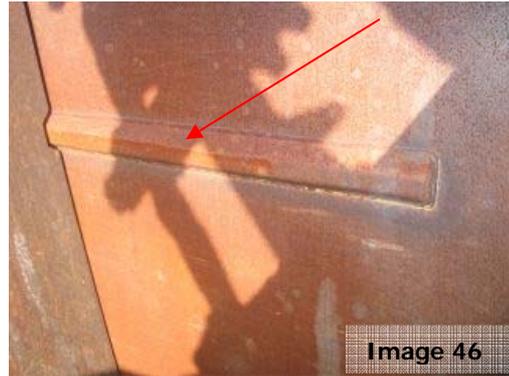
Image 46:

Another example of a protective plate, covering the hydraulic hoses.

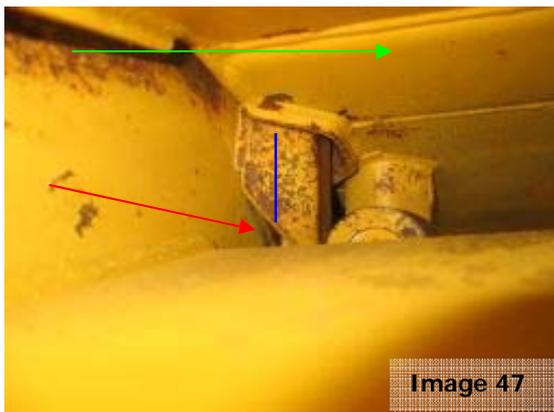
Image 46:

The ends of the protective covers, which have highlighted in the last few illustrations. In this picture the open-end (red arrow) can be seen behind the rear of the Bowl (green arrow) and this channel will require flushing to verify cleanliness.

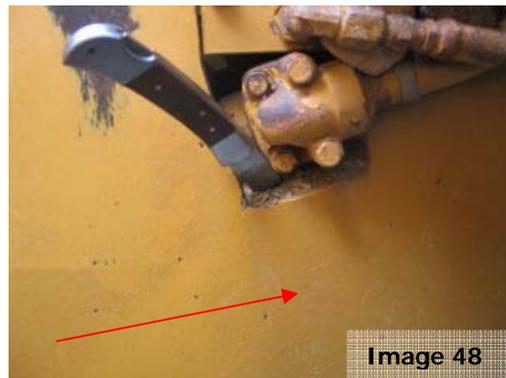
Image 48:

This illustration highlights the exit of the hydraulic hoses from the inside of the Bowl, just behind the rear. This is a natural opening on some models, allowing hundreds of litres of contamination to enter the sides. The knife is supported by the amount of contamination inside (The red arrow highlights the area full with contamination).

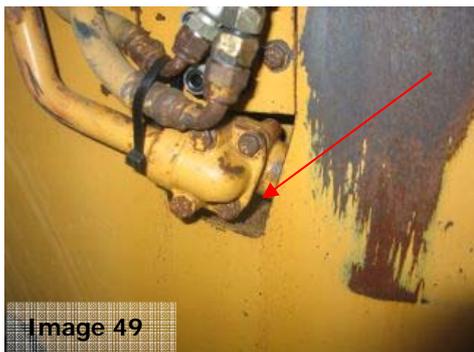
Image 49:

On some models these natural openings can be found on each side of the bowl, behind the rear face. This side is also full with contaminants.

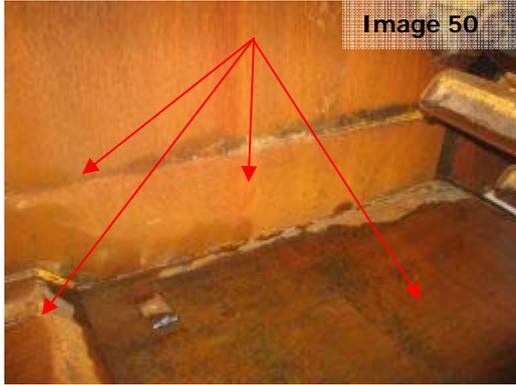
Image 50

Image 50:
The inside face of a typical Scraper Bowl. Check all surfaces carefully for any cracks, splits or evidence of repair. If detected, these areas will need to be investigated to be verified clean.

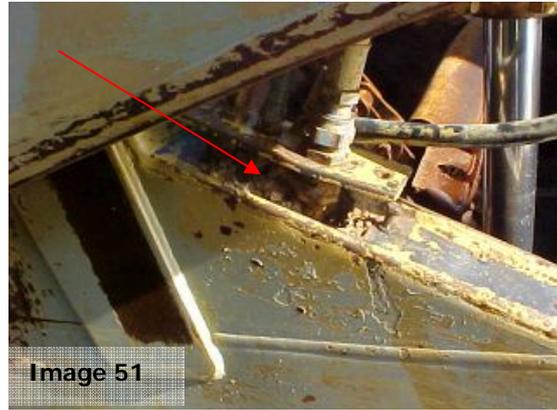
Image 51

Image 51:
This illustrates the hydraulic lines entering the sides of the Bowl at the front end. Several bolts have been removed, allowing access for inspection. This area has been illustrated to show that these sides can be full of contamination.

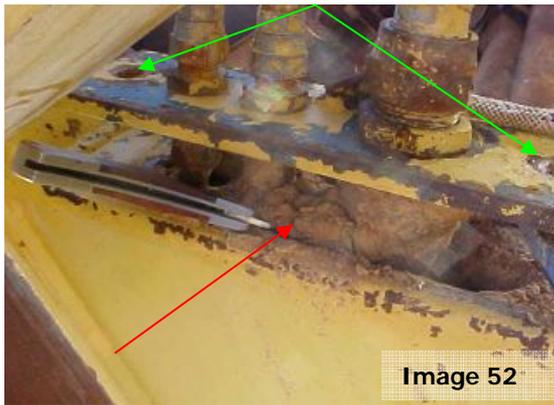
Image 52

Image 52:
A close view of where the hydraulics enter the side of the Bowl. Once again, several bolts (green arrows) have been removed to allow for cleaning and inspection. This area has been illustrated to show that these sides can be full of contamination.

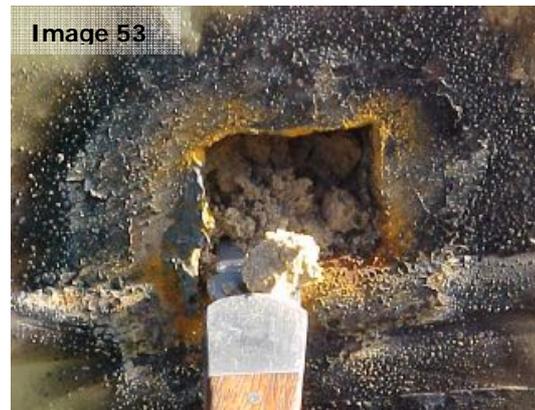
Image 53

Image 53:
Another illustration to highlight an area where repairs were detected. The area was examined and the inside of the bowl was contaminated.

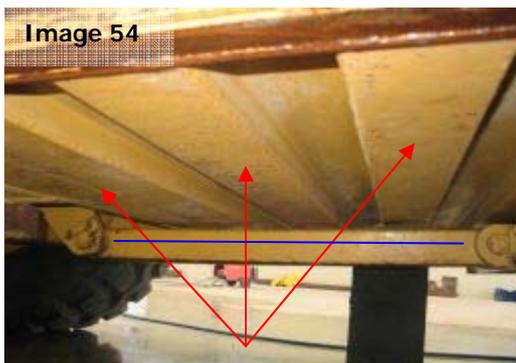
Image 54

Image 54:
The underside of the Scraper Bowl, showing individual gussets that can each harbour contamination. Check all surfaces for cracks, splits or evidence of repair. Again, tapping each compartment can assist on determining if these areas are full of contamination (dense sound compared to hollow). The beam highlighted by the blue line may also be hollow and require flushing.

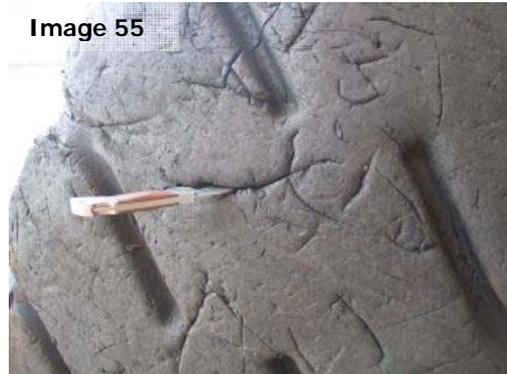
Image 55:

All cracks and splits in tyres must be verified to ensure that all are free of contamination.

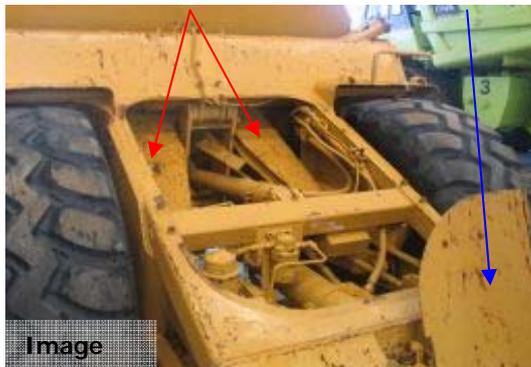
Image 56:

The rear end of the Scraper with all non-affixed panels removed, allowing access for cleaning and inspection. The red arrows highlight the rails under the rear, which will be seen later.

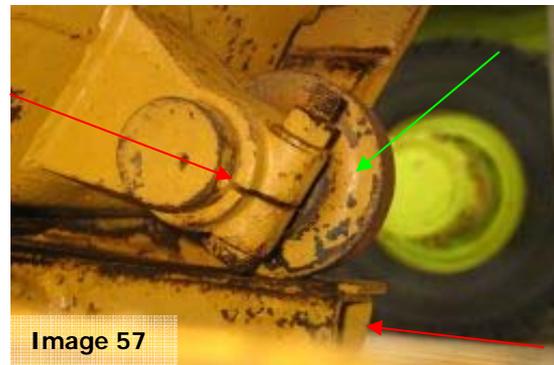
Image 57:

At the back of the bowl and under the rear, check the small Bowl pulley wheels (green arrow) and flush small recesses (red arrow).

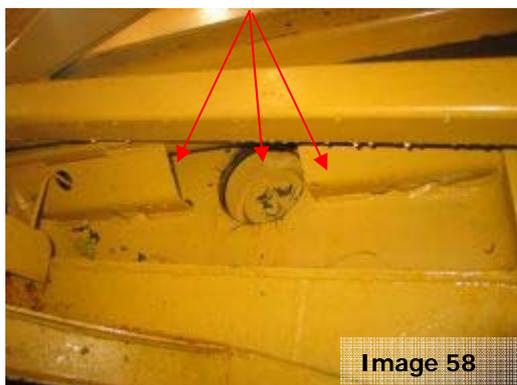
Image 58:

Hollow cavities (red arrows) such as these are common under the rear of Scrapers. All must be accessible at inspection.

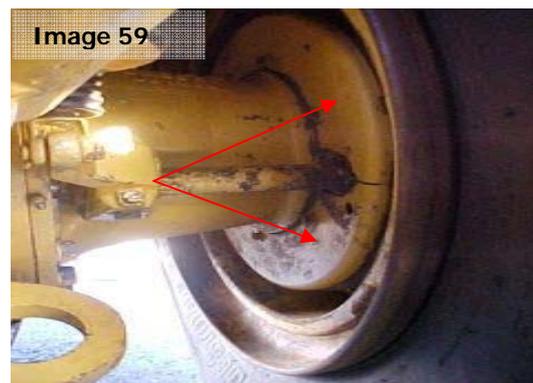
Image 59:

All internal non-affixed rim plates (red arrows) must be removed, allowing for cleaning and inspection.

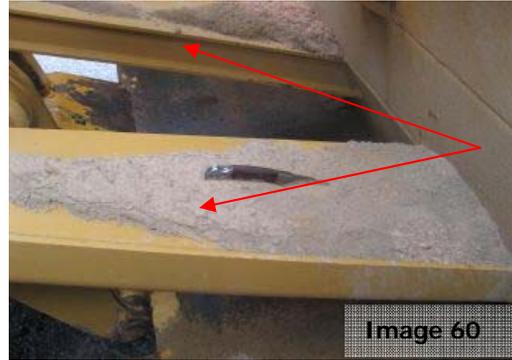
Image 60:

The rails (red arrows) as seen under the rear of the Scraper, behind the Bowl. These areas can hold significant amounts of contamination.

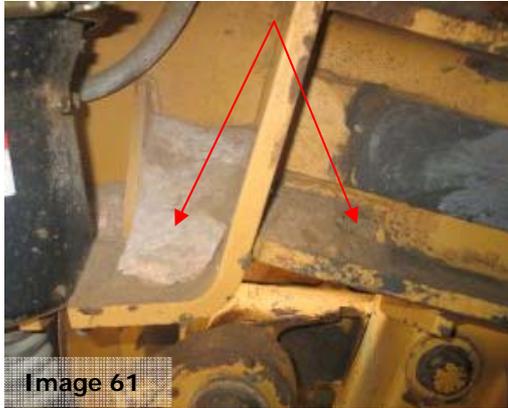
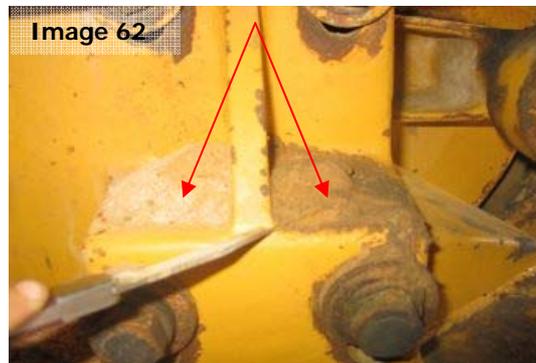
Images 62 & 63:

More examples of the different nooks and ledges that can be found under the rear of the Scraper, harbouring contamination.

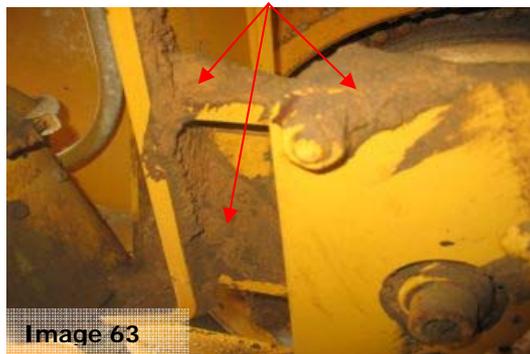
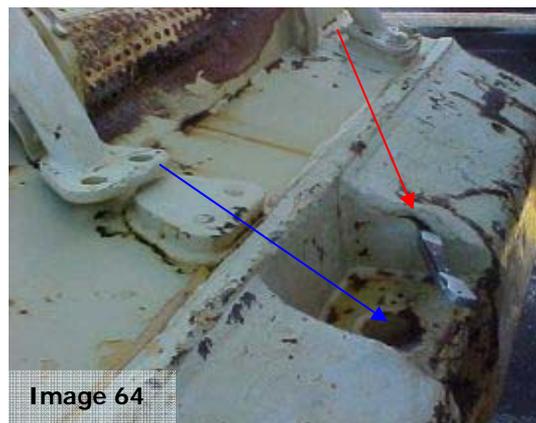
Images 64 & 65:

Examples of the rear drawbars on Scrapers. In each, a crack in the drawbar (red arrows) can be seen, which will require further investigation in order to verify the internal cleanliness. Remove the pins (blue arrows), as sometimes the access point to these areas maybe via this entrance (or drainage holes below).

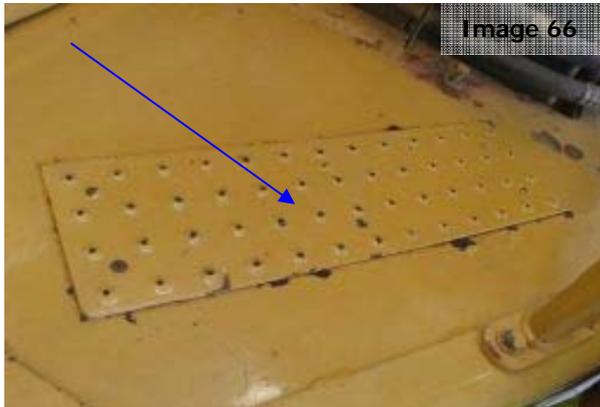
Image 66:
All non-slip checker plate must be flushed to verify cleanliness underneath.

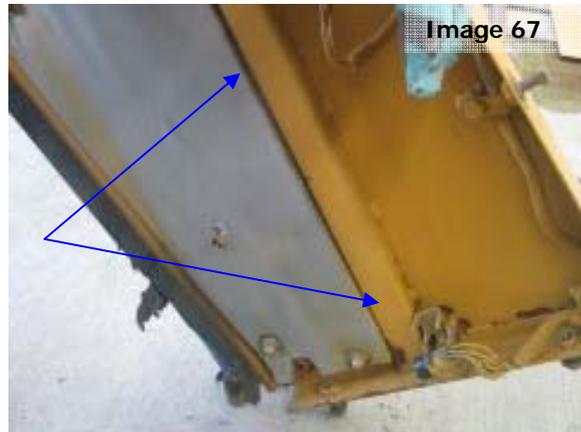
Image 67:
Check all engine covers for hollow support framework and flush to verify cleanliness if required.

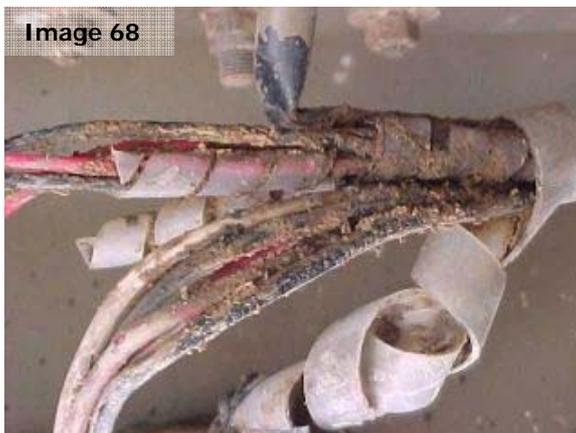
Image 68:
Check all wiring harnesses for internal cleanliness.
