Australian Quarantine and Inspection Service

SKID STEER LOADERS

BOBCATS

The following cleaning/inspection guide has been segmented to facilitate the process. The segmentation is as follows:

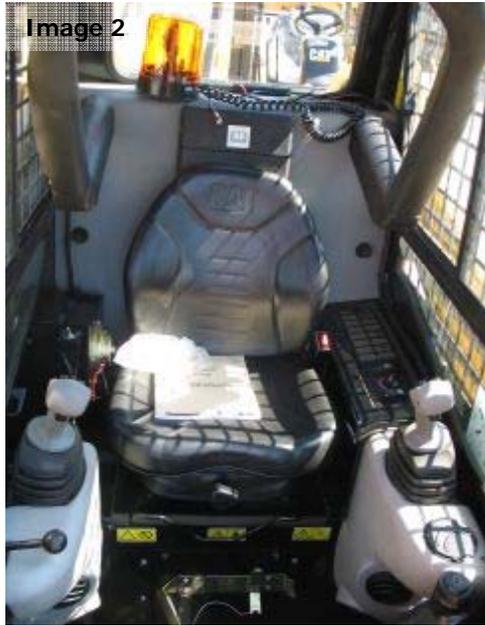
Image 2

These illustrations highlight the cabins of different Skid Steers. Some are more complex and enclosed with air-conditioning as shown in illustration 2, while in illustration 3 a very simple example is provided. Examples of how to clean the cabins and present these machines for Quarantine inspection follow.

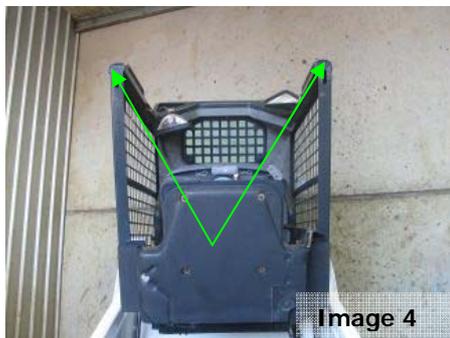
Image 4

Image 4:

On most models the housing, including the seat can be hydraulically lifted, exposing the back of the engine block and housing under the seat. While the cabin is elevated, check for any drainage holes on the cabin frame (green arrows) and flush to verify internal cleanliness.

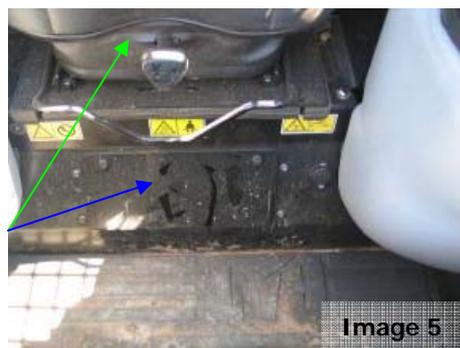
Image 5

Image 5:

On other models, the box section under the seat may be accessible via small non-affixed plates like the one illustrated by the blue arrow. The rubber seat shroud (green arrow) must be thoroughly cleaned both inside and out.

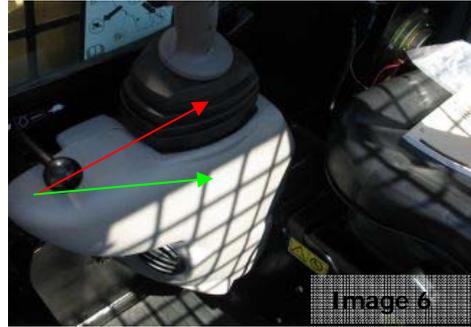
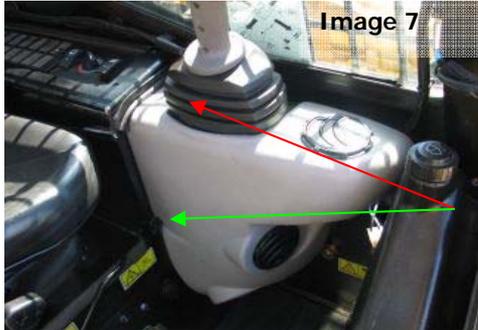
Images 6 & 7:

The joystick controls within the cabin. The internal housing (green arrows) must be cleaned and accessible at the time of inspection. All rubber shrouds (red arrows) must also be thoroughly cleaned and inspected, outside and in.

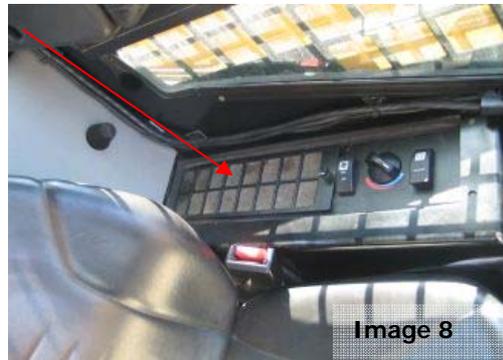
Image 8:

Remove all air-conditioning filters (red arrow) from inside the cabin and clean. These areas must be accessible for inspection.

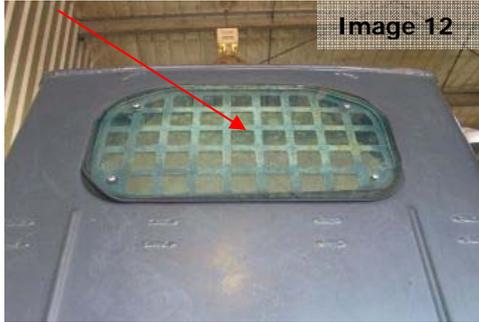
Image 12

Image 12:
On some models a small sunroof may be present. Ensure that all rubbers and seals around the sunroof are clean.

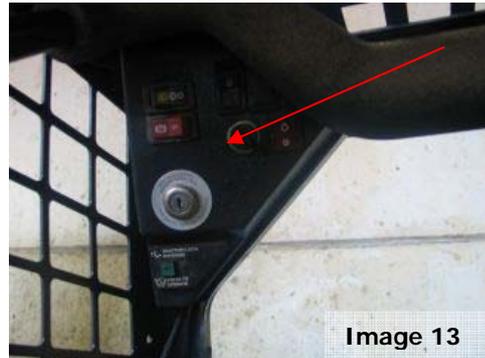
Image 13

Images 13 & 14:

From inside the cabin, most Bobcats have gauges or instrument panels (red arrows) mounted to the vertical housing. Contamination can easily enter behind these gauges and the areas behind, must be cleaned and accessible at the time of inspection.

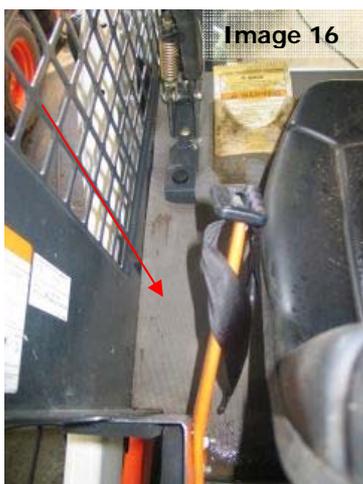
Image 16 & 17:

Highlights the insulation cover (red arrows) behind the seat inside the cabin. The glue holding these in place generally becomes redundant over time and any contamination found behind must be removed.

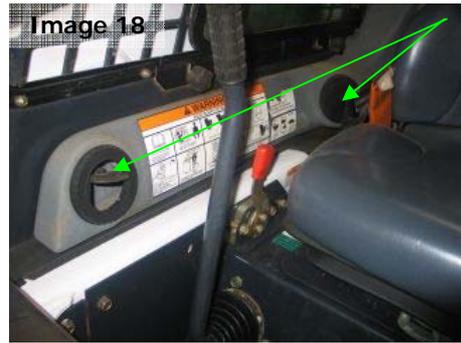
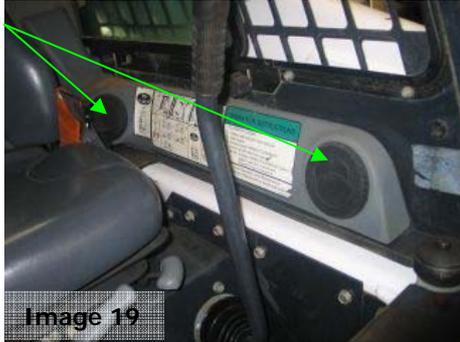
Images 18 & 19:

Inside the air-conditioned cabin, the air-conditioning vents (green arrows) must be internally cleaned and accessible at the time of inspection.

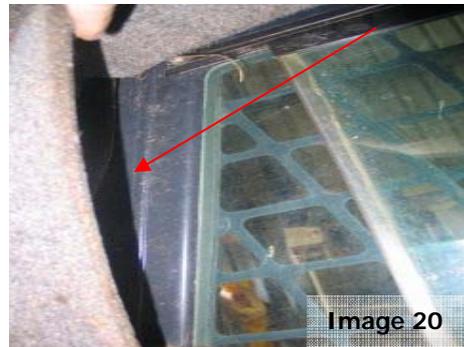
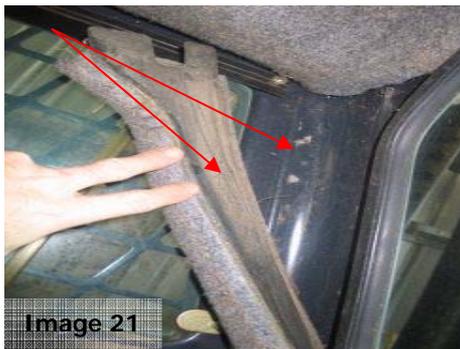
Images 20 & 21:

These pictures highlight the internal cabin linings, which have been opened for cleaning and inspection purposes.

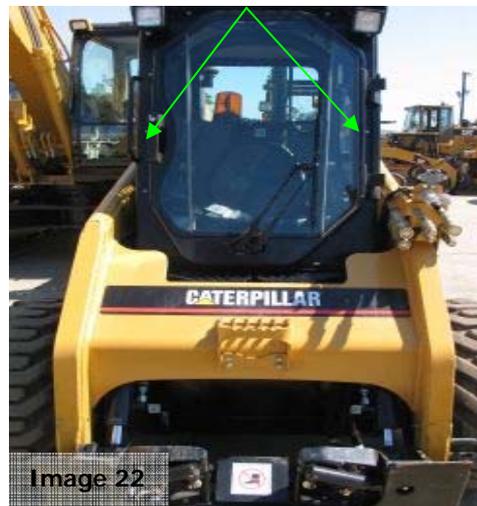
Image 22:

The external of the sealed, air-conditioned cabin. Check all windows and sills (green arrows) for contamination.

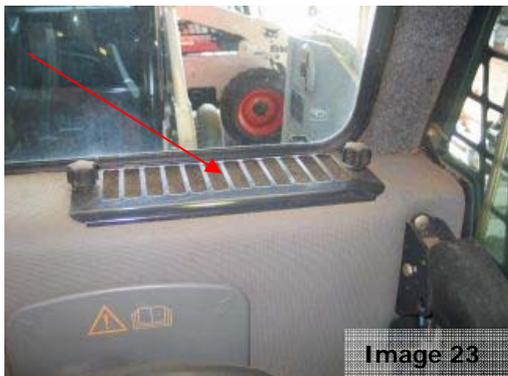
Image 23:

Another example of an internal air-conditioning vent (red arrow) that must be removed for cleaning and inspection.

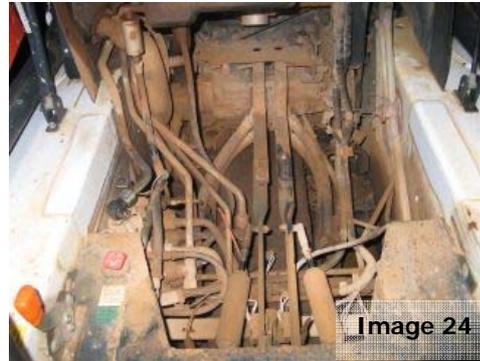
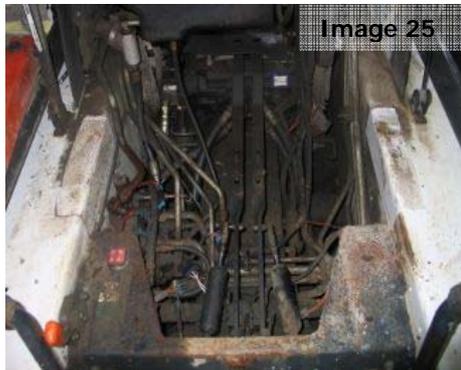
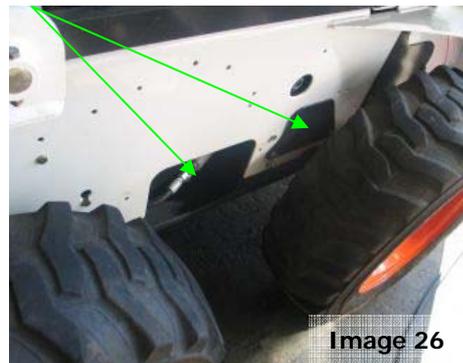
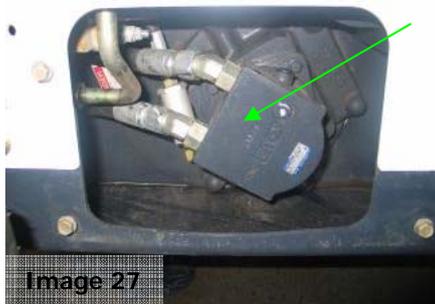
Images 24 & 25:

Several examples of the confined space under the cabin floor of the skid steer loader. This area can harbour significant amounts of contamination (as highlighted) and due to the restrictive space, cleaning and inspecting this area can be very challenging. Most Skid Steer Loaders have non-affixed belly plates which makes the removal of contamination from under the cabin very difficult. To remove all contamination, the Skid Steer may have to have the front end raised on ramps, allowing the contamination to be flushed out the rear.

Images 26 & 27:

The following photos demonstrate how on some models the side panels can be removed (green arrows), allowing cleaning and inspection access under the cabin. Removing these panels is not possible on all models of Skid Steer.

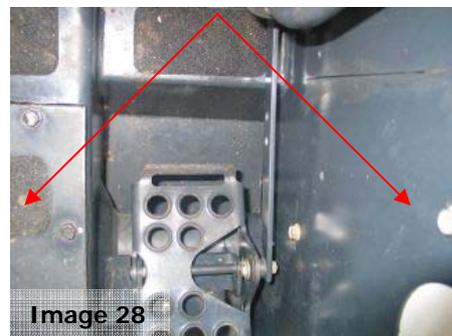
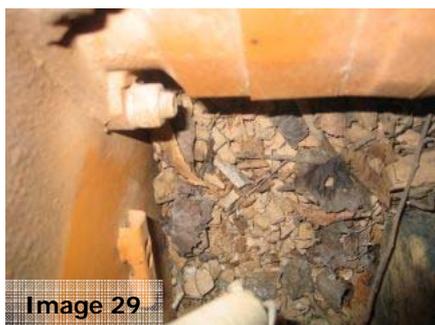
Image 28:

The foot pedal of a general Skid Steer Loader. All non-affixed panels (red arrows) must be removed, allowing cleaning and inspection access.

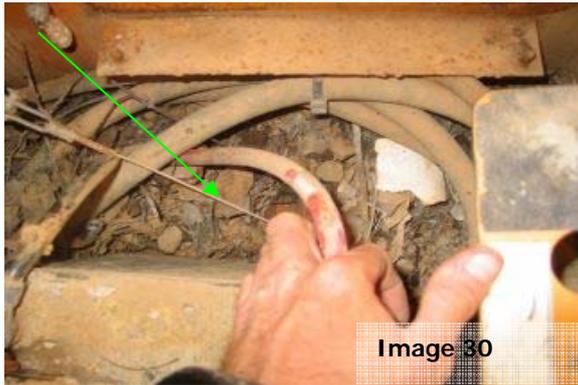
Image 29:

This image illustrates the amount of contamination that can be found under the foot pedal of a Skid Steer Loader.

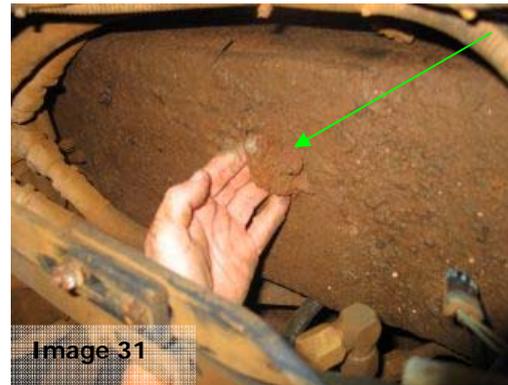
Image 30:
On the floor under the cabin large amounts of contamination can be seen in this illustration. All contamination including plant material and contaminated grease must be removed.

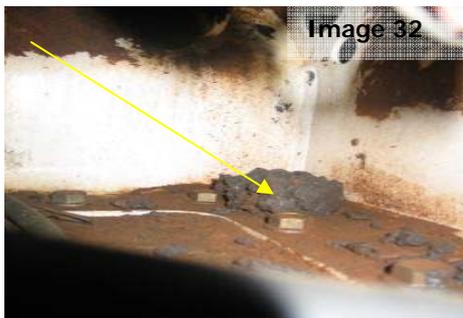
Image 31:
The internal walls under the cabin must be free of all contamination. This illustration highlights the amount of contamination that can be found under the cabin.

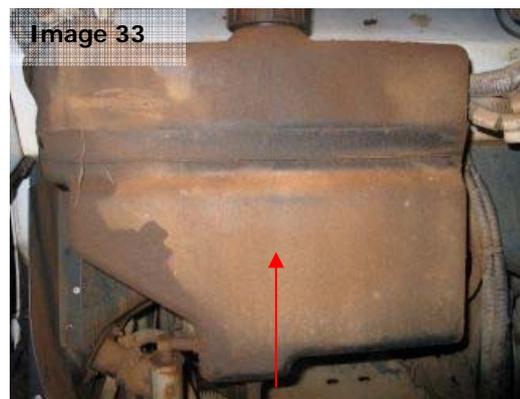
Image 33:
On this model the fuel cell (red arrow) is located behind the seat. All surfaces of the fuel cell must be clean. The band (green arrow) that holds the fuel cell in place must be loosened off so all contamination can be removed from underneath.

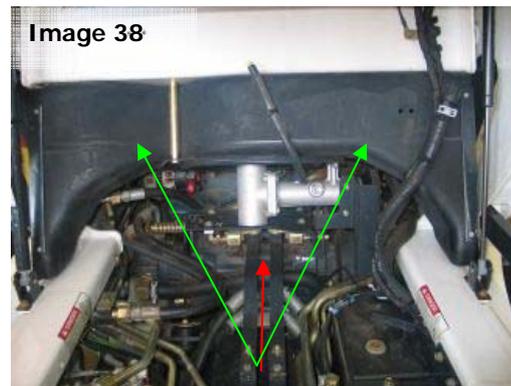
Image 38:

With the cabin raised, access to the front of the engine block (red arrow) and radiator fan (green arrows) is possible.

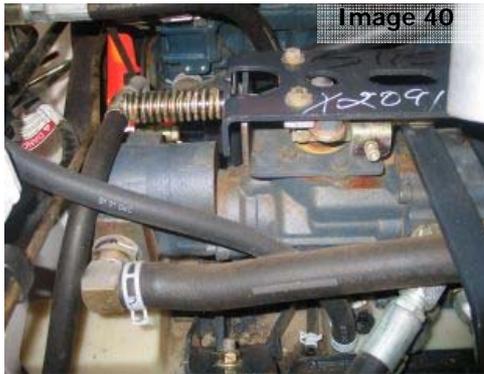
Image 39:

Illustrates the underside of the radiator fan (red arrow), which can be located once the cabin floor has been lifted. All internal surfaces and open-ended tubing (green arrow) must be verified clean.

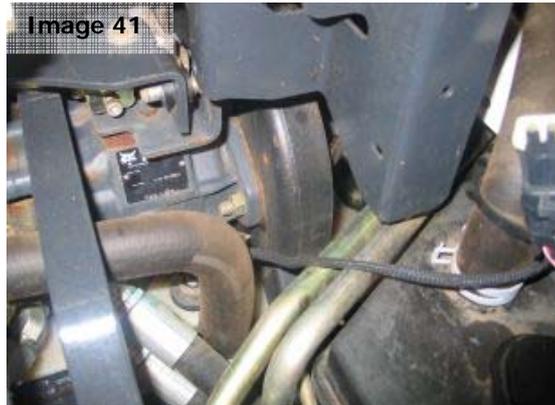
Images 40 & 41:

The front of the engine block as seen from under the cabin. This area is very congested with numerous nooks and ledges that will require thorough cleaning and possibly inspection with a flexible mirror.

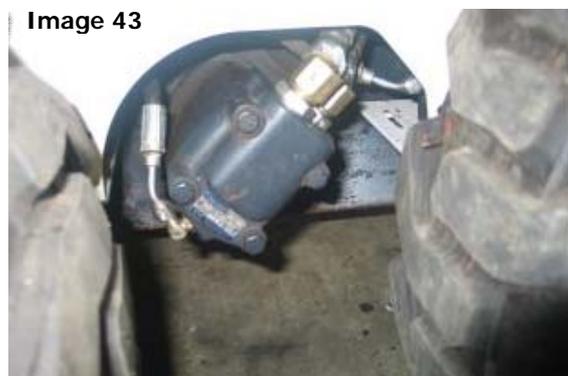
Image 43:

On this model an opening on the side of the Skid Steer can be found, allowing the contaminants removed from inside, an exit point.

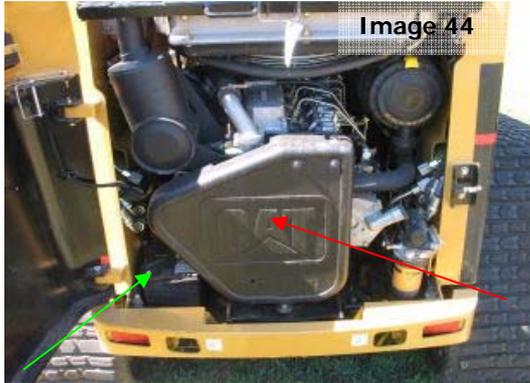
Image 44:

This image highlights the rear of the engine block and surrounding housing. This area is very congested, however some dismantling can facilitate the process. The plastic shroud (red arrow) and the battery (green arrow) can be removed to allow greater cleaning and inspection access.

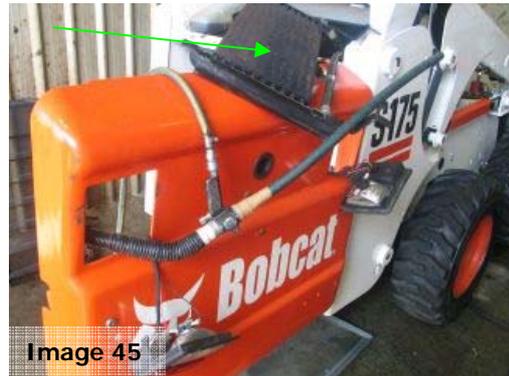
Image 45:

The lights have been removed from the rear door for cleaning and inspection. All foam insulation inside the door (reverse side) must be flushed to verify cleanliness. The radiator core (green arrow) has also been unbolted to facilitate the cleaning and inspection process.

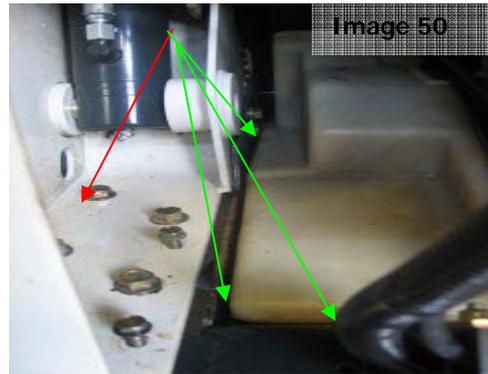
Images 50 & 51:

These illustrations highlight the fuel cell, which is generally located under the engine block. The fuel cell is moulded to fit in this location, however small gaps (green arrows) around the perimeter can allow contamination to enter and go underneath the fuel cell. These small gaps must be flushed at the time of inspection in order to verify cleanliness. The battery (red arrow) has been removed.

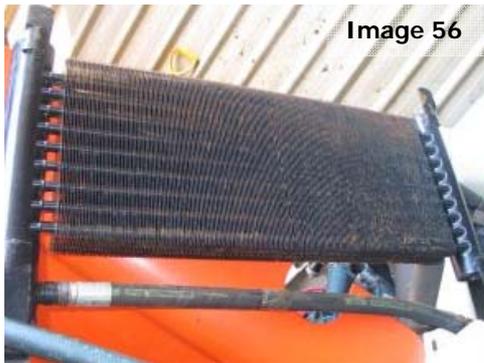
Image 56

Image 56:

This image highlights the radiator cooling fins. This unit has been unbolted for ease of flushing and inspection.

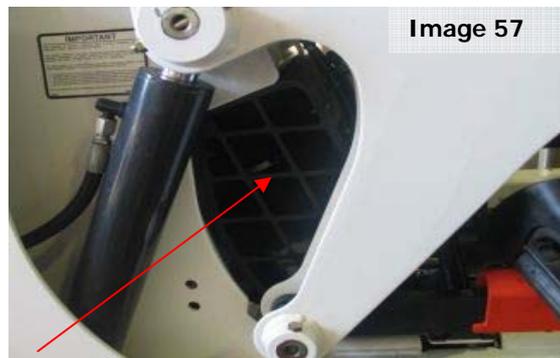
Image 57

On the side of the Skid Steers, small grill (red arrow) may be present which allow air into the radiator fan. See next illustration. Remove all grills to allow for cleaning and inspection.

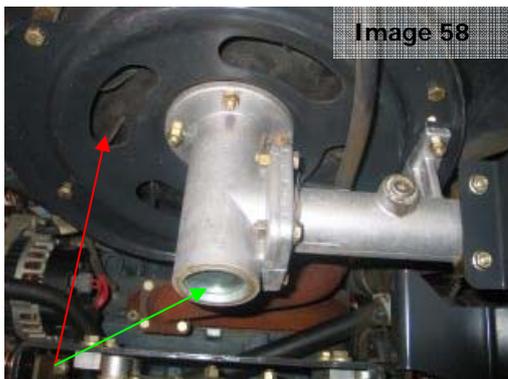
Image 58

Illustrates the underside of the radiator fan (red arrow), which can be located once the cabin floor has been lifted. All internal surfaces and open-ended tubing (green arrow) must be verified clean.

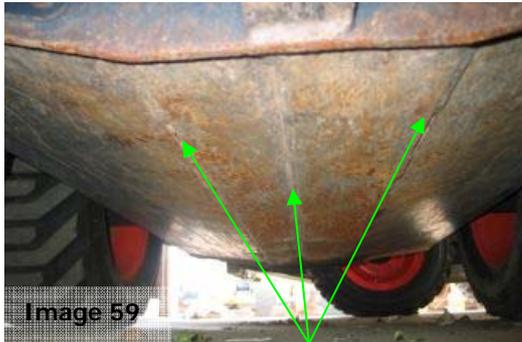
Image 59:

The underbelly of a typical Skid Steer Loader. These belly plates are generally affixed therefore making the removal of contamination from inside very difficult. On this model, the plates are seam welded and all contamination, even minor, must be removed from along the seams.

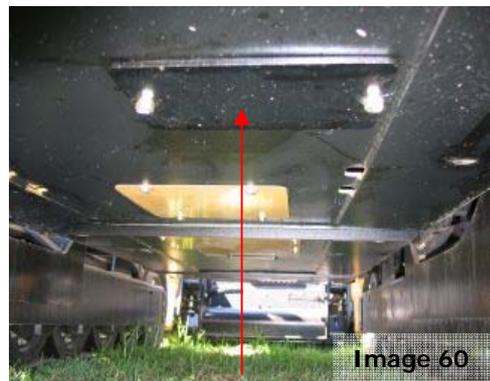
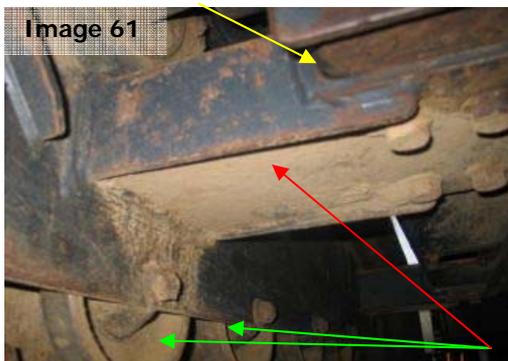
Images 61 & 62:

The rear axles on the tracked Skid Steer Loader. These areas are generally sealed, however the topside and underside (red arrows) can harbour contamination as illustrated in these pictures. The rollers (green arrows) are countersunk and also must be verified free of all contamination. Flush any small recesses (yellow arrows) to verify cleanliness.

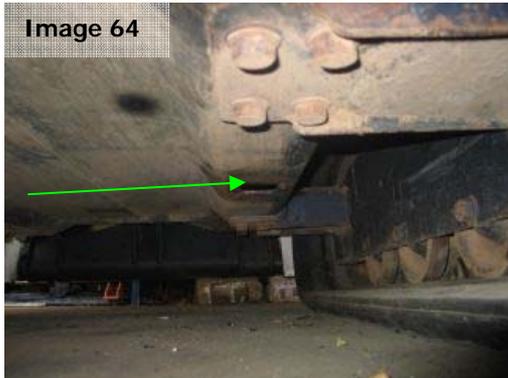
Images 65 & 66:

These illustrations highlight brackets (red arrows) that can be found under the rear on some models. These areas can harbour significant amounts of contamination as highlighted and therefore require checking to verify cleanliness.

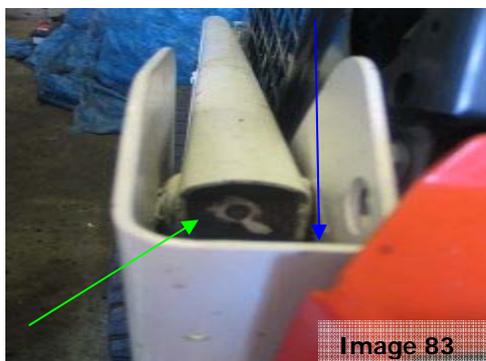
Images 83 & 84:

These images highlight the top of the Skid Steer push arms, which, on these examples, are open-ended channels (green arrows) that will require flushing in the presence of the inspecting officer to verify cleanliness. The blue arrows highlight the area directly below, which is illustrated next.

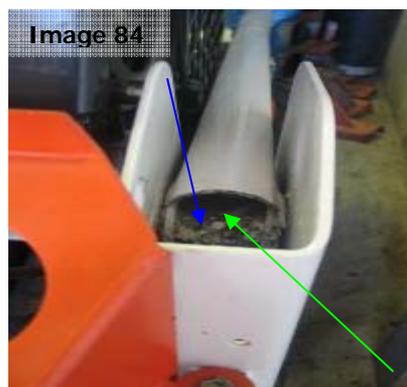
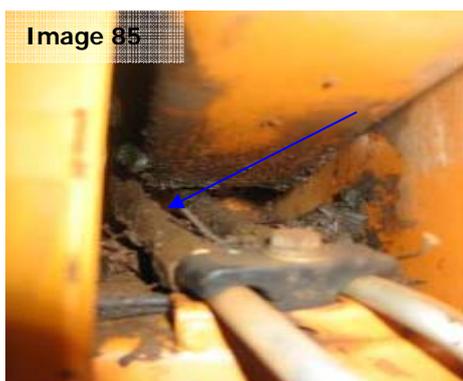
Images 85 & 86:

As the blue arrows in the last illustrations highlighted, the area directly below the push arm pivot points is an open area and can harbour significant amounts of contamination, including dirty grease. All contamination must be removed.

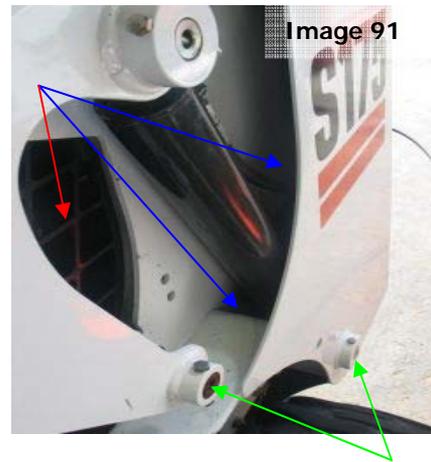
Image 92:

Check all openings (red arrow) and hydraulic hoses (blue arrows) for any contamination.

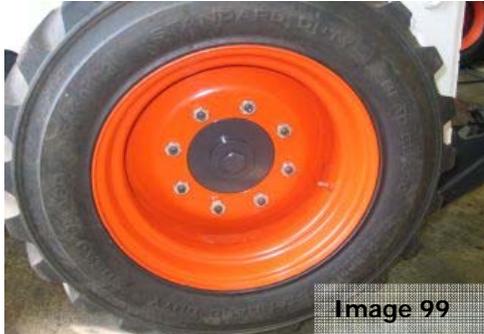
Image 99:

The outside wheel rim found on a typical Skid Steer Loader. Nothing too complex, but must be clean. All cracks and splits in any tyres must be free of contamination.

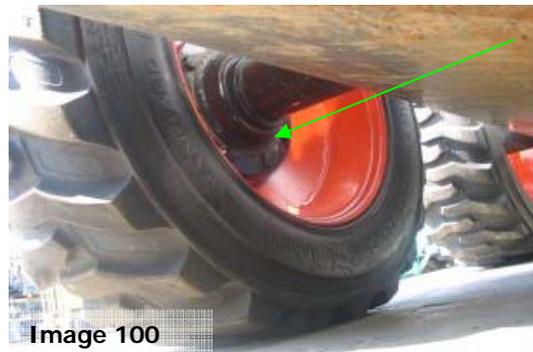
Image 100

The inside wheel rim. Again nothing too complex but again all surfaces must be free of all contamination.

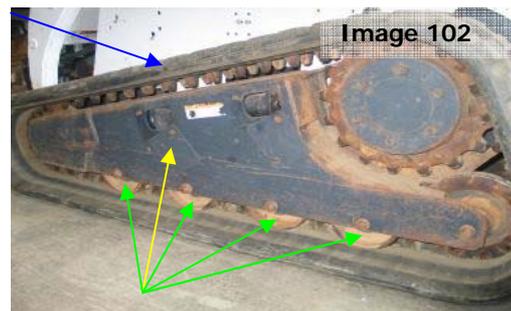
Image 102

The outer side of the track frame. All rollers (green arrows) must be cleaned and all non-affixed panels from the outside track frame (yellow arrow) are to be removed for cleaning and inspection. The inside of the track frame must be flushed to verify internal cleanliness. The rubber track pad (blue arrow) must be fully inspected for any cracks or splits, which can harbour contamination.

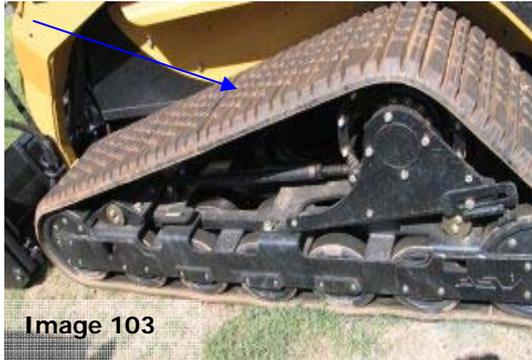
Image 103

On some of the latest models the rollers are not enclosed, making cleaning and inspection access easier. Each roller and the limited housing still requires thorough cleaning and inspection. The track pads must undergo one full revolution to enable full inspection.

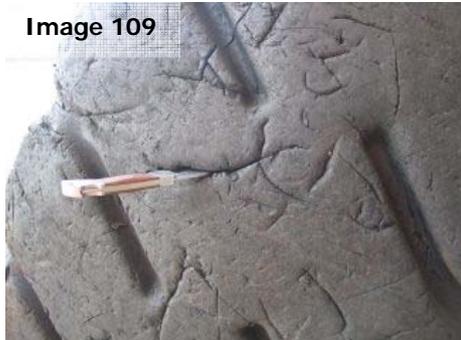
Image 109

Image 109:

All Skid Steer tyres must be checked for cracks and splits. If any cracks or splits are present, then all must be verified free of contamination.

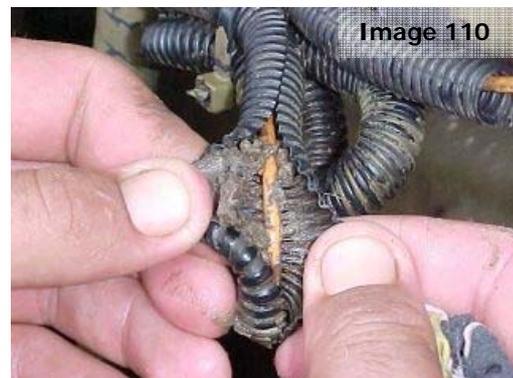
Image 110:

All wiring harnesses are to be carefully cleaned and inspected.

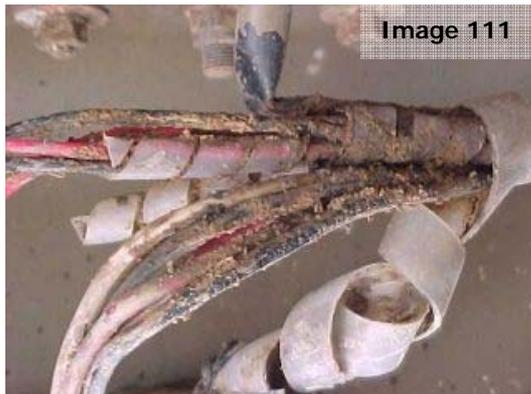
Image 111:

All looming around hydraulic hoses is to be carefully cleaned and inspected.
