Australian Quarantine and Inspection Service

# ARTICULATED DUMP TRUCKS

The following cleaning/inspection guide has been segmented to facilitate the process. The segmentation is as follows:

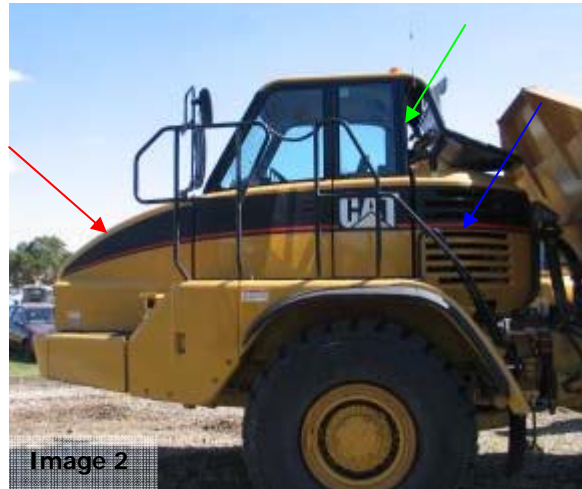
### Image 2:

The new style of Articulated Dump Truck cabin. Cabin door rubbers can be contaminated and are therefore an area of concern to AQIS. The electric engine cover is to be lifted, (red arrow), the rear radiator covers removed (blue arrow) and all handrails checked for open ends or drainage holes. On some models of Articulated Dump Trucks, the cabin can be hydraulically tilted, allowing access to the top of the engine block.

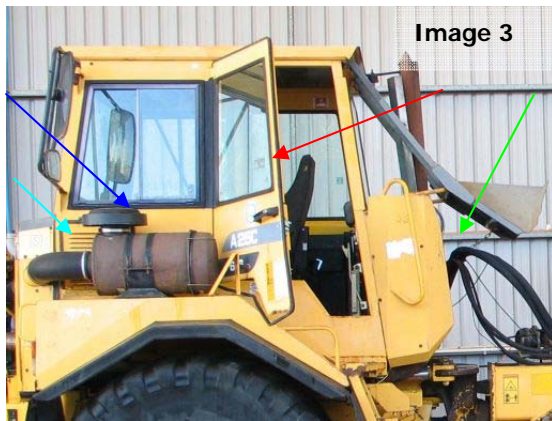
### Image 3:

The older style of Articulated Dump Truck cabin. Again , all cabin door rubbers (red arrow) may be of concern, the air-filter pre-cleaner (blue arrow) removed for cleaning and inspection as well as cabin vent covers (aqua arrow). The rear non-affixed panels have already been removed in this illustration (green arrow).

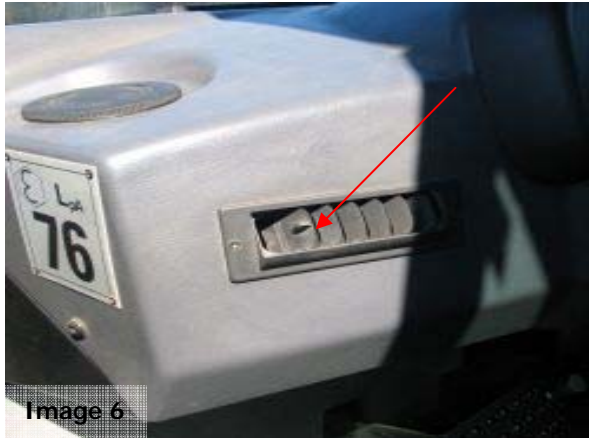
**Image 7:**

A close up of the air-vent cover. Remove the grill (red arrow) and check the cleanliness of the internal filter (pressurised air). The rubber cabin pedals (green arrow) have been removed for cleaning and inspection.

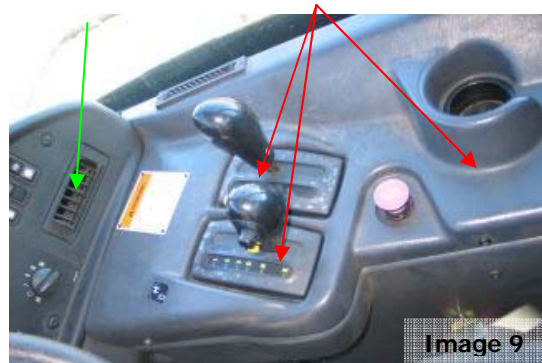
**Image 10:**

All storage compartments (red arrow) are to be internally cleaned as well as behind any internal wall panelling (green arrow).

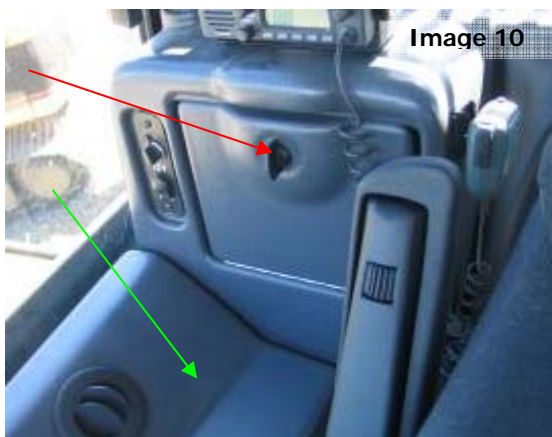
**Image 11:**

Inside the cabin, the floorpan has been removed, allowing inspection access to the top of the engine block (red arrow). The blue arrow highlights where the rubber pedal covers have been removed for cleaning and inspection, while the green arrow highlights the rubber seat shroud, which must be cleaned both internally and externally. On some of the newer models the whole cabin can be hydraulically tilted sideways, allowing access to the topside of the engine block.

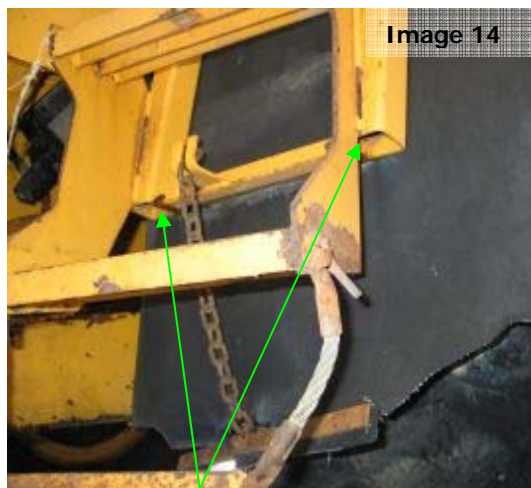
**Image 14:**

The ladder leading to the cabin may have open-ended channels as those highlighted by the green arrows. Each footstep must be thoroughly cleaned, including the underside.

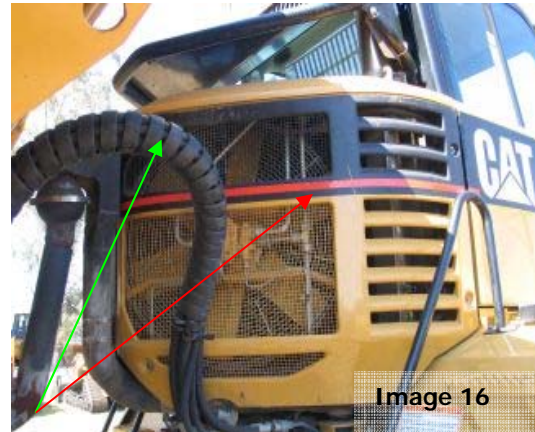
**Image 15 & 16:**

The non-affixed radiator cover panels, located behind the cabin. Both must be removed to allow access to the radiator and oil cooler fins, as well as the inside of the radiator shroud. All looming (green arrow) is to be checked for internal cleanliness.

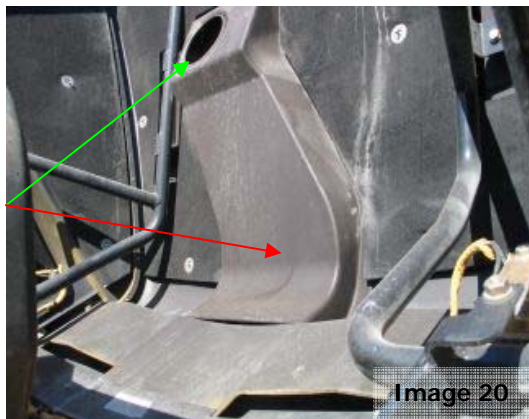
**Image 20:**

The air intake vent (red arrow) on the inside of the engine housing. The internal surfaces are to be verified clean.

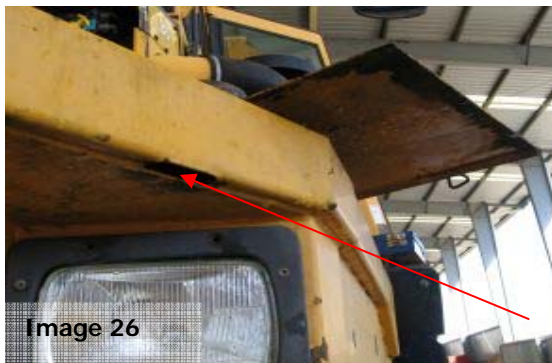
**Image 26:**

On some of the older models, drainage holes like the one highlighted by the red arrow above the headlight, require flushing to verify cleanliness.

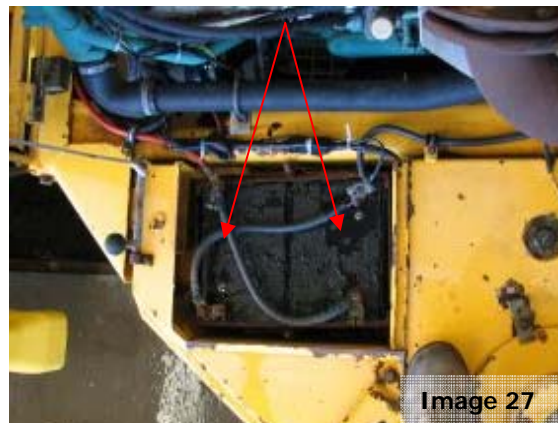
**Image 27:**

All batteries are to be loosened from tie-down points for underside cleaning and inspection.

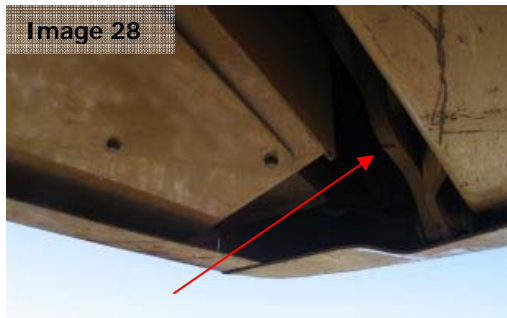
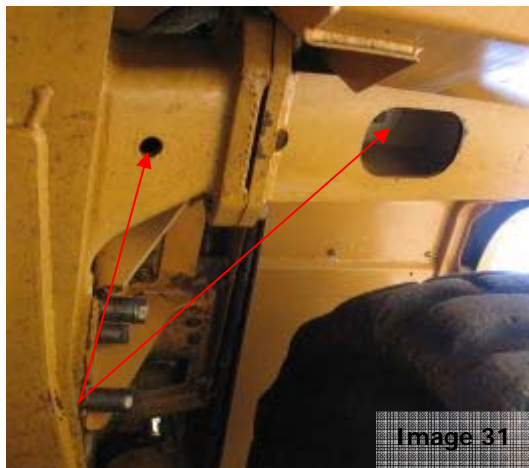
**Images 28 & 29:**

The underside of the front drawbar. On this model the area has no hollow channels, but rather numerous nooks and ledges that all require thorough cleaning and inspection.

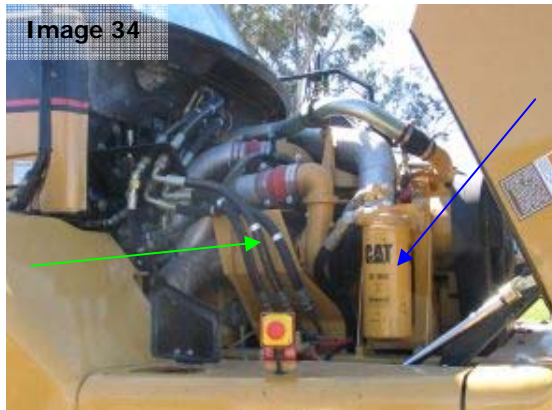
**Images 34 & 35:**

Both sides of the Dump Truck engine block. All hydraulic hoses (green arrows), oil filters (blue arrows) need to be thoroughly cleaned, as well as the side and front of the block and the air-filter (red arrow).

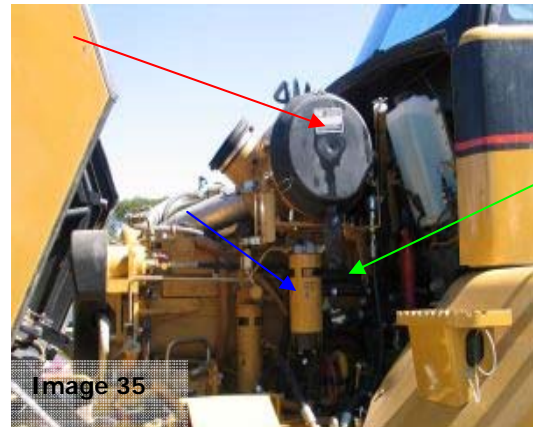
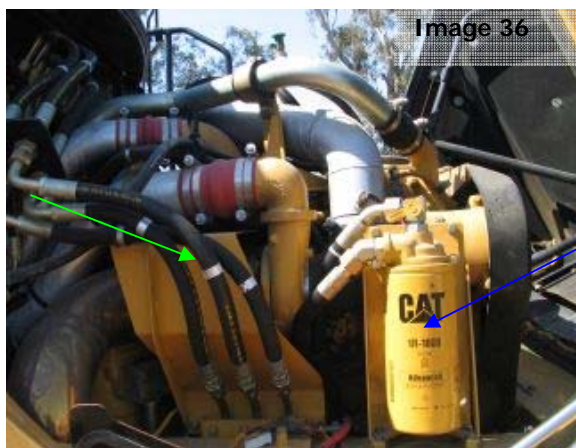
**Images 36 & 37:**

Both sides of the Dump Truck engine block. All hydraulic hoses (green arrows), oil and fuel filters (blue arrows) need to be thoroughly cleaned, as well as the side and front of the block.

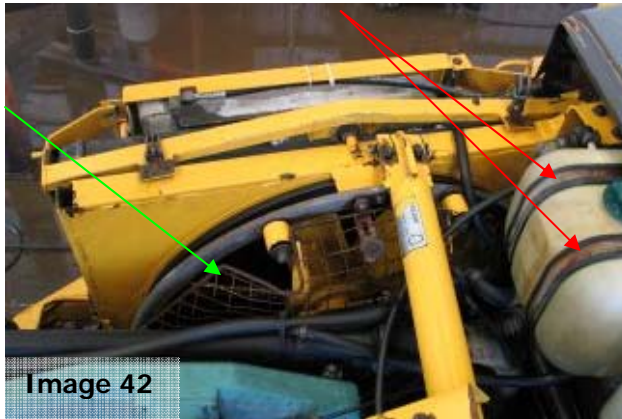
**Image 42:**

On older models, the radiator is located in front of the cabin. For cleaning and inspection, several non-affixed radiator cover panels have been removed. The shroud grill (green arrow) is still in place, preventing access into the bottom of the shroud. Loosen bands around tanks (red arrows) and flush.

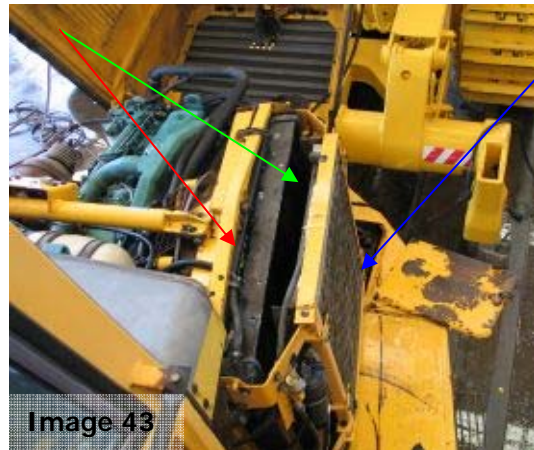
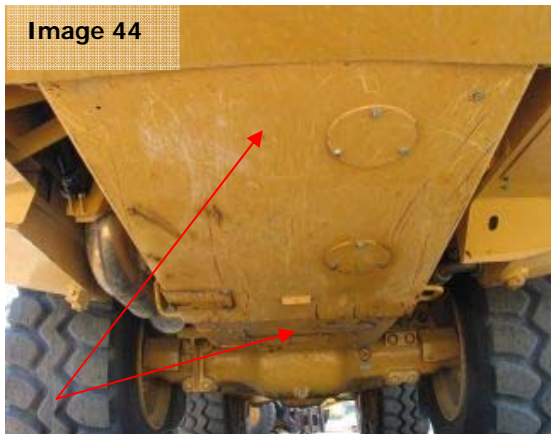
**Images 44 & 45:**

The belly plates in place under the Dump Truck, and then released on their hinges.

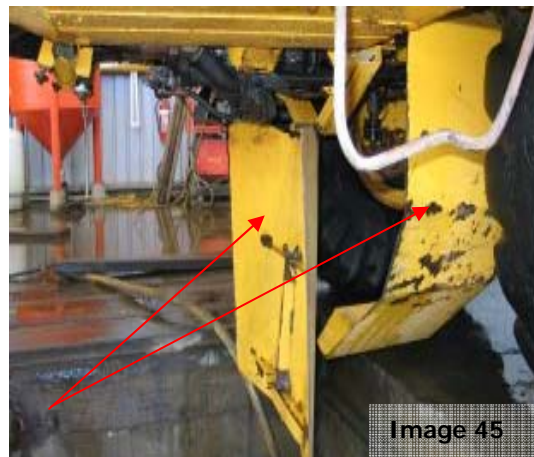
**Image 46:**

The underside cross-members where the belly plates attach. These can be hollow structures, as seen above (red arrows) and require flushing to verify cleanliness.

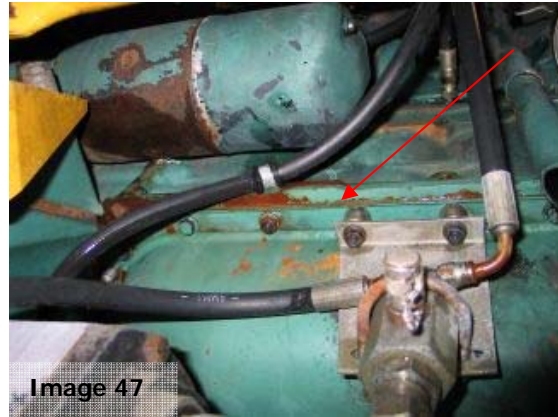
**Image 48:**

The belly plates have been removed, exposing the underside of the engine block for cleaning and inspection. Check the topside of the engine mounts (red arrows) for cleanliness. The foam insulation (green arrow) is highlighted next.

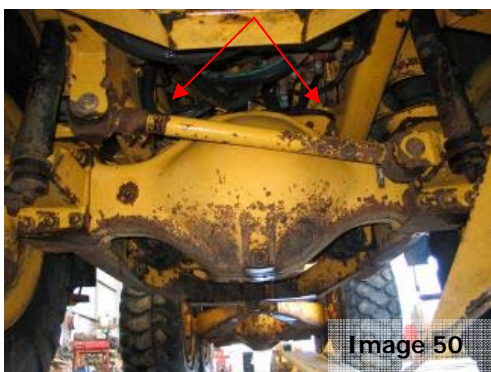
**Image 50:**

The topside of the differential (red arrows) must be thoroughly cleaned and inspected.

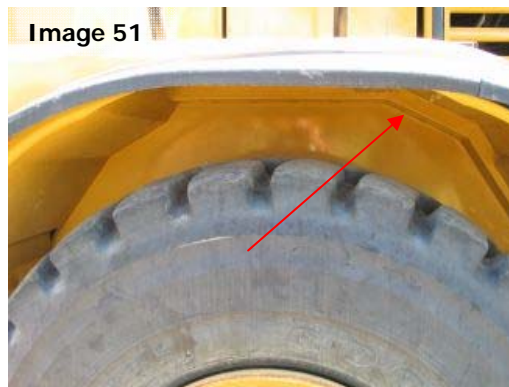
**Images 51 & 52:**

The front wheel arches on the newer models. Check all underside channels (red arrows) for open ends, or drainage holes.

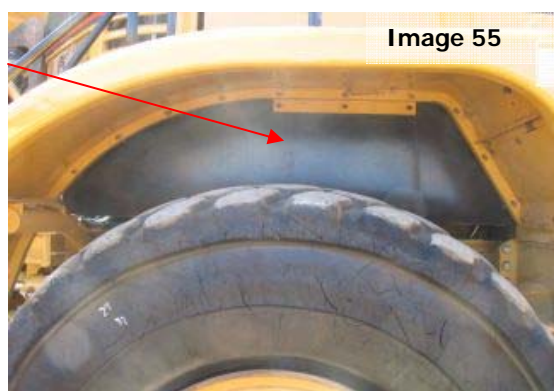
**Images 55 & 56:**

The wheel arches on the earlier models may have black protective shrouds (red arrows) on the inside, which can be removed to facilitate the access to the side of the engine, located under the cabin.

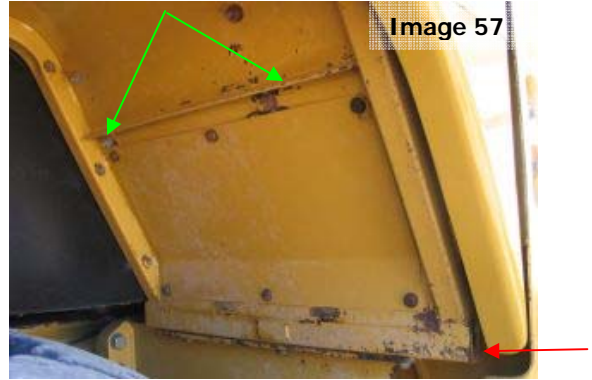
**Image 58:**

Highlighted by the red arrow is a small box section inside the wheel arch. Check for drainage holes underside or if only spot welded into place. If only-spot welded, the internal cleanliness will require verification.

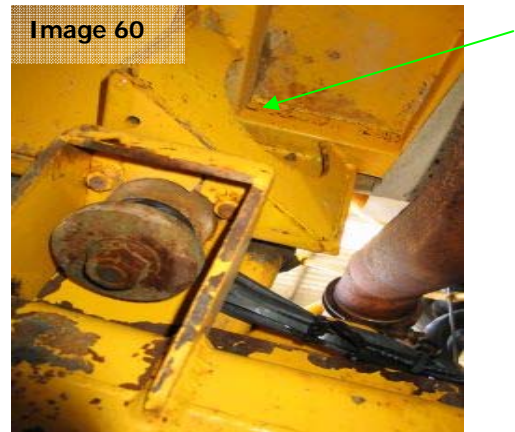
**Image 60:** On earlier models, the cavity highlighted by the green arrow can be found inside the front wheel, just above the chassis rail. This area can harbour a significant amount of contamination.

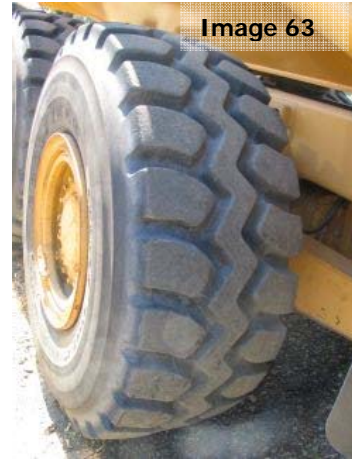
**Image 63:**

An example of an acceptable tyre, which can be easily cleaned and inspected.

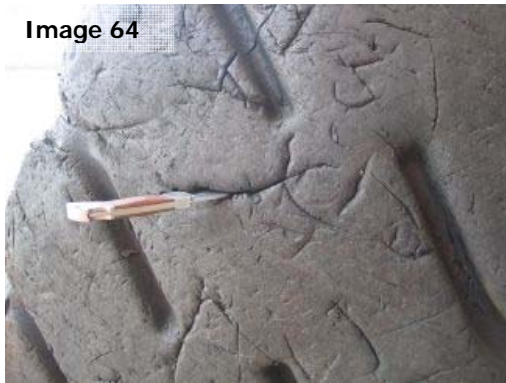
**Image 64:**

Imported tyres with cracks and splits like the ones illustrated must all be free of contamination and each verified at the time of inspection.

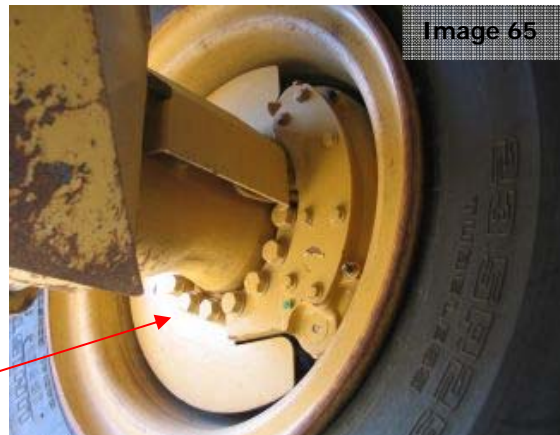
**Image 65:**

All non-affixed wheel rim covers (red arrow) are to be removed to facilitate the cleaning and inspection process.

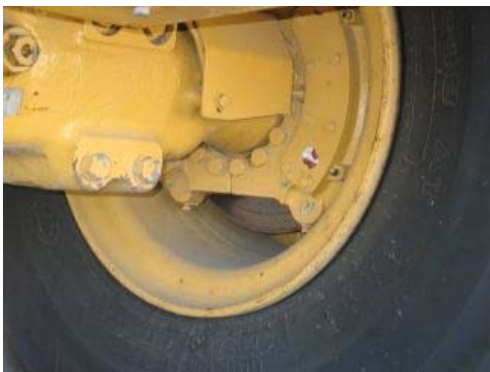
**Image 66:**

Congested rims like the one illustrated may require flushing as well as inspection to verify cleanliness.

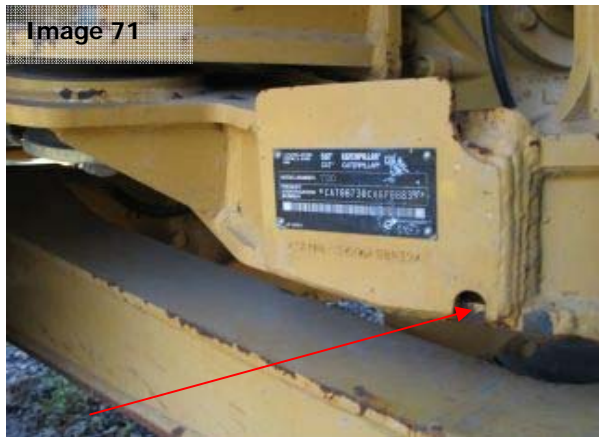
**Images 71 & 72:**

The drainage holes (red arrows) at the rear of the chassis, near the pivot point. These hollow channels must be flushed in the presence of the inspecting officer in order to verify cleanliness.

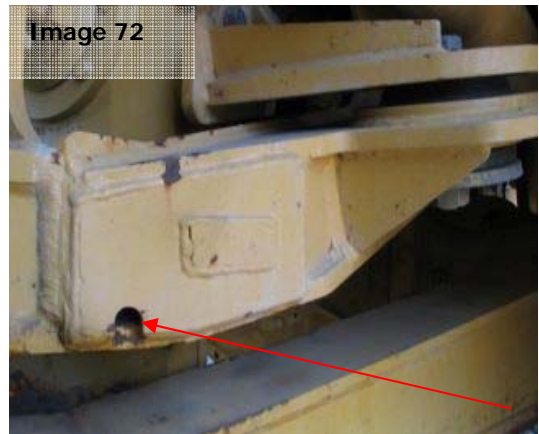
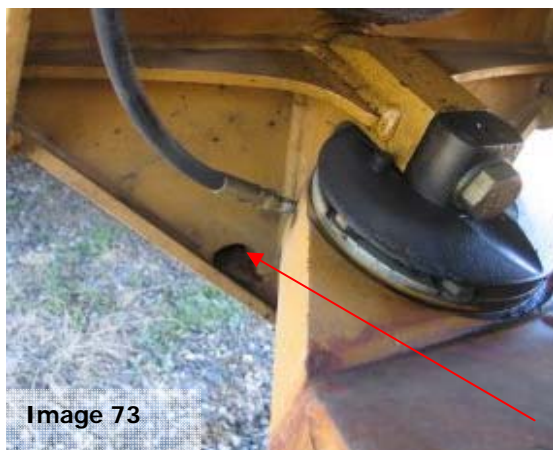
**Images 73 & 74:**

Just behind the pivot point is the start of the rear chassis. Check for drainage holes like those illustrated (red arrows) and flush to verify internal cleanliness.

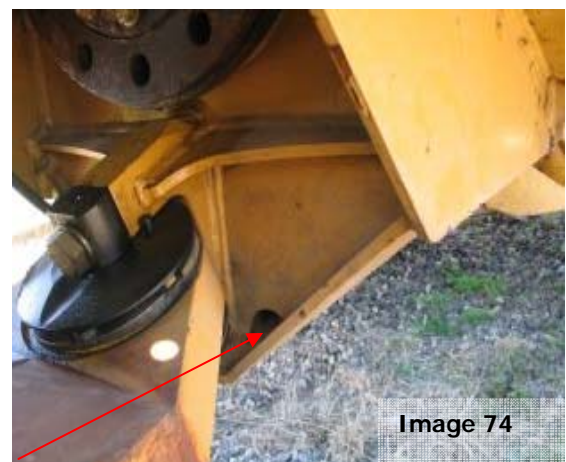
**Image 75:**

To enable cleaning and inspection of the rear chassis, the Dump Tray must be lifted (locking pins must be in place). All plastic conduit (red arrows) is to be flushed to verify internal cleanliness.

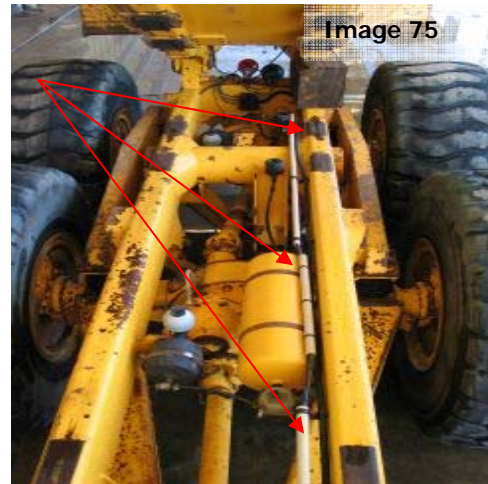
**Image 76:**

The first universal joint (red arrow) on the rear chassis. All contaminated grease must be removed. Check that all ledges (blue arrows) and countersunk holes (green arrows) are free of contamination.

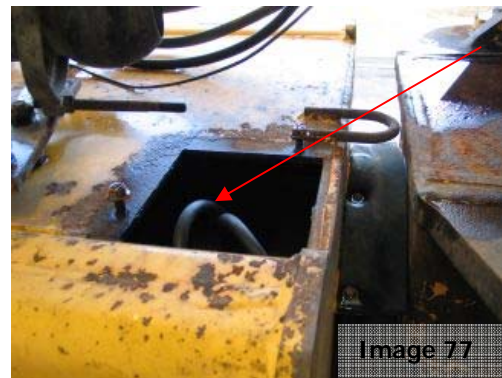
**Image 77:**

Box sections like the one illustrated are found at the front of the rear chassis. This one has a non-affixed panel at the top, which allows access for cleaning and inspection.

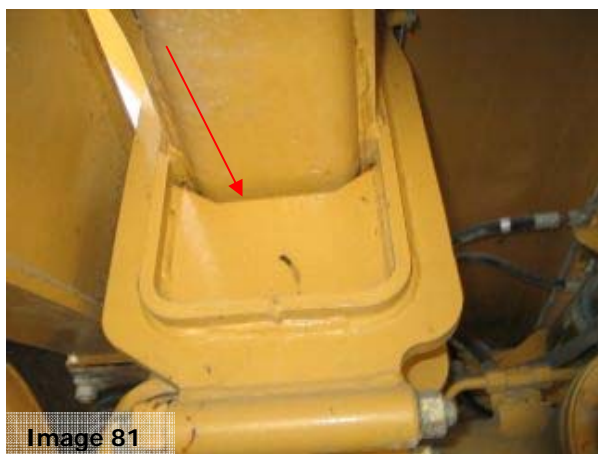
**Image 81**

Some sections on the rear chassis may have hollow sections as highlighted by the red arrow and require flushing to verify cleanliness.

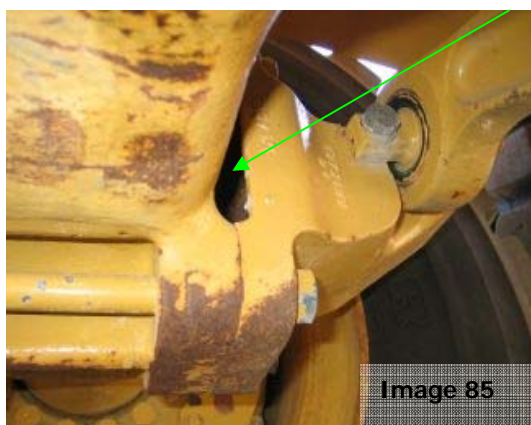
**Image 85:**

Another view of the small bracket on the rear of the axel, highlighting the small opening (green arrow), where a 90 degree lance can be inserted to flush this area and verify cleanliness.

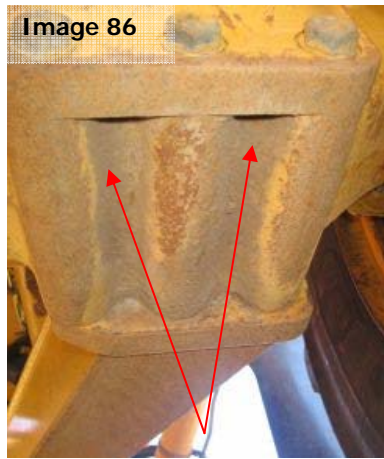
**Image 86:**  
The underside of the axel on the rear chassis. Ensure all contamination has been removed from this undulating surface.

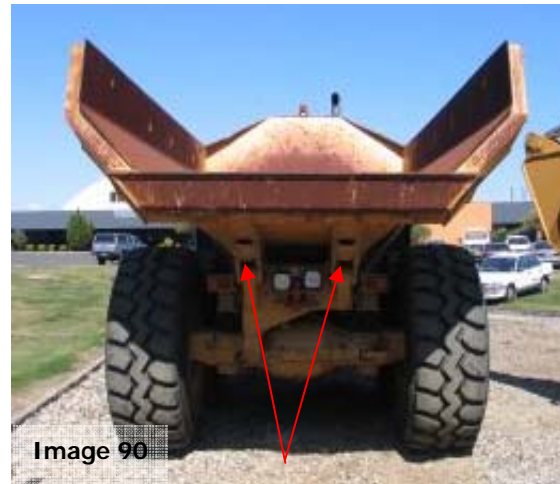
### Image 91:

The internal 'skin' of the tray must be thoroughly checked for any cracks, splits or evidence of repair. The sides (red arrows) are only single skinned however the green arrows highlight hollow areas that can harbour contamination if breached.

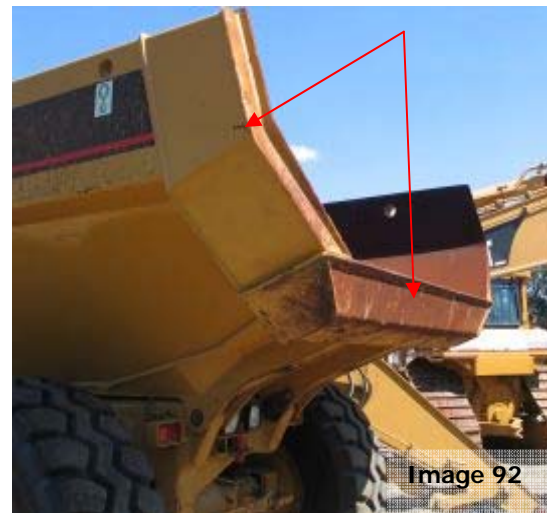
### Image 92:

The rear section of the tray also has hollow sections (red arrows) that can harbour contamination if cracked, split or breached. Check along weld seams for any evidence of damage or breaches, allowing contamination to enter these sections.

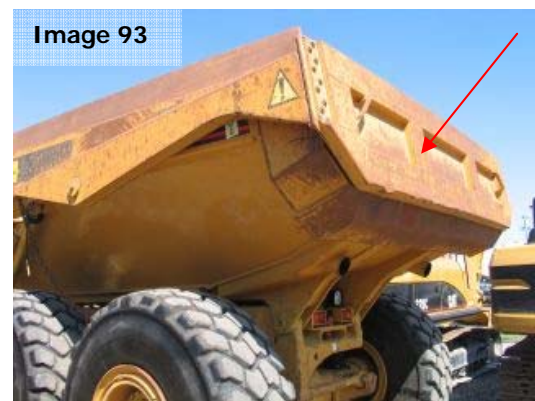
### Image 93:

On some models a rear tray door may be present. These dump tray doors have hollow sections. Check both the internal and external surfaces as well as the welding seams for any cracks, splits or evidence of repair. *If any cracks, splits or evidence of repair is found on any part of the dump tray, these must be investigated and it will be the responsibility of the importer to verify these areas are clean and free of contamination.*

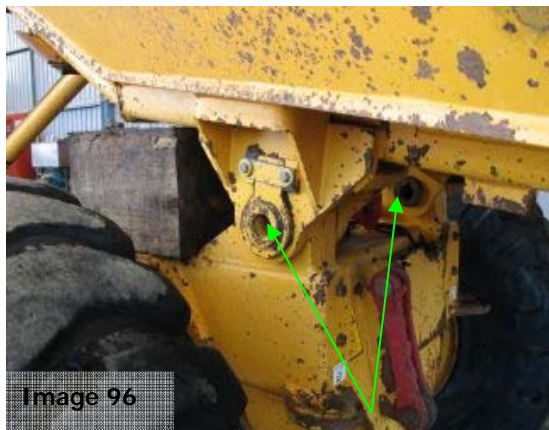
**Image 96:**

All contaminated grease must be removed from all pivot points.

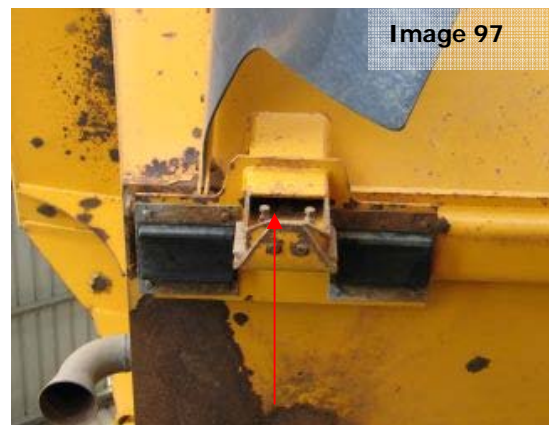
**Image 98:**

Evidence of repair (green arrows). This illustration was from under the tray, where the hinges for the rear door attach. The section it attaches to is hollow (red arrow) and will require further investigation.

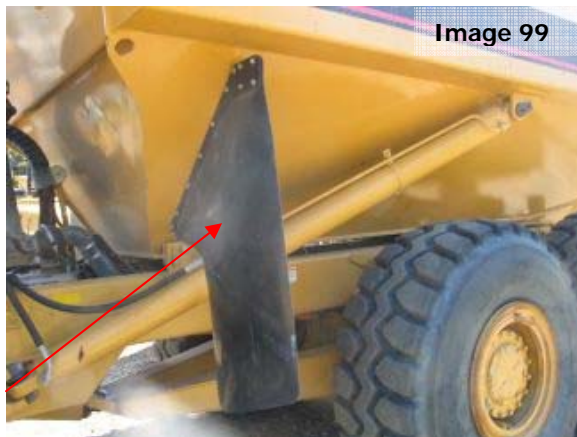
Image 99

The rear mudguards and the small recess where it attaches to the tray. This area must be flushed to verify cleanliness.

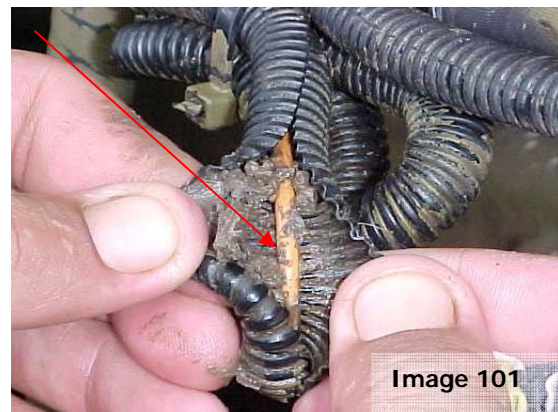
Image 101

All wiring harnesses must be free of contamination and thoroughly checked.

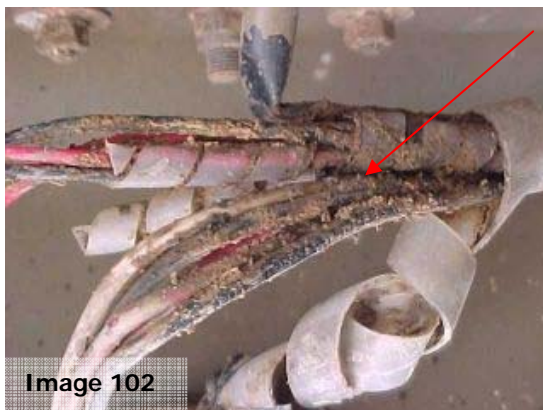
Image 102

All looming must be free of contamination and thoroughly checked.

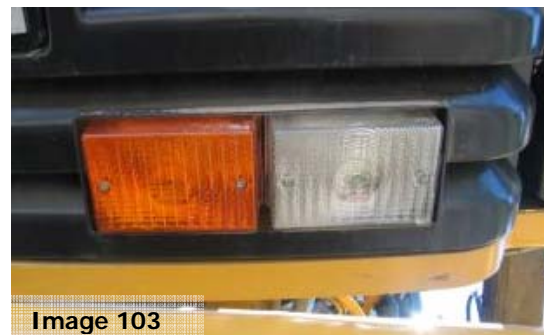
Image 103

Verify that the internal light fittings are clean.

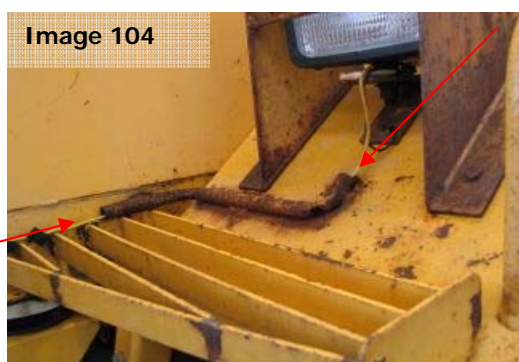
### Image 104:

Flush all hollow tubing as highlighted by the red arrows.
