CATERPILLAR DOZERS

D8, D9, D10 & D11 SERIES

The following cleaning/inspection guide has been segmented to facilitate the process. The segmentation is as follows:

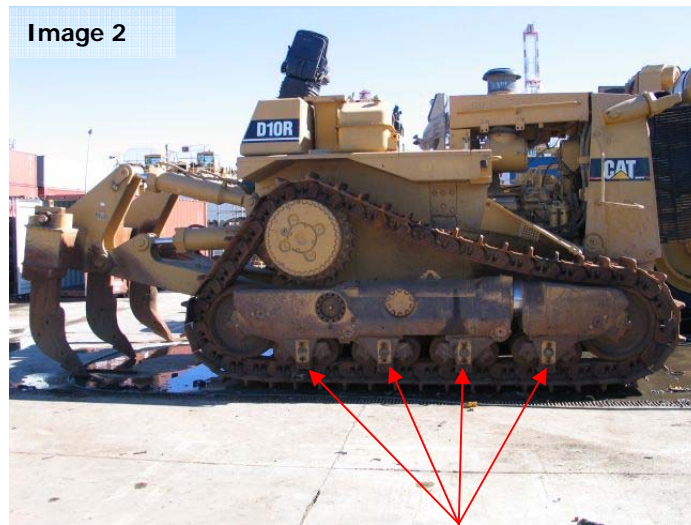
Image 2:

Landscape shot of a typical Caterpillar Dozer. Structurally, the D8, D9, D10 & D11 series are basically the same except for small variations and obviously size differences.

Note that the cabin has been removed for shipping purposes as well as the bearing covers (red arrows). There are 16 bearing covers in total. On the D10, these bearing covers are rectangular, however on the D8's they are oval shaped and on the D11 they are triangular. These bearing covers must be removed for cleaning and inspection purposes.

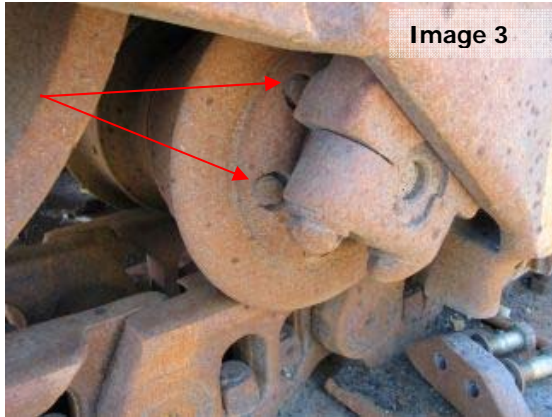
Image 3:

The tracks on any dozer need to be rolled to allow the cleaning and inspection of the countersunk bolt heads (red arrows) on each of the rollers.

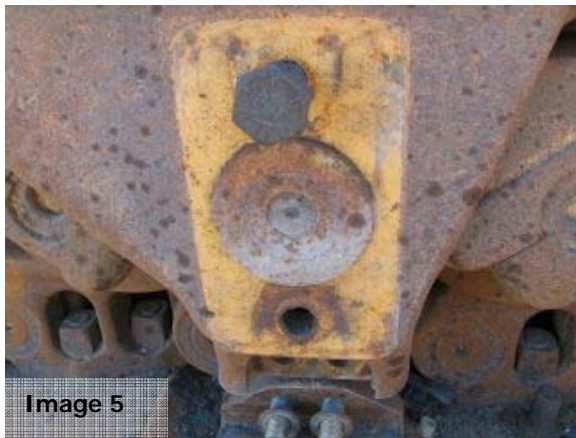
Image 6:

Bearing cover on a D8 still attached.

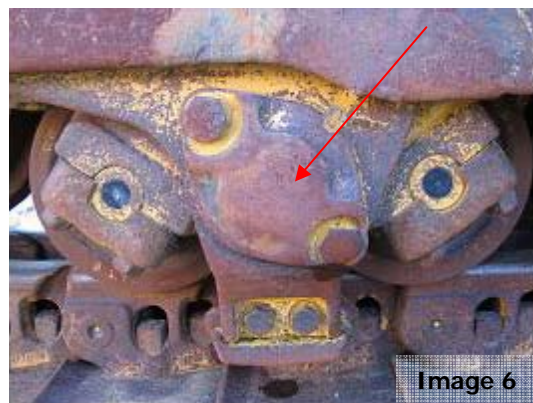
Image 7:

This illustration shows the small gaps between the track pad nuts, which require careful cleaning and inspection. To inspect the rear of these nuts, either use a small inspection mirror or inspect the backside of the outside nuts from the inside of the track frame and vice versa.

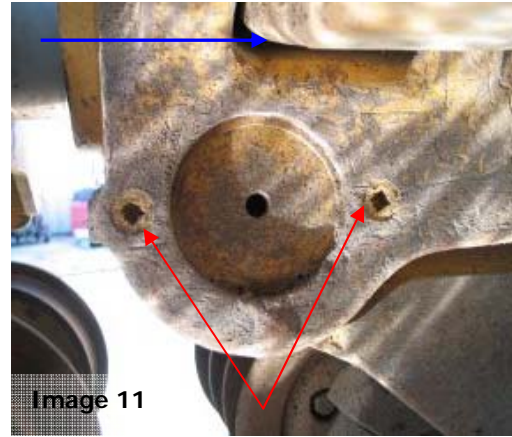
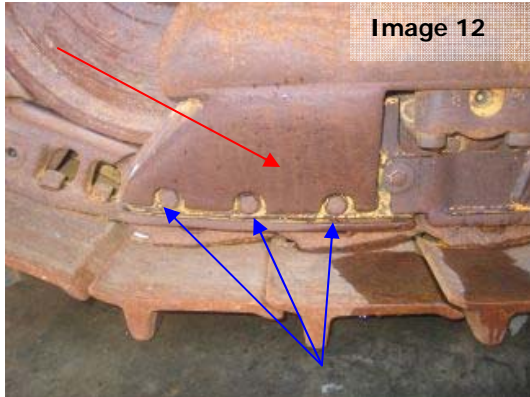
Image 12:

On the ends of some models will be protective plates (red arrow), as illustrated above. The structures are generally hollow and need to be flushed via the small open gaps at the bottom (blue arrows) to verify cleanliness.

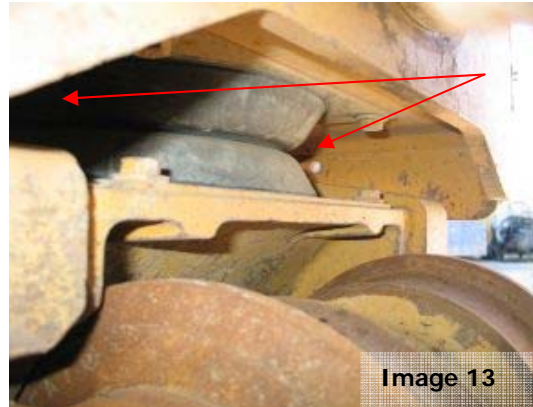
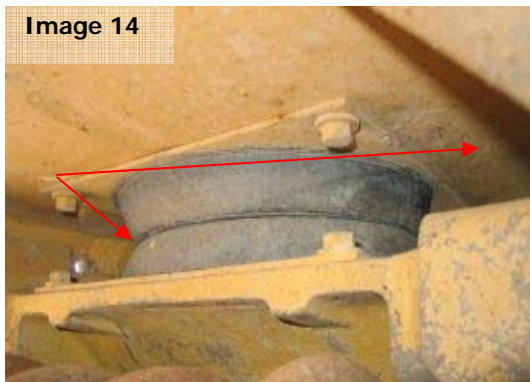
Images 13 & 14:

Inside the track frame highlighting the rubber mounts and horizontal ledges that can be found inside many track frames. The inside of all track frames needs to be thoroughly cleaned and inspected.

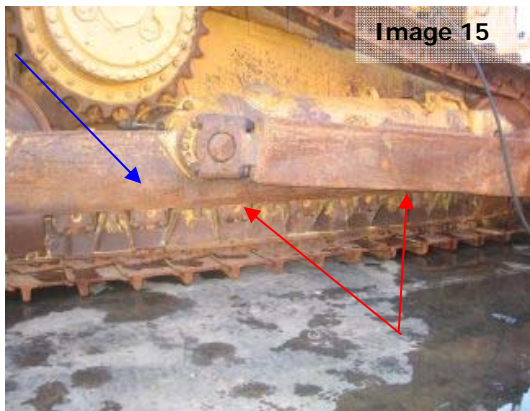
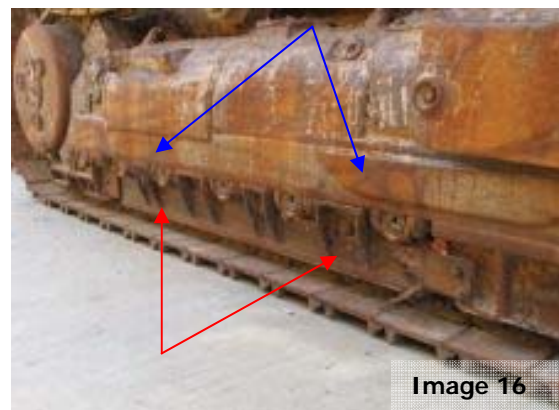
Images 15 & 16:

Several illustrations of Rock Guards (red arrows) attached to Dozer Tracks. If rock guards are present, these must be removed from both the outside and inside of the track frame to allow access for both cleaning and inspection. The channel above the rock guards (blue arrows) is hollow and must be flushed via the boltholes once the rock guards have been removed. See general section for example of hollow frame above rock guards.

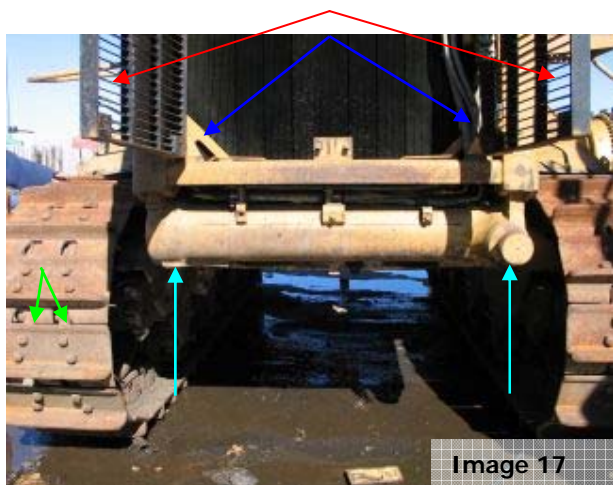
Image 17:

The radiator grill (red arrows) has been opened, allowing access to the radiator fins. If the grill cannot be opened as illustrated it must be removed at the time of inspection.

The green arrows show the track pads slightly opened when at the apex. The aqua arrows highlight where the bolts holding the belly plates in place have been removed. This chassis is hollow and will require the removal of the belly plates and flushing via the bolt holes to verify cleanliness (in the

presence of the inspecting officer). The blue arrows are to highlight the two vertical pillars either side of the radiator. These are hollow and can generally be accessed for flushing via small drainage holes, located in behind the radiator grill.

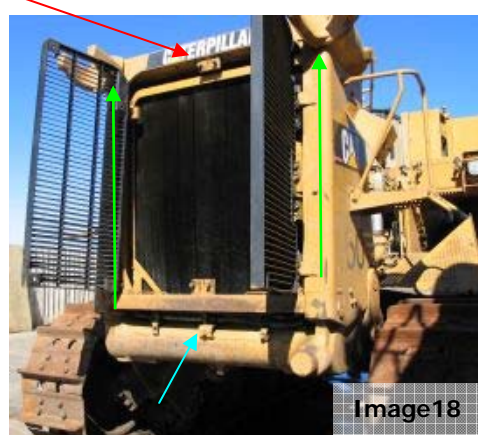
Image 18:

This illustration is showing the bolt holes where the belly plate has been removed, allowing access to the circular nose bar. This area must be flushed in the presence of the inspecting officer to verify cleanliness.

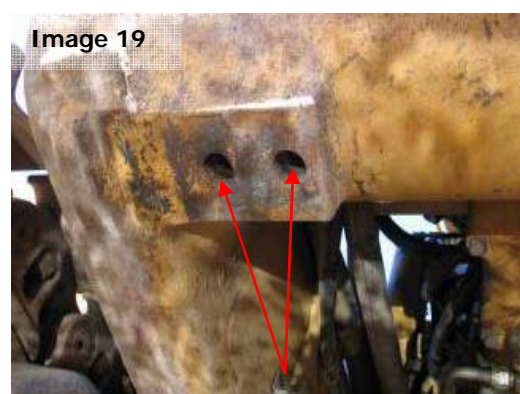
Image 19:

Illustrates where the belly plate bolts have been removed, allowing access to the hollow side chassis rail (see aqua arrow in illustration below). This area must be flushed in the presence of the inspecting officer to verify cleanliness.

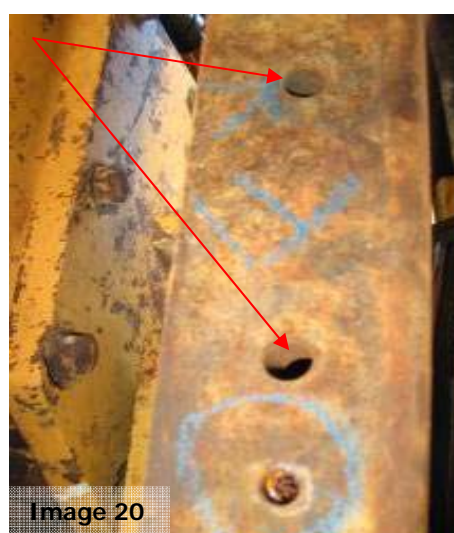
Image 21:

The aqua arrow highlights the hollow side chassis rail that can be accessed via the belly plate bolt holes. The red arrow highlights other belly plate bolts that must be removed from the sheath to verify cleanliness.

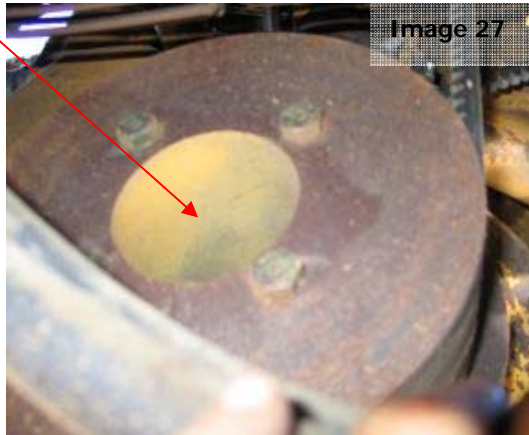
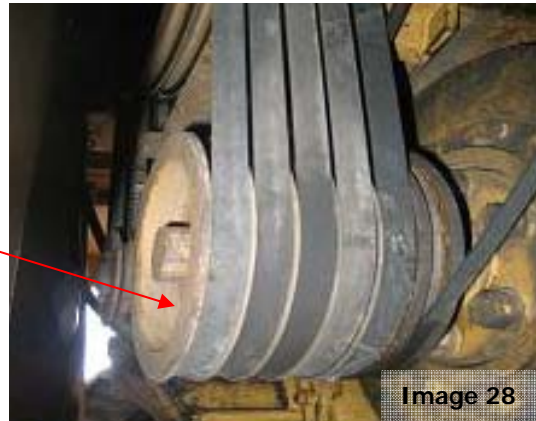
Images 27 & 28:

Examples of Harmonic Balancers that are found at the front of the engine block. These areas are generally hollow and can harbour contamination.

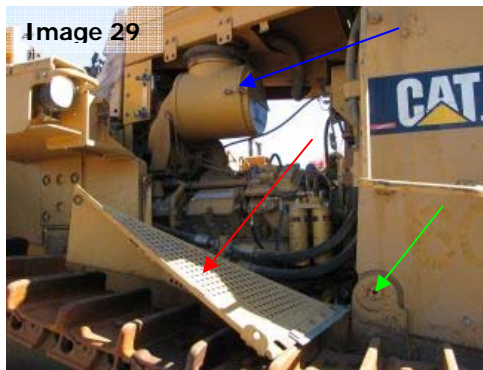
Image 29:

The right-hand side of the Dozer engine housing. All non-affixed engine covers have been removed for cleaning and inspection. The red arrow highlights the checker plate inside the engine cover, which will require flushing at the time of inspection. The air-filter (blue arrow) will need to be removed from the housing and verified clean (high pressure air). Remove all contaminated grease from pivot points (green arrow)

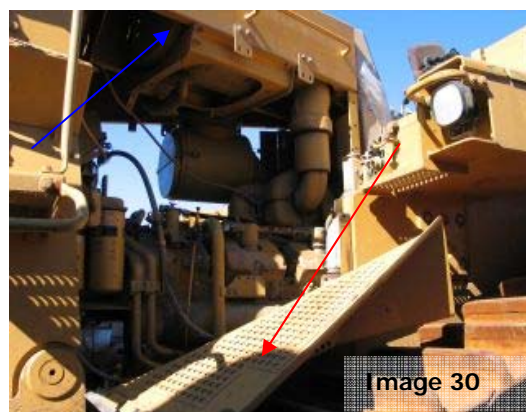
Image 30:

The left-hand side of the Dozer engine housing. All non-affixed engine covers are to be removed for cleaning and inspection. The red arrow highlights the checker plate inside the engine cover, which will require flushing at the time of inspection. Check all framework inside the engine cover for hollow channels which will require flushing if not completely sealed.

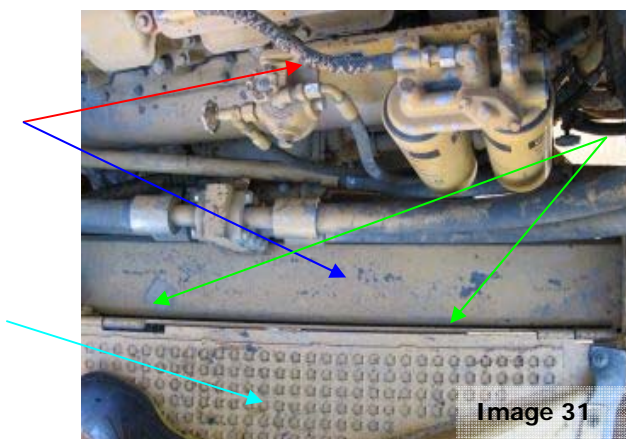
Image 31:

The side of the engine block (red arrow) and hollow chassis rail (blue arrow). The engine cover has been laid back on the hinge, exposing a small gap (green arrows) between the side cover and the chassis rail. Flush along this small opening to remove all contaminants. Flush checker plate (aqua arrow).

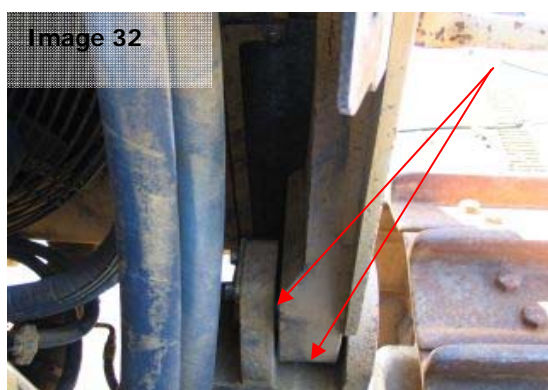
Image 32:

Check that all pivot points (red arrows) such as the one either side of the radiator has been thoroughly cleaned and all contaminated grease removed.

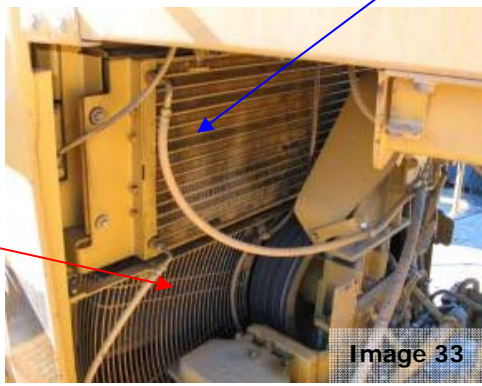
Image 33:

The front end of the engine block, the oil cooler and the radiator grill. The radiator grill (red arrow) must be removed, allowing access to the inside of the radiator shroud. The oil cooler (blue arrow) needs to be flushed in the presence of the inspecting officer to verify cleanliness of the fins.

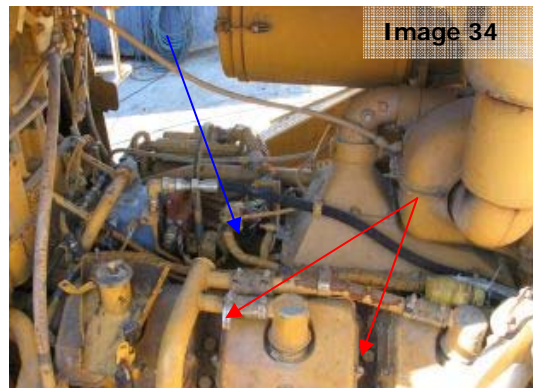
Image 34:

The topside of a typical Dozer block. Check between each tappet cover (red arrows) and along the centre of the block. Best to flush these areas after visual inspection to ensure all contamination has been removed.

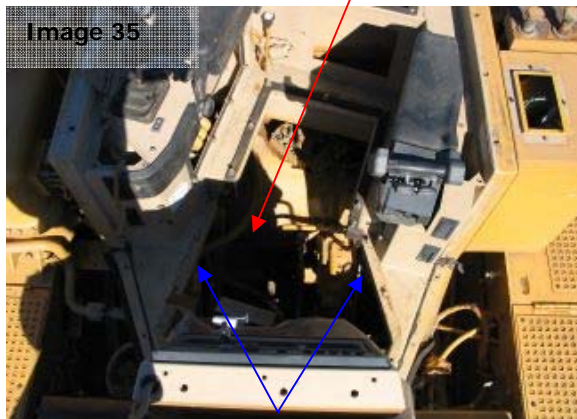
Image 35:

The floorpan (red arrow) and seat have been removed, allowing access to the hollow framework (blue arrows) below the floorpan and the top of the transmission.

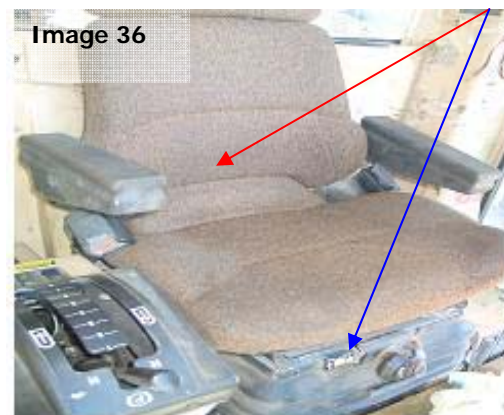
Image 36

The seat must be removed to allow the floorpan to be taken out, allowing access to the top of the transmission and inside the joystick control panels (see following pictures). Once the seat has been removed, ensure the rubber seat shroud is clean inside.

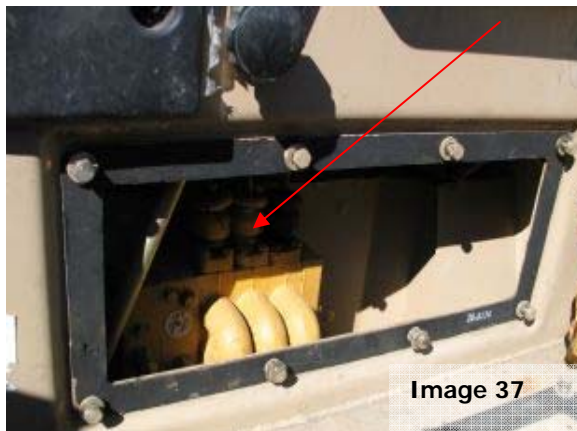
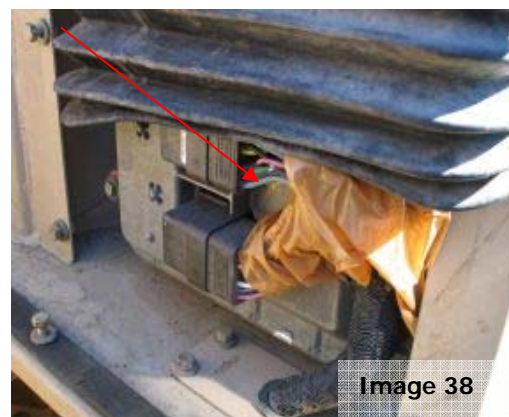
Images 37 & 38:

These pictures illustrate the joystick control panels located either side of the seat. All non-affixed panels have been removed, allowing access for cleaning and inspection. These areas sometimes have ledges inside which harbour contamination and need to be thoroughly inspected. The joystick control on the right houses the electronics and care must be taken when inspecting this area.

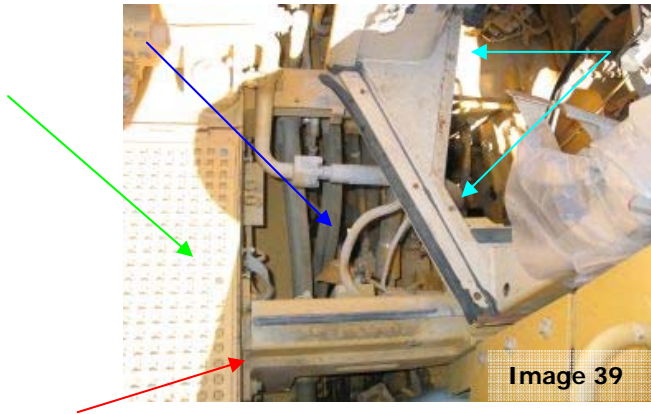
Image 39:

The red arrow indicates the open-ended box channel that runs along the front of the cabin, below the instrument panel. The floor panel just outside the door has been removed, allowing access to this hollow open-ended channel (blue arrow). All checker plate flooring (green arrow) and hollow channels must be flushed at the time of inspection. The aqua arrows highlight where the floorpan attaches to the base. These channels are open-ended also and will be illustrated later.

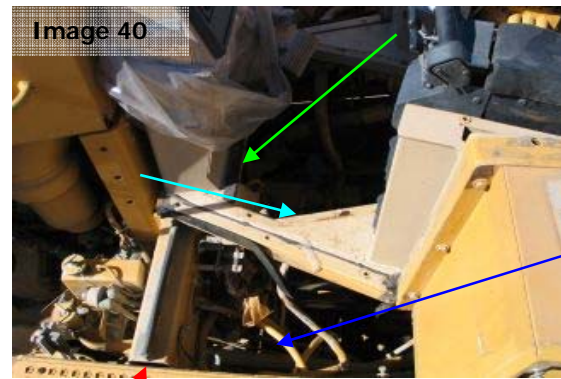
Image 40:

The opposite side of the cabin, again showing the open-ended hollow channel below the floorpan (red arrow). The blue arrow indicates where the floor panel has been removed from outside the cabin, exposing this channel. On smaller dozers this channel may not be open-ended, but rather have a small opening on the underside, in the centre as indicated by the green arrow.

The aqua arrows highlight where the floorpan attaches to the base. These channels are open-ended also and will be illustrated

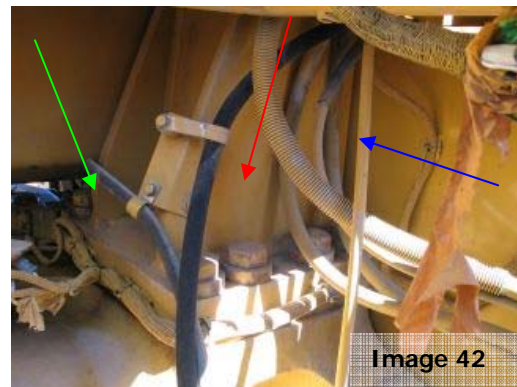
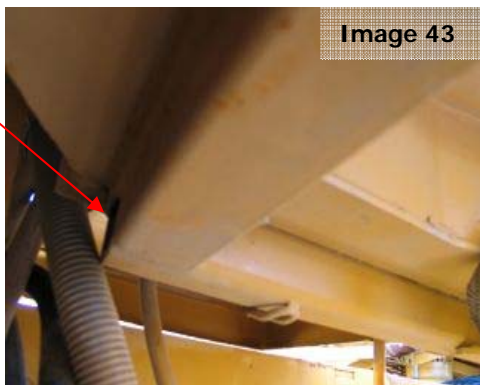
Images 41 & 42:

Below the floorpan and towards the rear, are the base supports of the ROPS (roll over protection system). These do not sit flush against the side wall of the dozer and will require flushing along these seams (blue arrows) to verify cleanliness. There are a series of bolts along the backside (out of view but highlighted by the green arrows), which require thorough inspection.

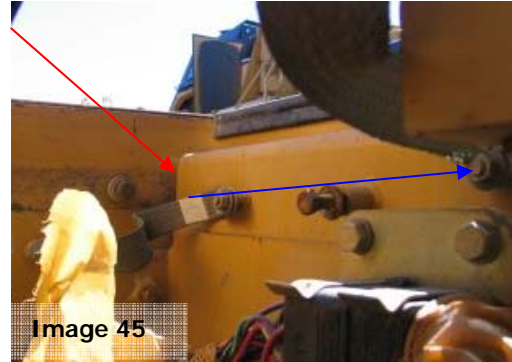
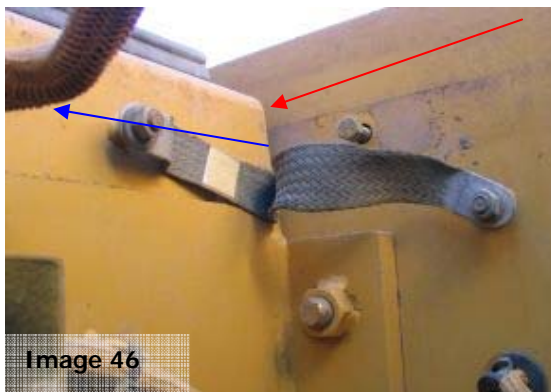
Images 45 & 46:

Another view of the open-ended box channel that runs along the front of the cabin, below the floorpan. The red arrows highlight the access points where these can be flushed (blue arrow).

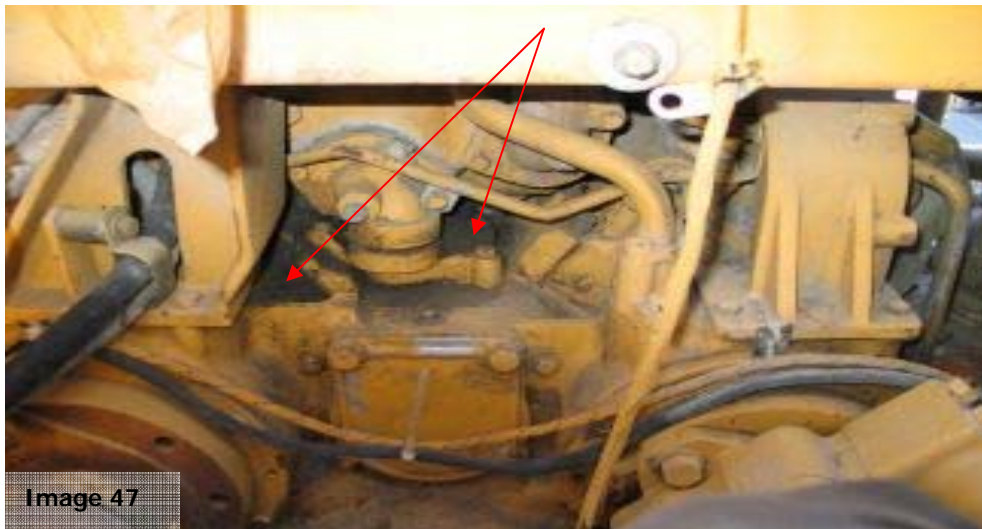
Image 47:

The back of the engine block as seen from below the floorpan. The firewall has been removed, allowing access. Note the red arrow highlighting the contamination at the rear of the block. The firewall must be either removed or loosened to allow inspection of the back of the engine block.

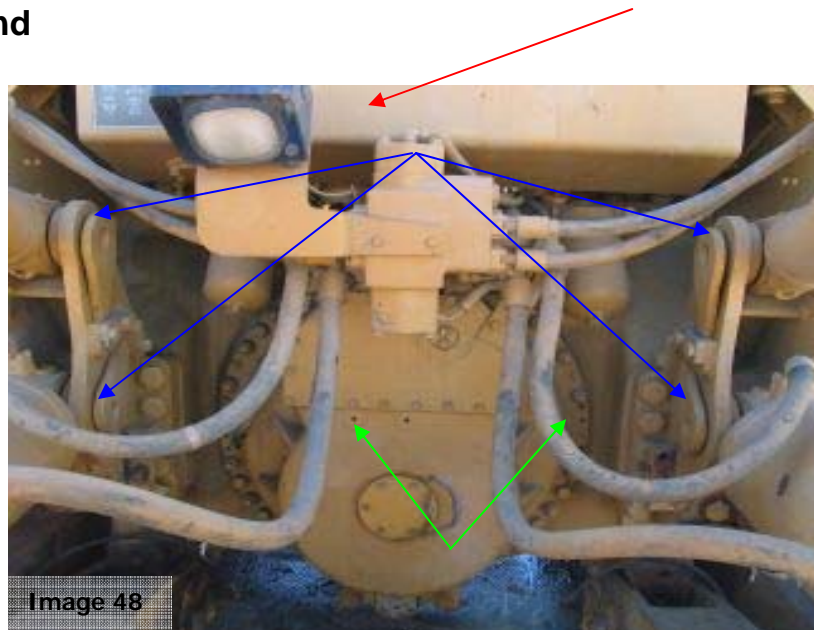
Image 48:

The rear end of a typical Dozer. The panel below the fuel cell (red arrow) must be removed allowing access to the topside of the bell housing and the rear of the ROPS. Each of the ripper cradle pivot points must be totally free of contaminated grease (blue arrows). Check all countersunk holes to ensure all are free of contamination (green arrows).

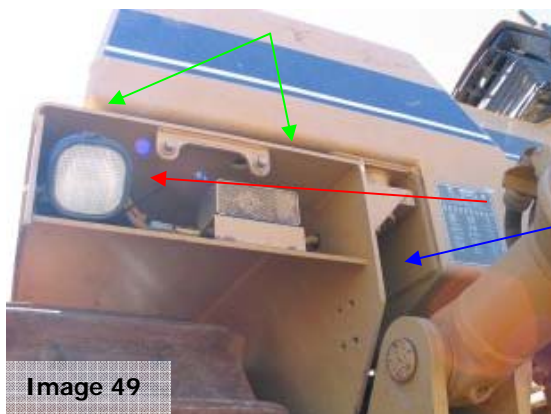
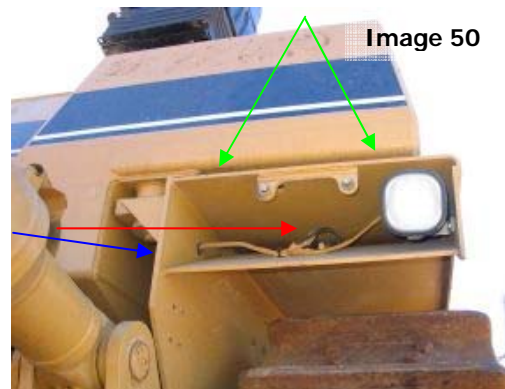
Images 49 & 50:

The rear tail lights and hollow cavities. The plates have been removed allowing access to these areas. Check inside the small cavity highlighted by the blue arrows. Ensure that the small recess (green arrows) between the bottom of the fuel cell and the top of the arch is free of all contamination.

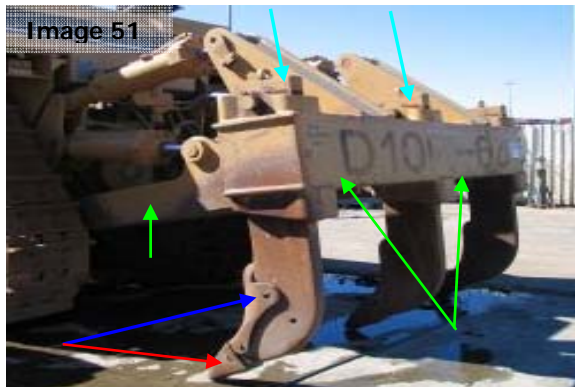
Image 51:

A typical ripper cradle and Cutting Teeth. The cutting teeth (red arrows and wear plates (blue arrow) must be removed from each blade to allow cleaning and inspection. Check the underside of the ripper cradle for drainage holes (see following illustration). Ensure that the small gap between the blade and the cradle (aqua arrows) is flushed at the time of inspection.

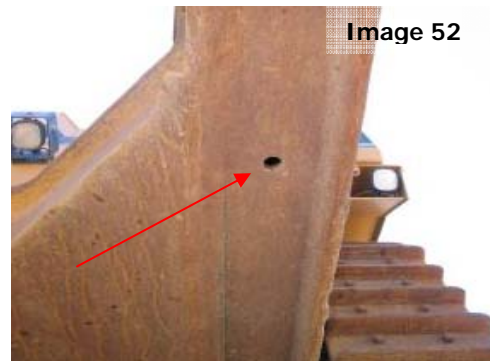
Image 52

The underside of a typical ripper cradle with a drainage hole (red arrow). If the drainage hole is present, this hollow cavity will need to be flushed in the presence of the inspecting officer in order to verify cleanliness.

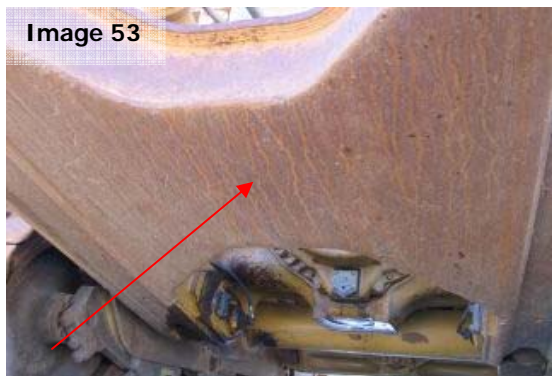
Image 53:

The middle of the ripper cradle (red arrow) is also hollow and may not have any drainage holes. If no drainage holes are located, check carefully for cracks, splits or evidence of repair.

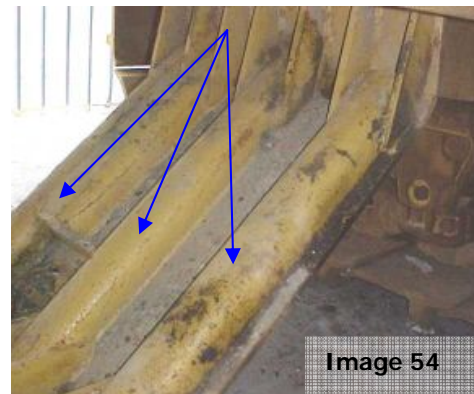
Image 54

The inside of a typical belly plate. Check along each of the gussets (blue arrows) as on some models these are open-ended and require flushing in the presence of the inspecting officer in order to verify cleanliness.

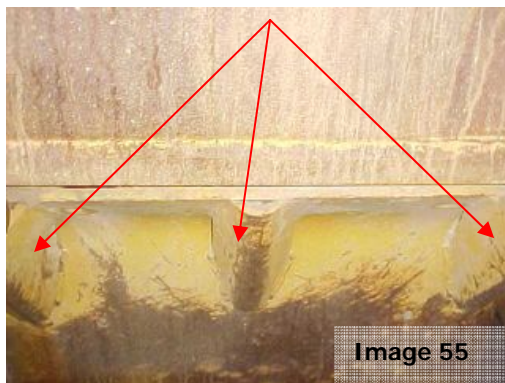
Image 55

On some belly plates, gussets can be found on the outside of the belly plate, as highlighted by the red arrows. These need to be flushed to verify clean.

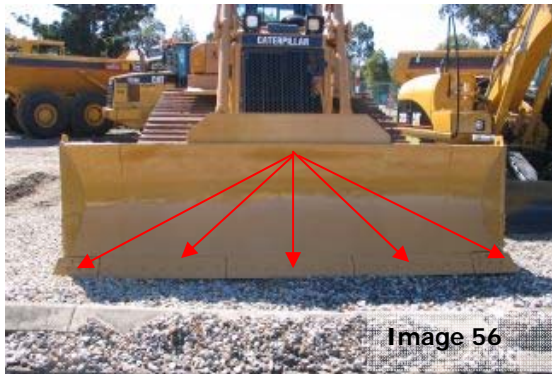
Image 56:

A typical blade on a Dozer. All cutting teeth (red arrows) must be loosened and flushed to verify cleanliness. Check for any cracks, splits or evidence of repair to all surfaces. If detected, the internal of the blade will have to be verified clean.

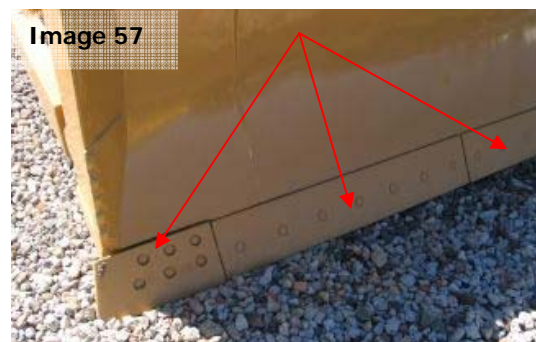
Image 57:

A close up of the cutting teeth on a blade that need to be loosened and flushed to verify cleanliness.

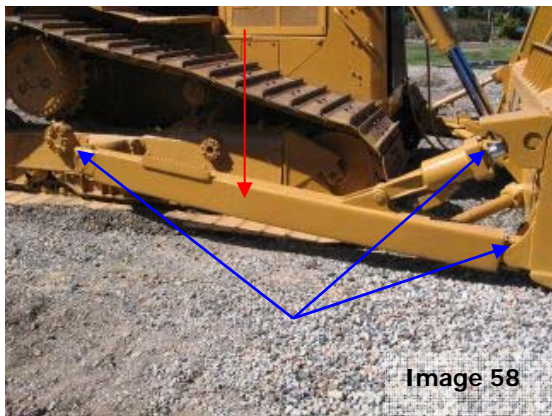
Image 58:

The push arms (red arrow) on a Dozer. These are generally sealed units, but check for any cracks, splits or evidence of repair. Ensure all contaminated grease is removed from pivot points (blue arrows).

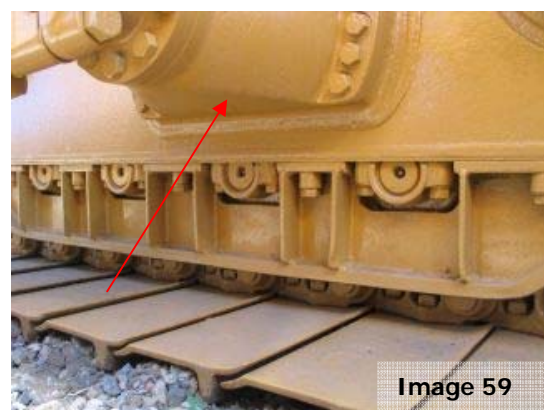
Image 59:

Illustrates where the push arms attach to the track frames. These units may have drainage holes underside (red arrow), which will require flushing if present.

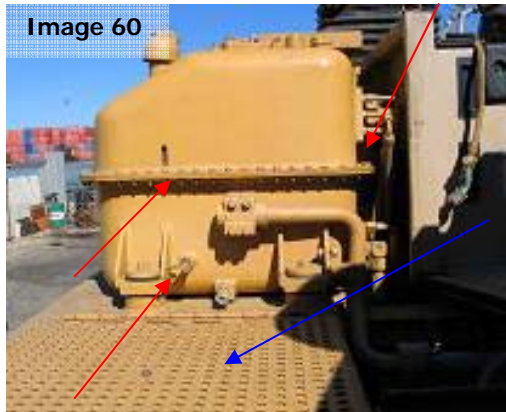
Image 60:

The oil tank located outside the cabin. The rear and underside (red arrows) require thorough cleaning and inspection. All checker plate (blue arrow) requires flushing in the presence of the inspecting officer.

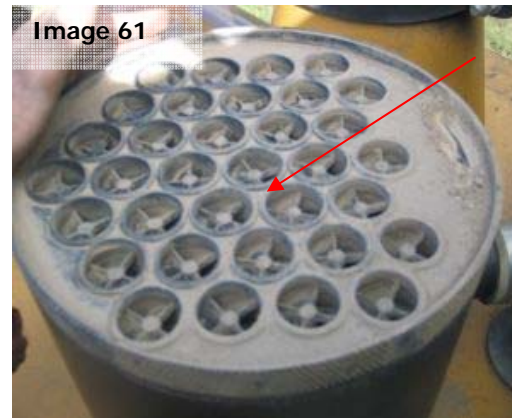
Image 61:

Air-filter pre cleaners or dust collectors must have the covers removed and be cleaned.

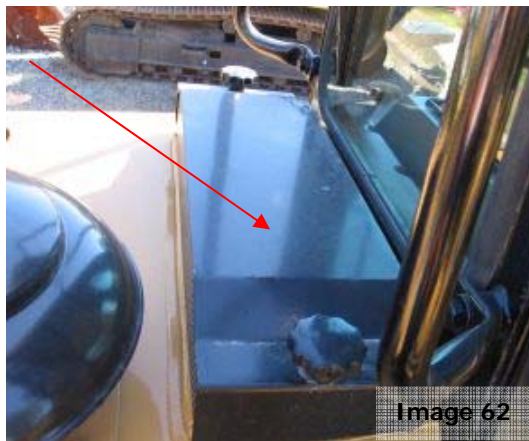
Image 62:

On some models the air-conditioning filter can be found on the topside of the engine cover, just below the windscreen. Remove filter, check for cleanliness. The filter housing will also require inspection.

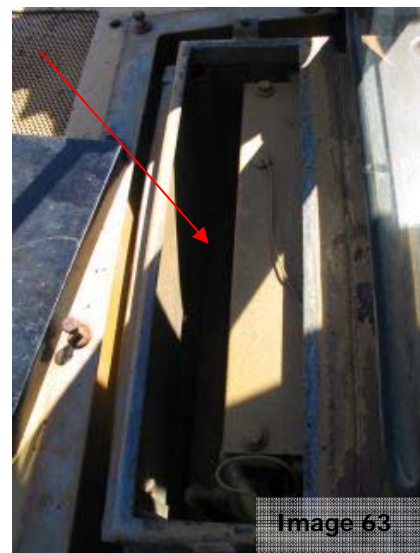
Image 63:

Check the air-filter housing for internal cleanliness.

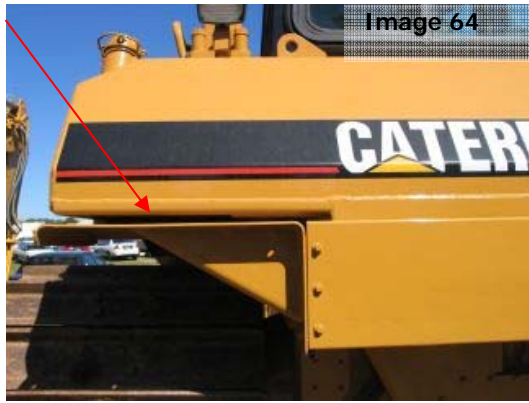
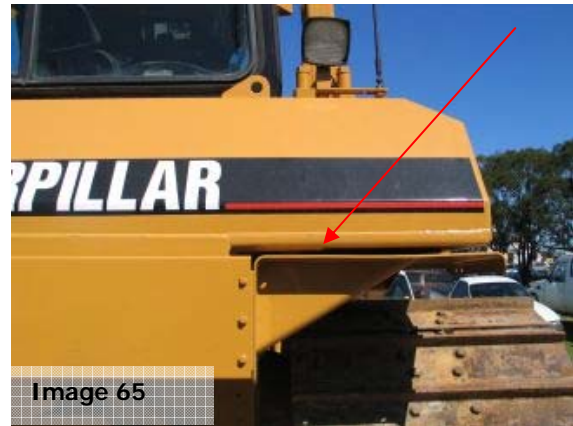
Images 64 & 65:

All surfaces of the fuel cell need to be carefully cleaned and inspected, particularly the back and underside (red arrows).

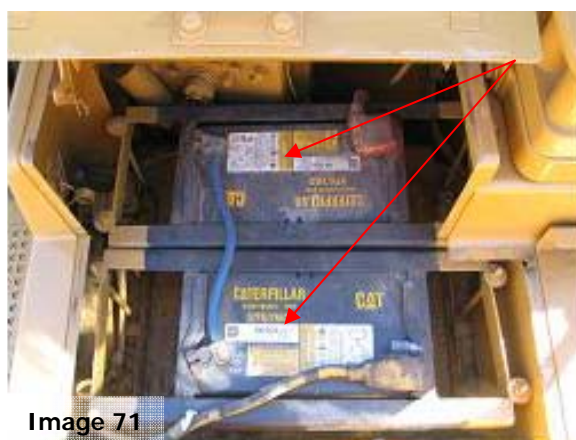
Image 71

All batteries are to be loosened from the tie-down points for cleaning and inspection.
