# MINI EXCAVATORS

*The information provided in this guide merely aims to assist machinery importers meeting the Import Permit Conditions (Clean as New). Importers should note that this guide is not exhaustive and AQIS makes no warranties or representations with respect to the accuracy or completeness of that information and will bear no liability with respect to that information. Importers must satisfy all quarantine concerns and comply with quarantine conditions applicable at the time of entry. The Commonwealth through AQIS is not liable for any costs arising from or associated with decisions of importers to import based on conditions presented here which are not current at the time of importation. It is the importer's responsibility to verify the accuracy and completeness of the information at the time of importation.*

## 1. Tracks

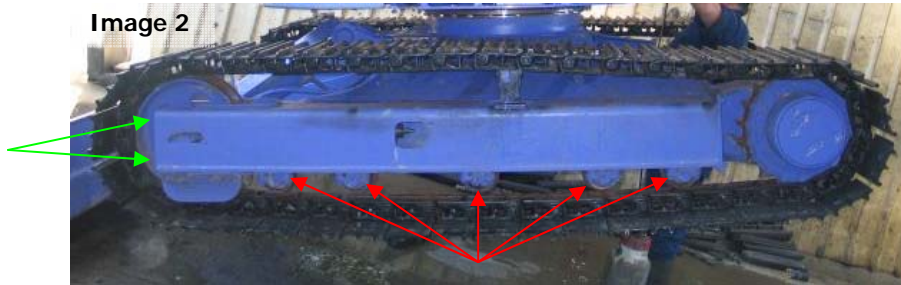
**Image 2:**

The tracks on any excavator are the main area that comes into contact with soil and other Quarantine risk material. Thorough cleaning and inspection techniques are required. In order to facilitate the cleaning and inspection process, all non-affixed panels, rock guards and motor covers must be dismantled. The red line indicates the rollers and the green arrows highlight the hollow channels on the idler wheel frame.

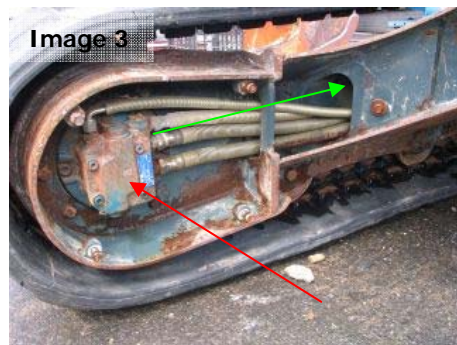
**Image 3:**

Red line indicates that the motor cover has been removed, allowing access to the drive motor. The green arrow indicates the hollow channel, which extends up through the frame into the turret or slew ring. These hollow areas on each side need to be thoroughly flushed to ensure cleanliness. The blue arrow indicates the area at the rear of the motor cover, which can be easily overlooked.

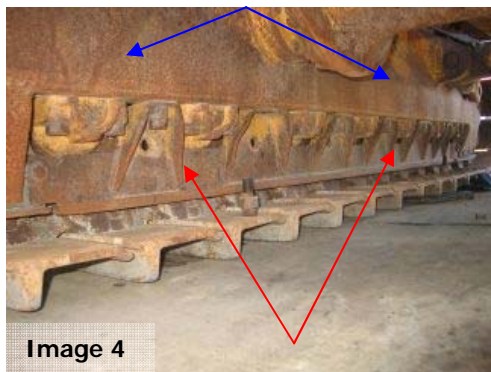
**Image 4:**

Rock Guards would be rare on mini excavators however if present, these must be removed to allow cleaning and inspection access to the inside track frame. The blue arrows highlighting the frame above the rock guards maybe a hollow channel or at least an internal ledge, which requires inspection

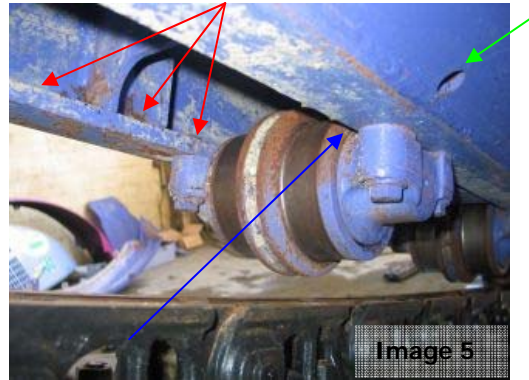
**Image 5:**

This picture highlights some of the internal ledges found inside track frames. All ledges and small recesses either side of each roller (blue arrow) must be thoroughly cleaned and inspected. The drainage hole under the slew ring (green arrow) requires flushing to verify internal cleanliness.

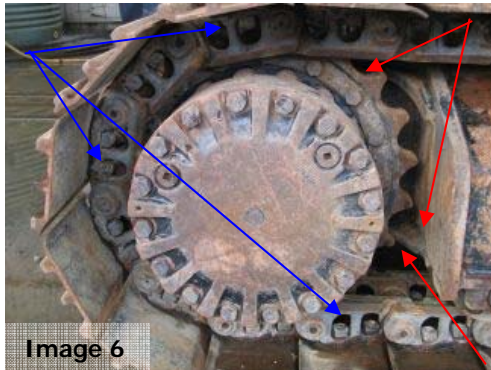
**Image 6:**

This picture indicates the outside of the drive motor. The red arrows highlight the rear of the motor cover and the blue arrows highlight each track nut.

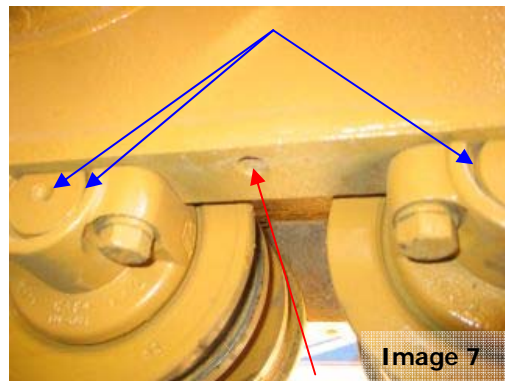
**Image 7:**

The blue arrows highlight the small gaps either side of each nut where contamination is commonly found. Inspect the rear of the inside nuts (red arrows) from the outside and vice versa.

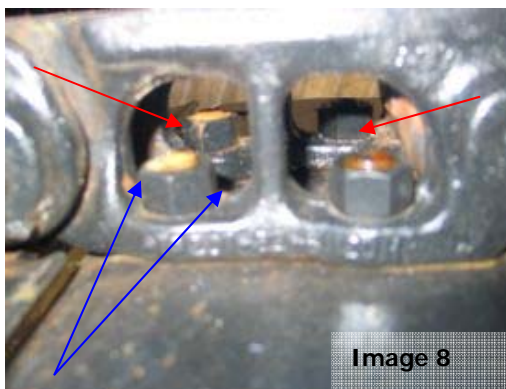
**Image 8:**

This picture highlights the roller and the bolt hole (red arrow) where rock guards may be attached. The channel may be hollow and will require flushing to verify cleanliness. The small recesses (blue arrows) on the outside of the rollers may become compacted with contamination.

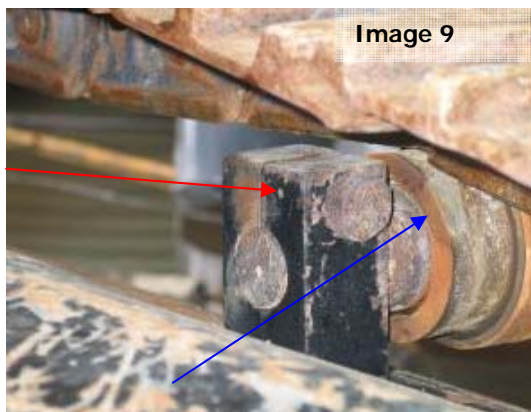
**Image 9:**

Indicates the top roller above the track frame. The red arrow highlights the small gap at the rear, which must be flushed while the blue highlights the small gap at the rear of the roller.

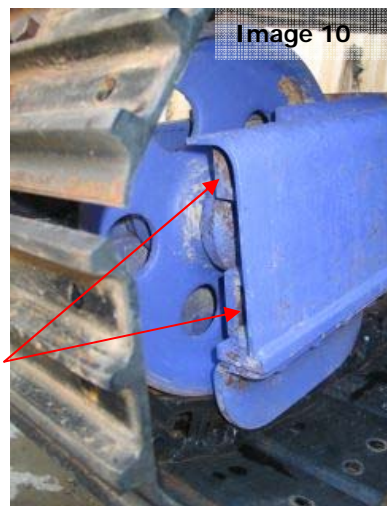
**Image 10:**

The red arrows show the hollow framework that requires thorough cleaning and inspection. All tracked machines must undergo one full revolution to ensure track pad cleanliness. The next illustration highlights the track pads opening slightly at the apex, allowing this area to be cleaned.

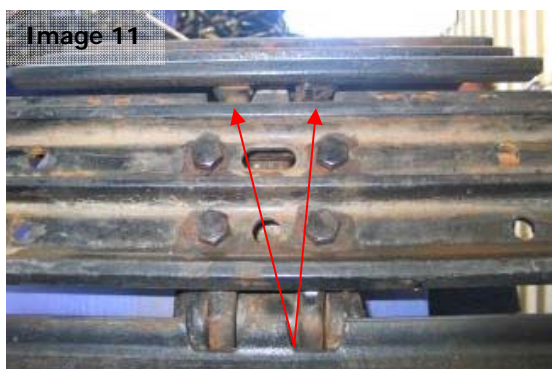
**Image 11:**

As the tracks revolve, they open slightly at the apex (red arrows) and allow for cleaning and inspection.

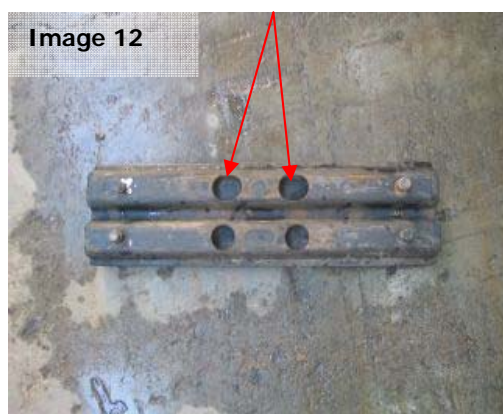
**Image 12:**

Each individual rubber track pad has been removed, allowing access to the small recesses that can be compacted with contamination. Each track pad must be verified clean.

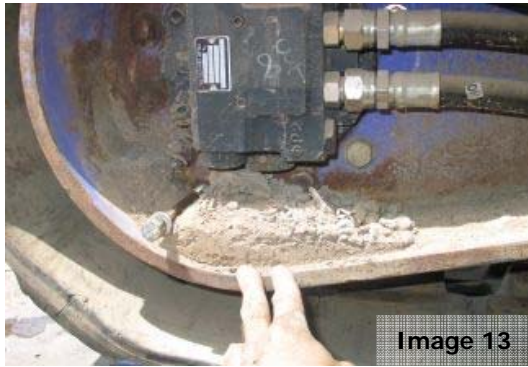
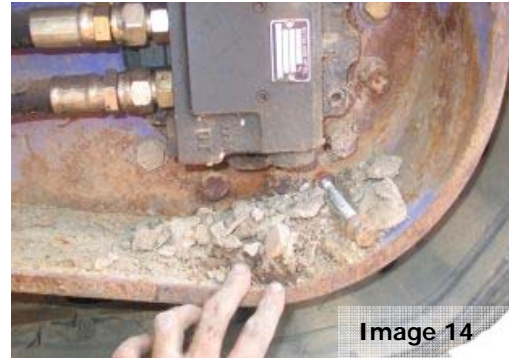
**Images 13 & 14:**

Examples of contamination found inside motor covers. Access will be required to verify the cleanliness inside the drive motors.

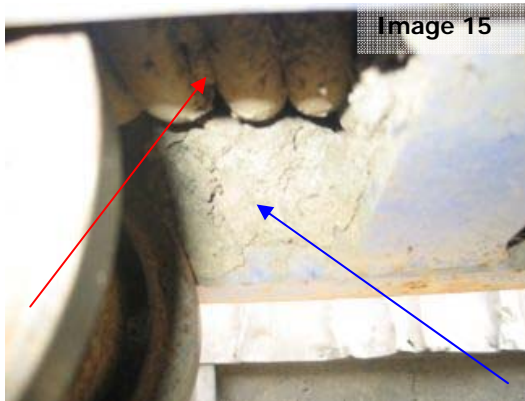
Image 15

The inside of the track frame, just highlighting the track adjuster spring (red arrow) and contamination (blue arrow) on one of the internal ledges that must be removed.

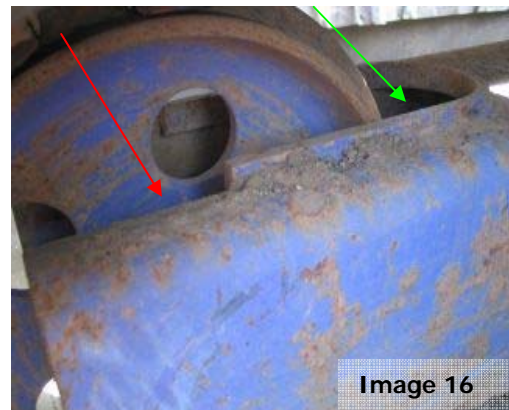
Image 16

At the opposite end to the drive motor is the idler wheel (red arrow). Ensure that all surfaces either side of the idler wheel is clean as well as any ledges behind (green arrow).

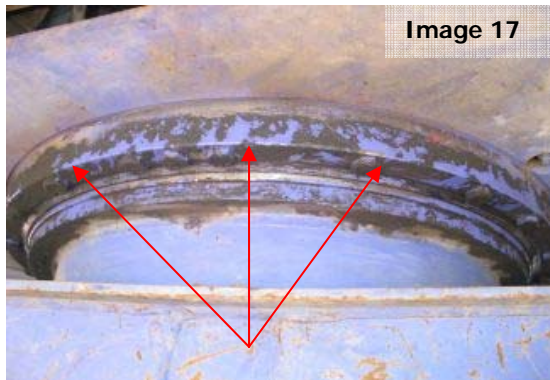
**Image 17:**  
All contaminated grease (red arrows) must be removed from the outer slew ring during the cleaning process.

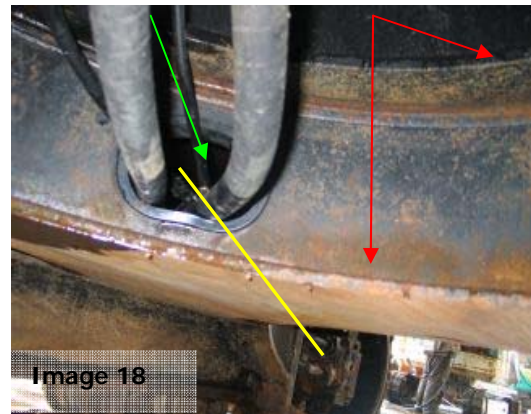
**Image 18:**  
The red arrows highlight the various ledges that can be found inside the turret/slew ring, each ledge requires thorough cleaning. The green arrow points to the hollow channel where the hydraulic hoses run down through the turret housing to the drive motors (yellow line demonstrates the path of the hydraulic hoses). This area must be flushed in the presence of the inspecting officer to verify cleanliness.

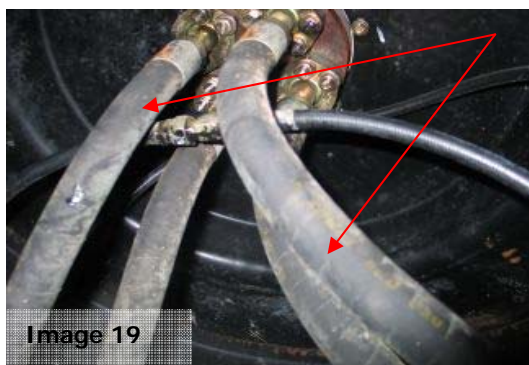
**Image 19:**  
The hydraulic hoses inside the turret/slew ring. Each hose must be individually cleaned.

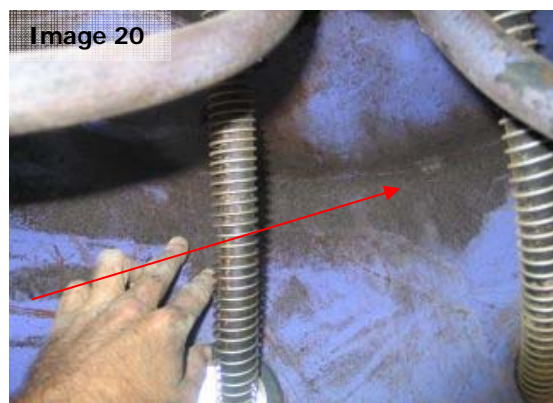
**Image 20:**  
All contaminated grease (red arrow) must be removed from the inside surfaces of the slew ring during the cleaning process.

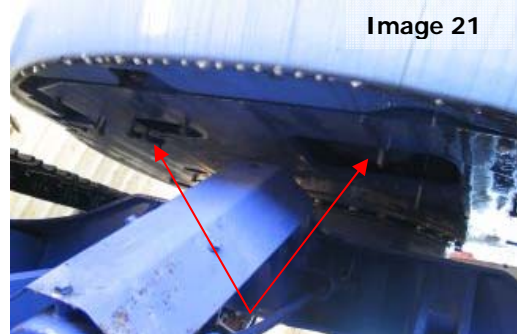
**Image 22:**

All non-affixed engine covers and shrouds have been removed, allowing for cleaning and inspection.

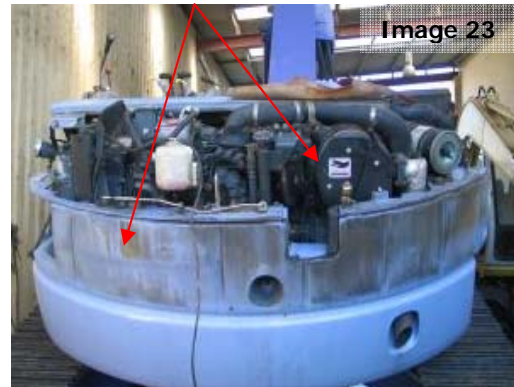
**Image 23:**

Example of the amount of dismantling required to facilitate the cleaning and inspection process. The rear shroud and engine cover have been removed in this illustration.

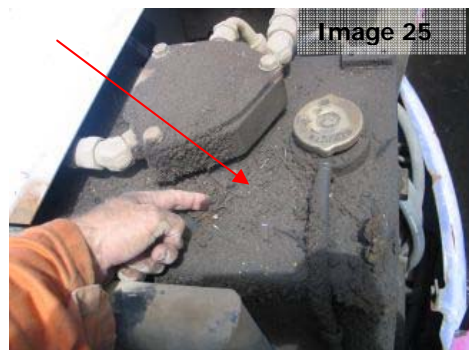
**Image 25:**

The topside of the fuel cell, accessible for cleaning and inspection after the engine covers are removed.

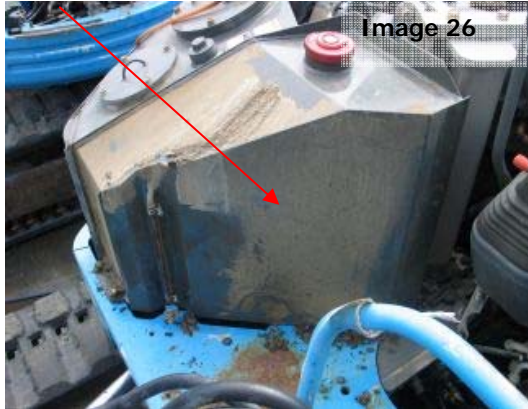
**Image26:**

The side of the fuel cell, accessible for cleaning and inspection after the engine covers are removed.

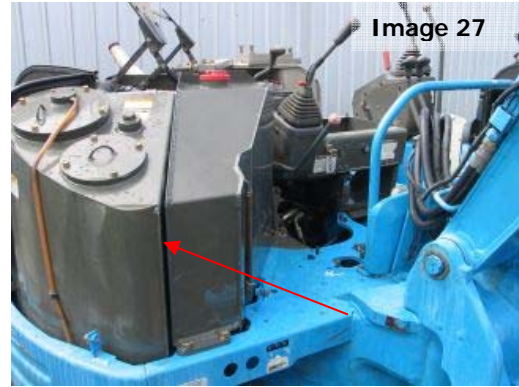
**Image 27:**

On some models, a small recess (red arrow) can be found between tanks. To access this recess for cleaning and inspection, dismantling may be required.

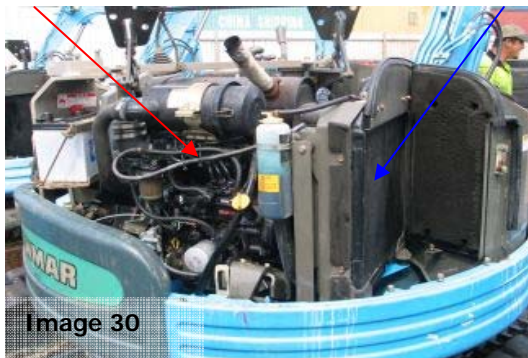
**Image 29:**

The radiator grill (red arrow) must be removed to allow cleaning and inspection access to the inside of the radiator shroud. Remove the air filter and check for cleanliness (pressurised air).

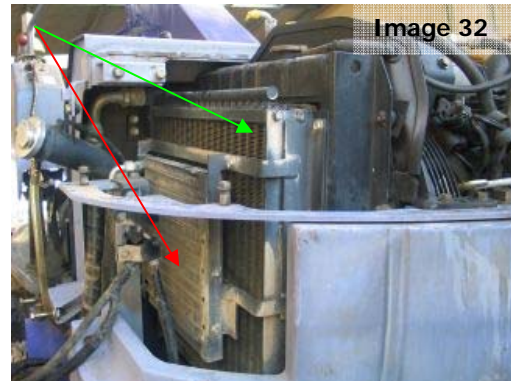
**Image 32:**

The radiator (green arrow) and oil cooler (red arrow) must be flushed in the presence of the inspecting officer to verify cleanliness of the fins.

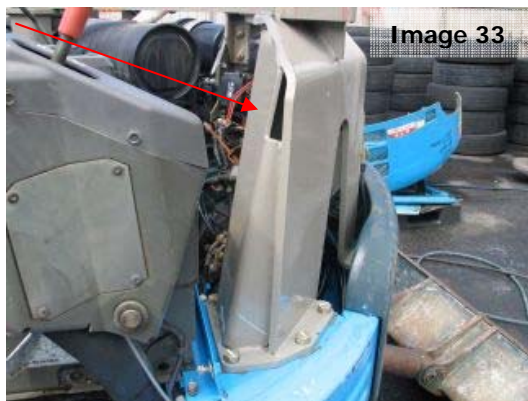
**Image 33:**

Once the engine covers have been removed, areas like the one highlighted become accessible for cleaning and inspection.

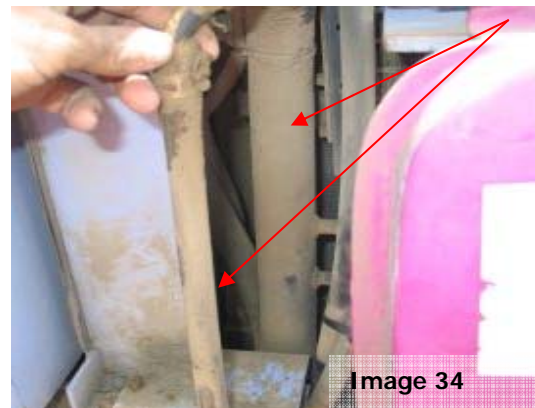
**Image 34:**

All hoses (red arrows) must be thoroughly cleaned and inspected. These were only accessible for cleaning and inspection after dismantling of the engine covers.

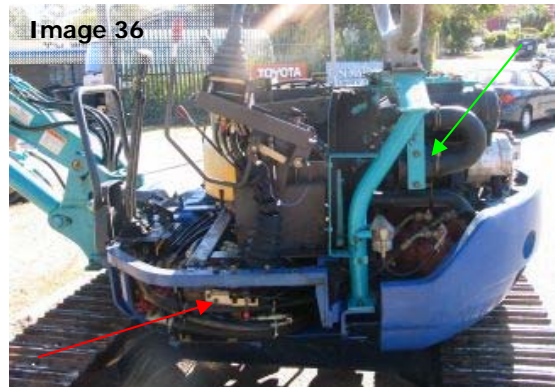
**Image 36:**

Evidence of dismantling on another model of excavator. All shrouds (red arrow) and engine covers (green arrow) have been removed to facilitate the cleaning and inspection process.

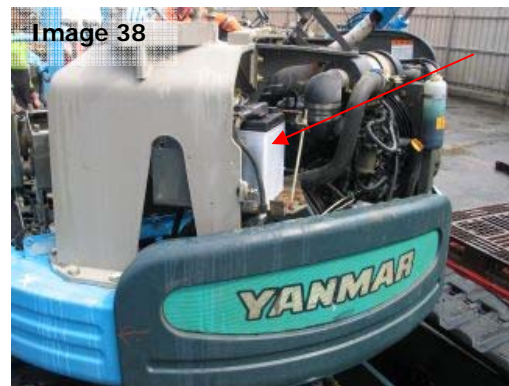
**Image 38:**

The batteries must be loosened from the tie-down points to allow for cleaning and inspection of the underside.

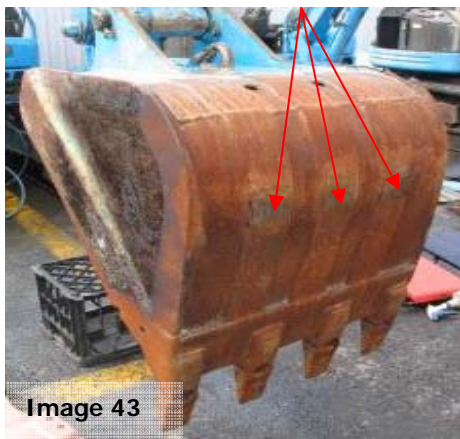
Image 43

Check all wear plates on the bottom of the bucket. If only spot-welded, these will have to be flushed to verify cleanliness. Check all surfaces of the bucket for any cracks, splits or evidence of repair.

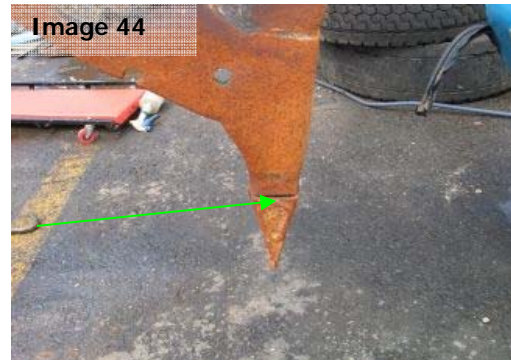
Image 44

All cutting teeth (green arrow) on the bucket must be removed for internal cleaning and inspection.

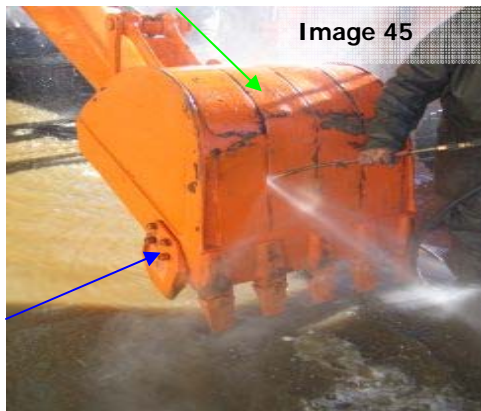
Image 45

An example of flushing the spot-welded wear plates (green arrow) on the bottom of the bucket. All side wear plates (blue arrow) must be loosened off and flushed.

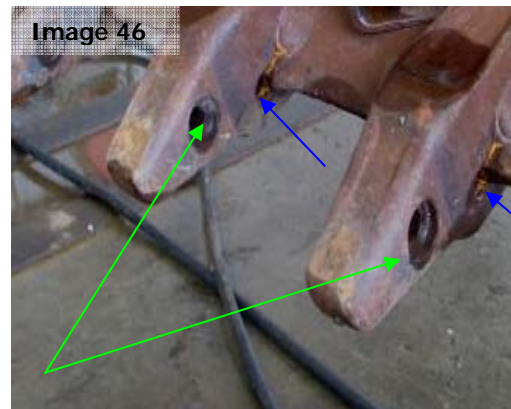
Image 46

A close up of the boots and which the cutting teeth are mounted. Ensure around each pinhole is clean. The blue arrows highlight a narrow opening that tends to become compacted with risk material and can be overlooked if the cutting teeth are still attached.

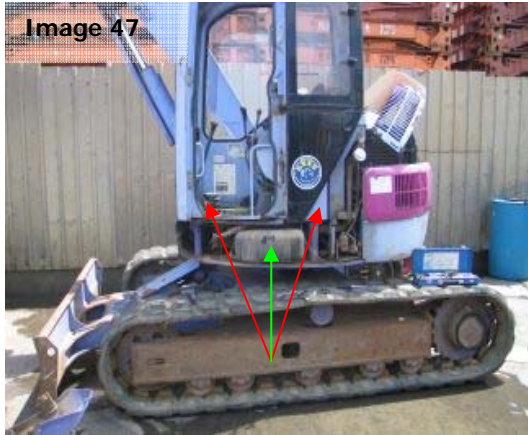
**Image 47:**

Some mini excavators may have a cabin as illustrated. Check the framework for drainage holes on the underside (red arrows) and the underside shroud (green arrow) has been removed to allow cleaning and inspection access to the myriad of hydraulics under the floorpan. On some models, the cabin may need to be unbolted and lifted to allow cleaning and inspection of the fuel cell and hydraulic hoses under the seat.

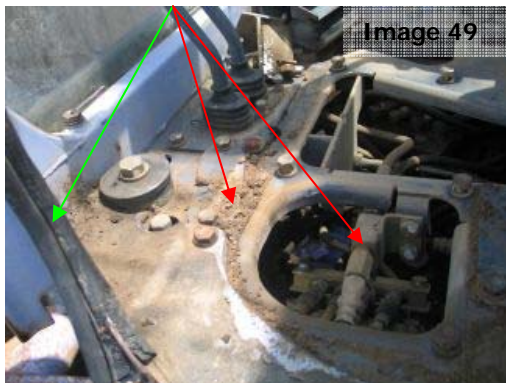
**Image 49:**

An example of the contamination found after the rubber floor mats and floorpans have been removed. Cabin door rubbers (green arrow) can be contaminated and are therefore an area of concern to AQIS.

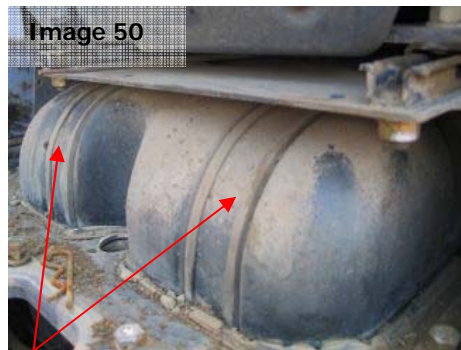
**Image 50:**

An illustration of the fuel cell under the seat. In some instances, the cabin will require unbolting and lifting to allow cleaning and inspection access to the topside of the fuel cell and hydraulic hoses (currently not in view). The bands around the tank (red arrow) need to be loosened off and flushed to remove any contaminants.

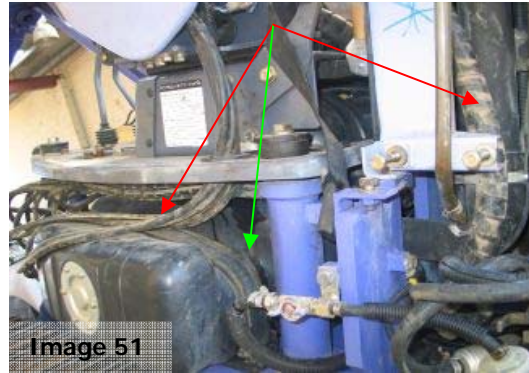
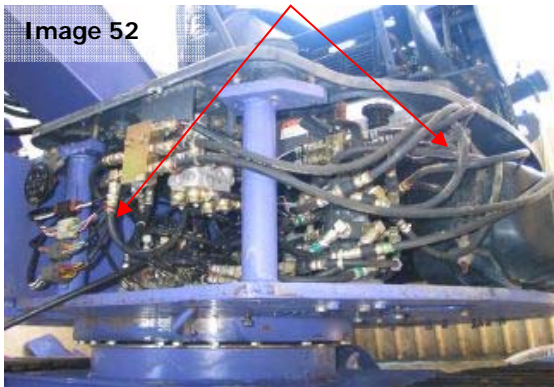
**Images 51 & 52:**

These pictures illustrate the access provided for cleaning and inspection, once the shrouds around the underside of the cabin have been removed. All hydraulic hoses and looming (red arrows) require thorough cleaning and inspection. The bands around the fuel cell (green arrow) also need to be loosened and flushed to remove any contaminants.

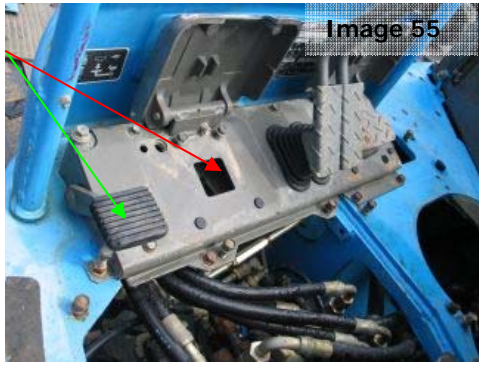
**Image 55:**

On some models, a hollow section below the foot pedals (red arrow) will require internal cleaning and inspection. Each foot pedal cover requires cleaning (green arrow) – see next illustration.

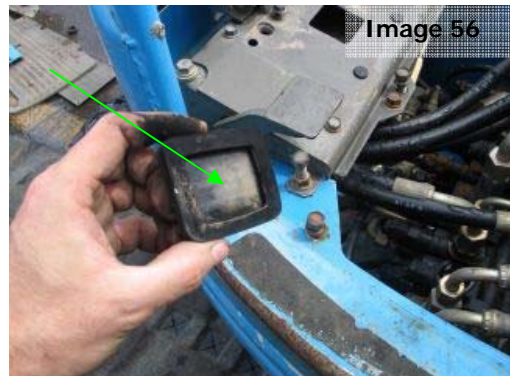
**Image 56:**

Each individual foot pedal has been removed for cleaning and inspection.

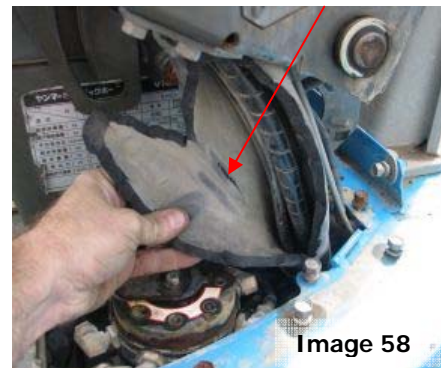
**Image 58:**

All foam insulation (red arrow) around electrical cabling must be internally cleaned and inspected.

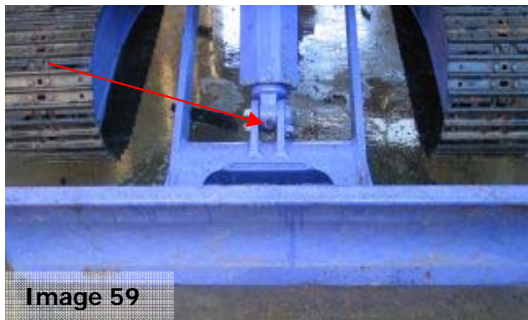
**Image 59:**

Check all surfaces of the blade to verify free of any cracks, splits or evidence of repair. All contaminated grease must be removed from all pivot points (red arrow).

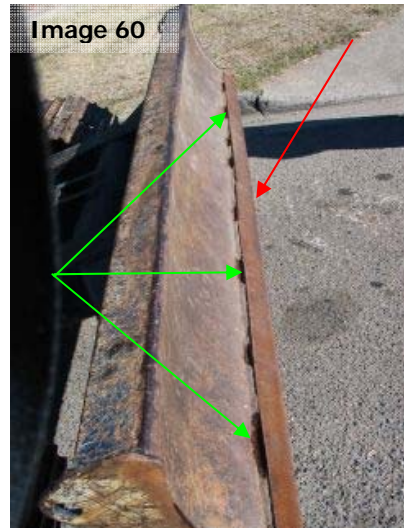
**Image 60:**

On this blade a cutting blade has been spot welded to the face (red arrow). All recesses (green arrows) along the blade must be flushed to verify cleanliness.

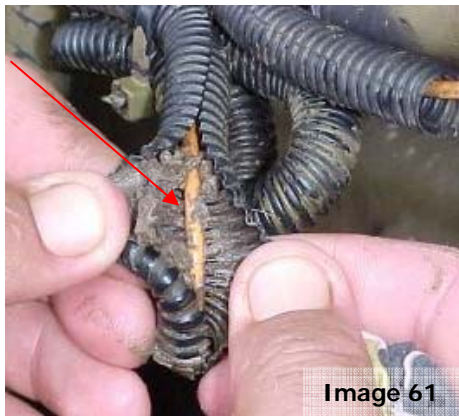
**Image 61:**

All wiring harnesses must be thoroughly cleaned and inspected.

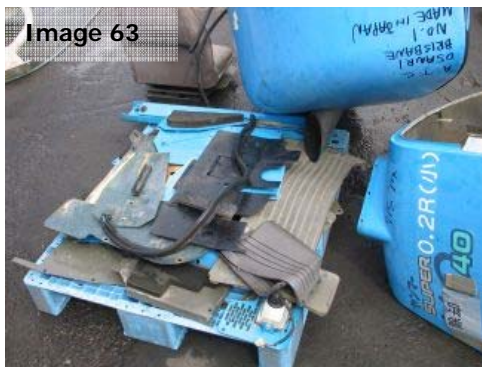
**Image 63:**

An example of the amount of dismantling required for cleaning and inspection.
