Australian Quarantine and Inspection Service

MINI TRACTORS

The following cleaning/inspection guide has been segmented to facilitate the process. The segmentation is as follows:

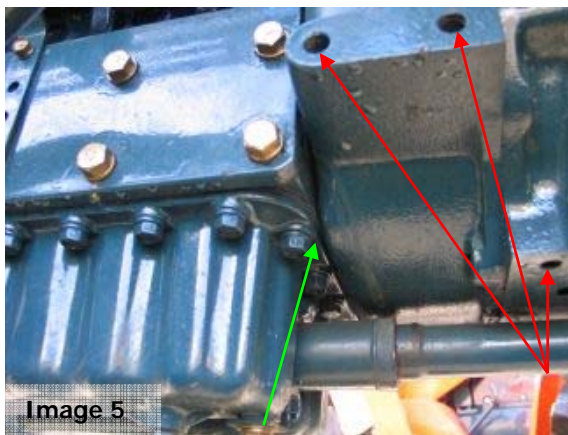
Image 5:

The rear end of the sump. All countersink holes must be free of contamination. On this model there is a small recess above the sump (green arrow) that may require flushing to verify cleanliness.

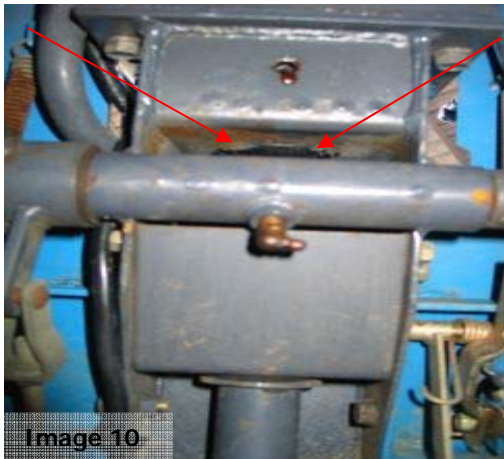
Image 11:

If drainage holes are present (red arrow), flush to verify internal cleanliness.

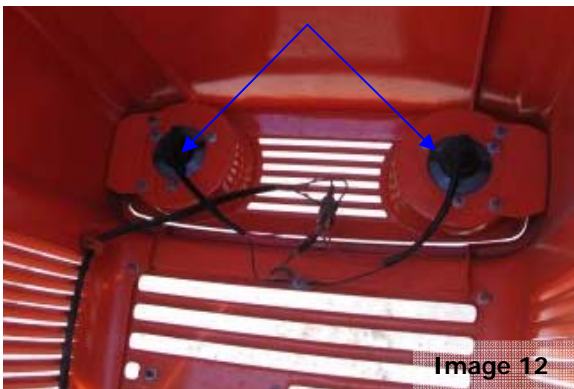
Image 12:

Verify all internal light covers (blue arrows) are clean and free of contamination.

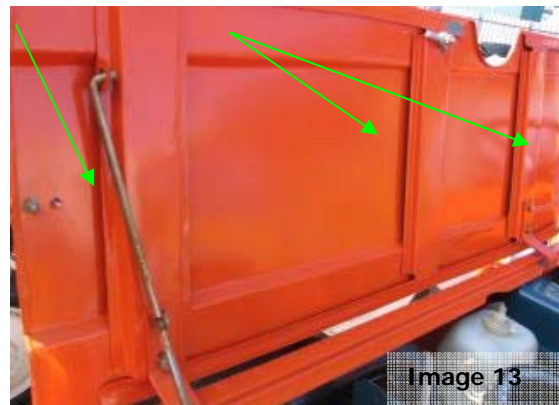
Image 13:

These open support channels (green arrows) inside the top of the engine cover must be thoroughly cleaned and inspected.

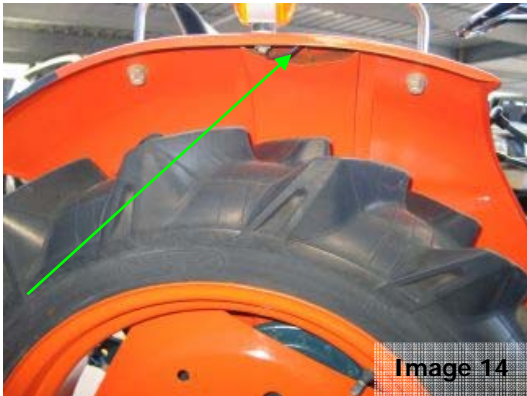
Image 14

The inside rear wheel arches highlighting the hollow support cavities (green arrows). These hollow channels must be flushed in the presence of the inspecting officer to verify internal cleanliness.

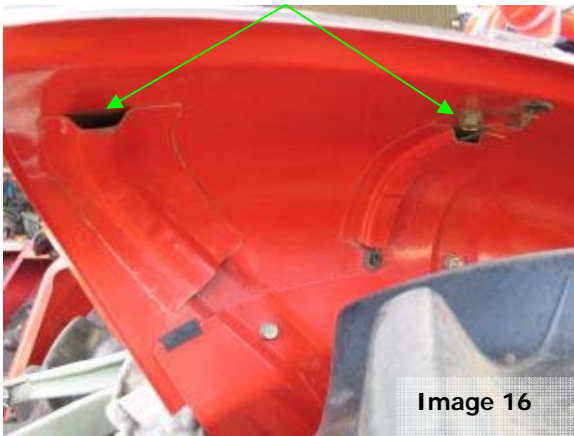
Image 16

On some models, numerous hollow support channels may be found under the rear wheel arches. All require flushing to remove any internal contamination.

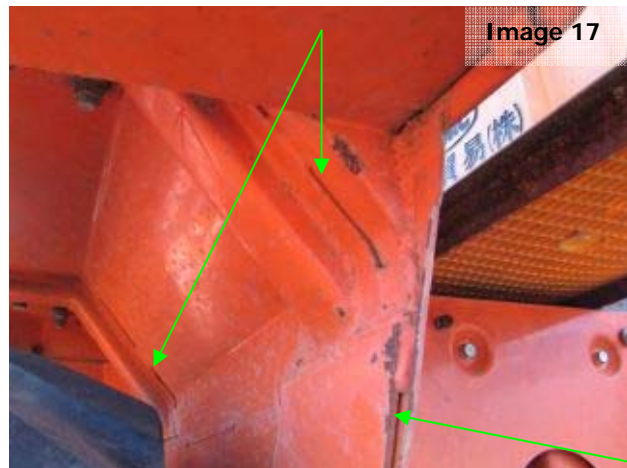
Image 17

This illustration shows spot-welded hollow support channels under the rear arches. Due to these channels not being sealed units, contamination can enter via the small recesses (green arrows) and these require flushing to verify internal cleanliness.

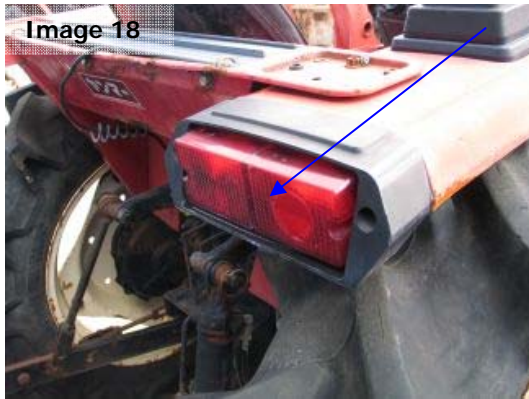
Image 18

The internal cleanliness of the light covers must be verified clean.

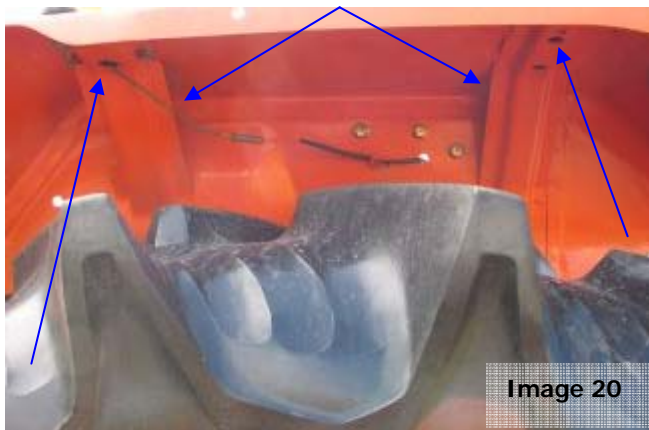
Image 20

Another illustration of the variety of hollow support channels (blue arrows) under the rear wheel arches that require flushing to verify internal cleanliness.

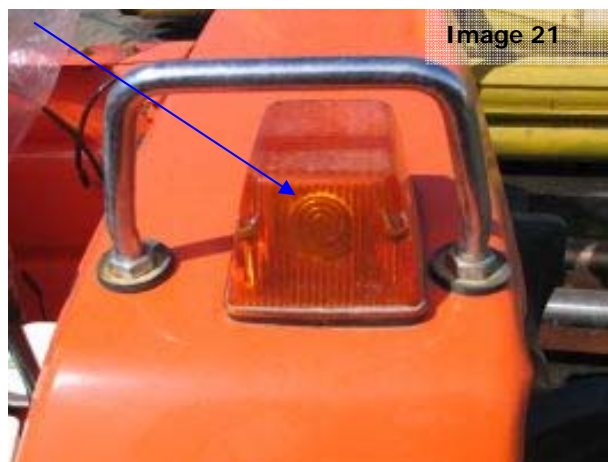
Image 21

The internal cleanliness of the light covers on top of the wheel arches must be verified.

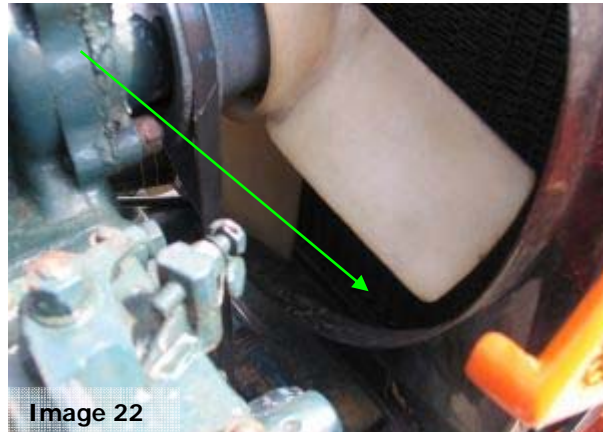
Image 22

Most radiators do not have an internal grill cover, which allows cleaning and inspection access to the inside of the shroud.

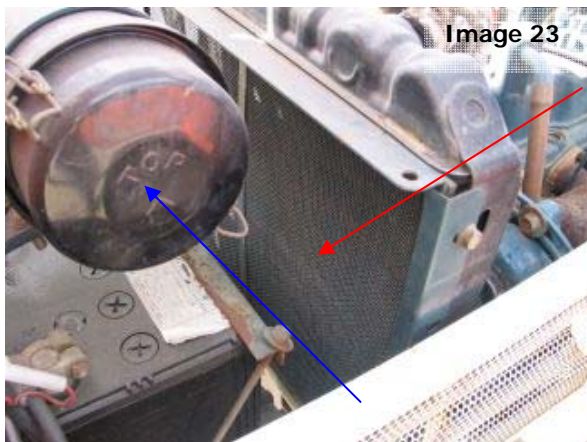
Image 23

The red arrow highlights the mesh grill commonly found at the front of the radiator. These mesh grills must be removed to allow debris caught in the radiator core to be flushed out and removed. Remove the air-filter (blue arrow) and verify cleanliness.

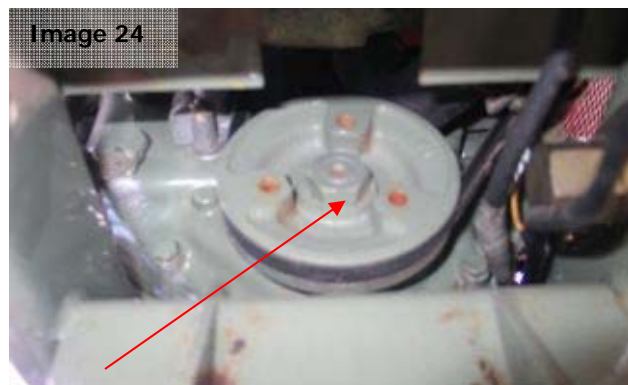
Image 24

The harmonic balancer found at the front of the engine block. These areas are generally concave, can harbour contamination and must be verified clean.

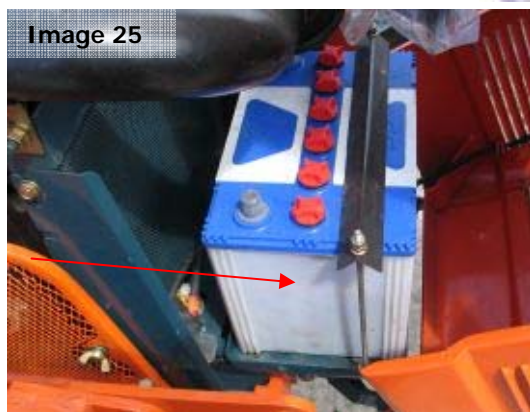
Image 25

All batteries must be loosened from the tie down points for underside cleaning and inspection.

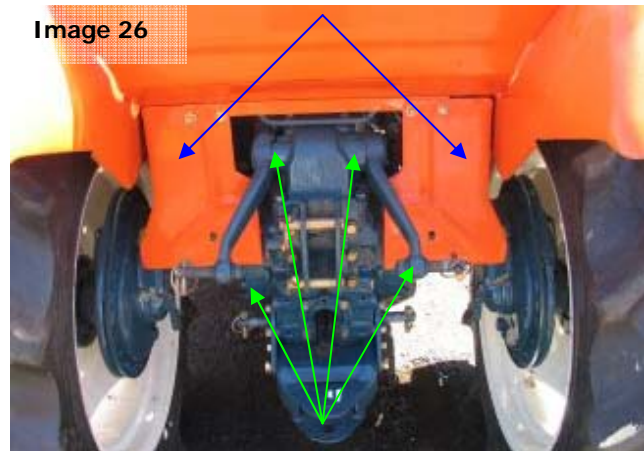
Image 26:

The rear view of a typical mini tractor. To facilitate the cleaning and inspection process, remove all non-affixed panels (blue arrows). All contaminated grease must be removed from the linkage arms and pivot points (green arrows).

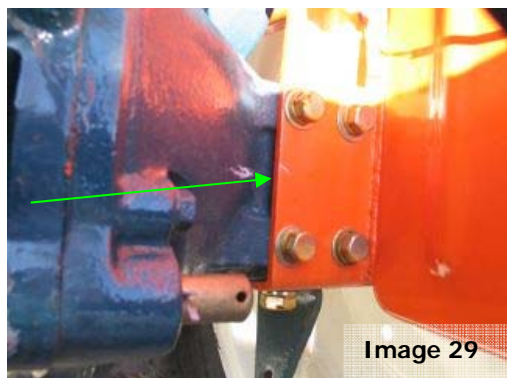
Images 28 & 29:

These two illustrations highlight the small recesses that can be found on the rear axles on some models. The green arrows highlight a small gap that must be flushed to verify cleanliness.

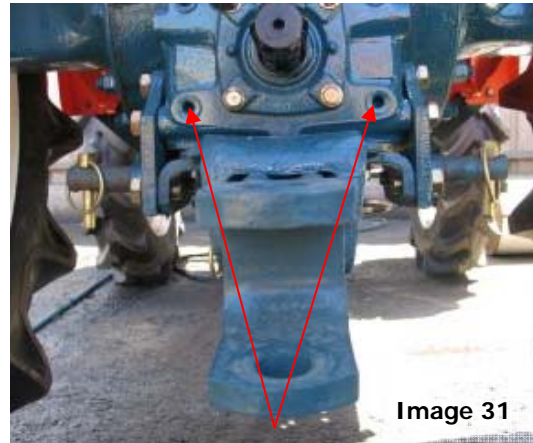
Image 31:
All countersunk holes (red arrows) must be free of contamination.

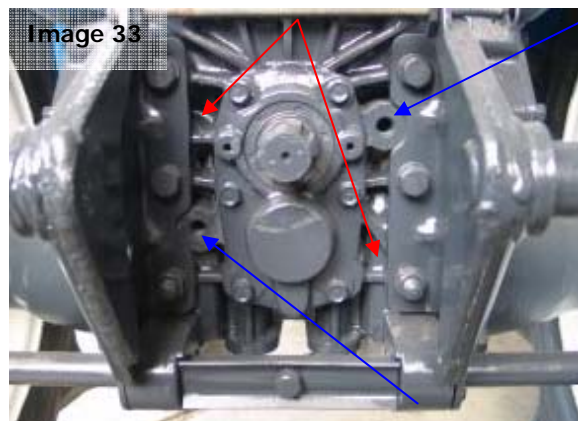
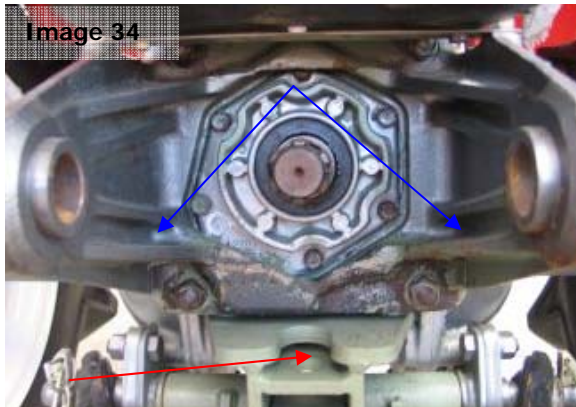
Image 32:
In conjunction with verifying countersunk holes, on some models, other small recesses (green arrows) can be flushed to verify cleanliness.

Image 33:
Another example of the rear of a mini tractor. This model has numerous ledges (red arrows) and countersunk holes (blue arrows) that must be cleaned and verified.

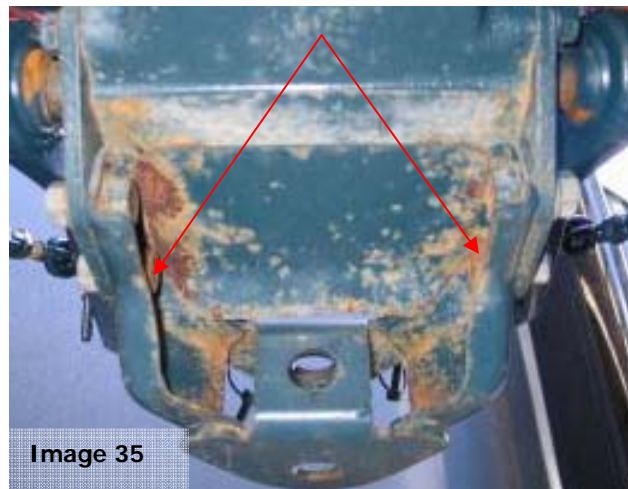
Image 35

The underside of the linkage at the rear. These generally have small ledges (red arrows) that must be checked for cleanliness.

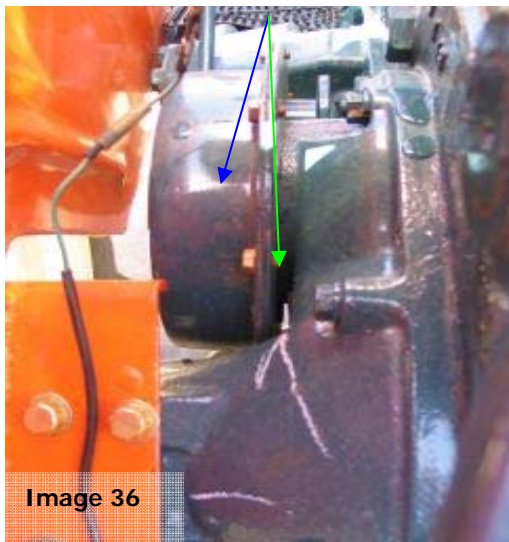
Image 36

Small recesses between the chain cover (blue arrows) and housing like those highlighted by the green arrows must be verified.

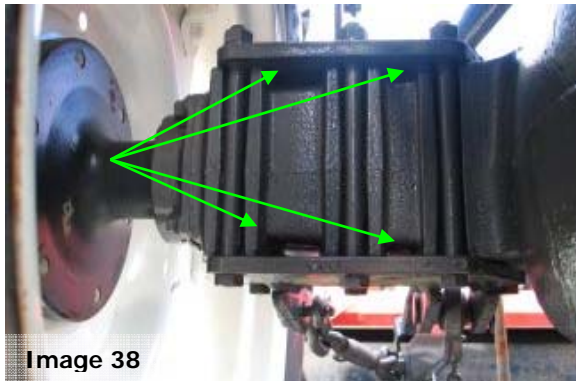
Images 38 & 39:

All surfaces of the rear axles must be free of contamination and some may require flushing of recesses (green arrows) to verify cleanliness.

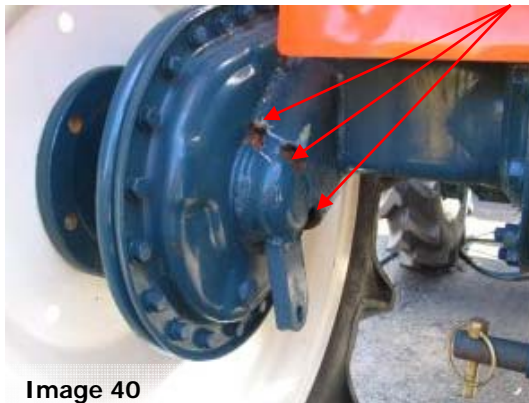
Image 40 & 41:

On some models, small gaps can be found in the inside hub housing (red arrows). These areas that can harbour contamination will be further illustrated next.

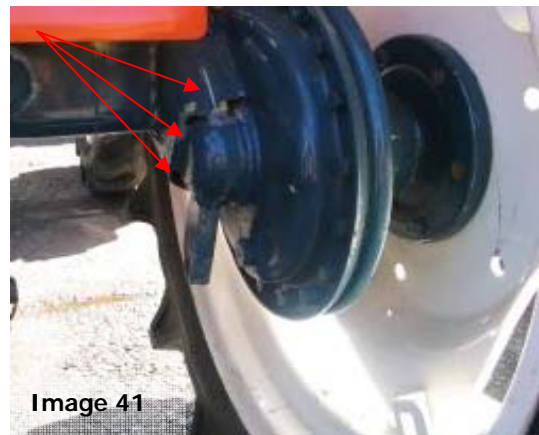
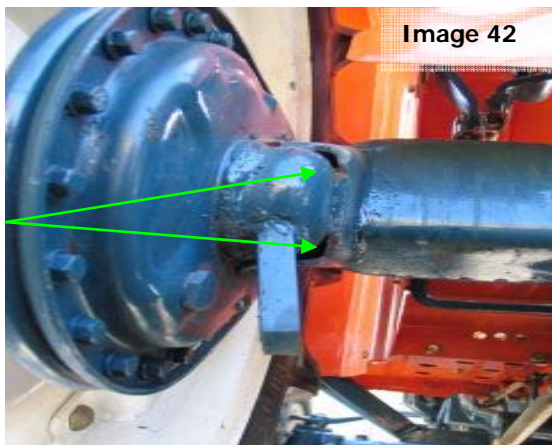
Images 42 & 43:

A closer view of the small openings (green arrows) that may be found on the rear hubs on some model mini tractors. These must be flushed to verify cleanliness.

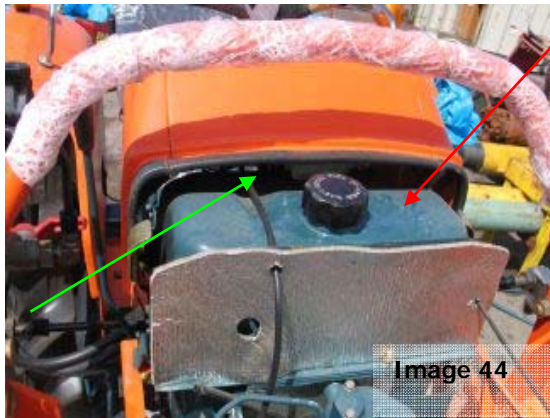
Image 44:

On most models, when the engine cover is lifted, the topside of the fuel cell (red arrow) becomes accessible for cleaning. The front and topside of the fuel cell (green arrow) is covered by the instrument panel, however this area requires thorough cleaning and inspection.

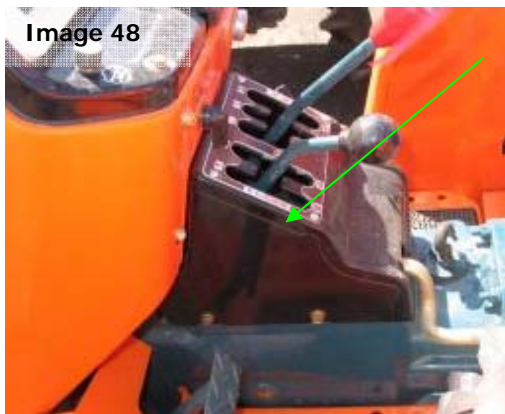
Images 48 & 49:

Several illustrations of the variety of gearbox covers (green arrows) found on mini tractors. These non-affixed covers must be removed for cleaning and inspection.

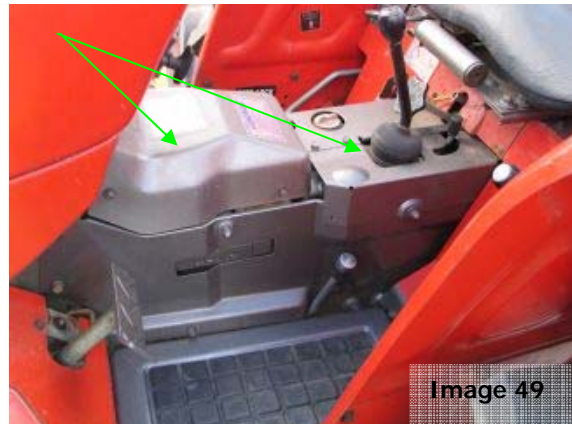
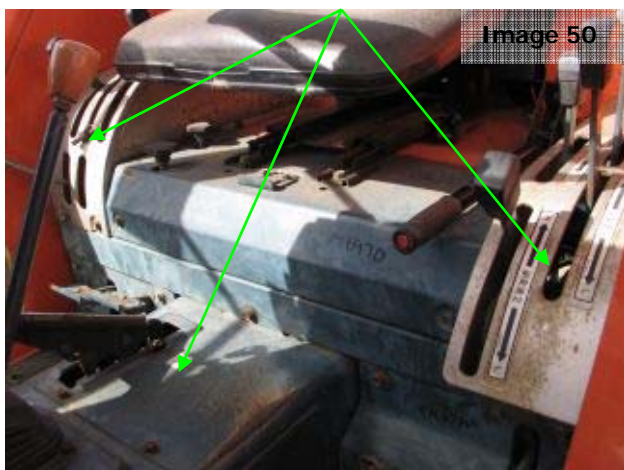
Images 50 & 51:

On other models the gear levers may be found under or beside the seat. These non-affixed covers (green arrows) must be removed for cleaning and inspection.

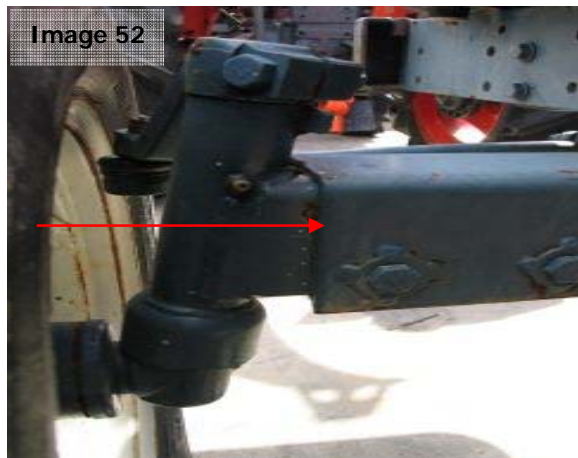
Images 52 & 53:

Two examples of hollow front axles that require flushing to verify internal access. While the example on the left only highlights a small recess between the inner and outer sleeve (red arrow), the example on the right shows an open-ended axles (green arrow).

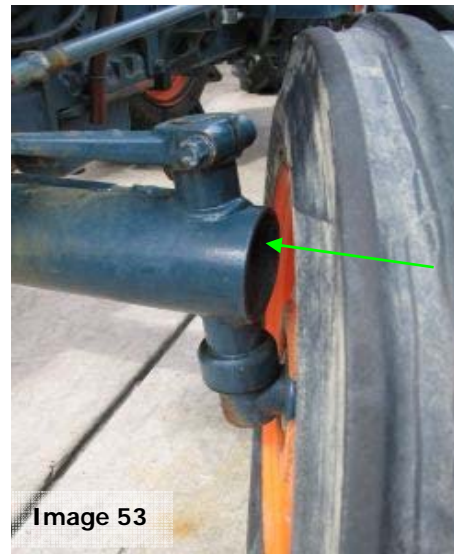
Image 54:

All pivot points and push arms must be free of contaminated grease.

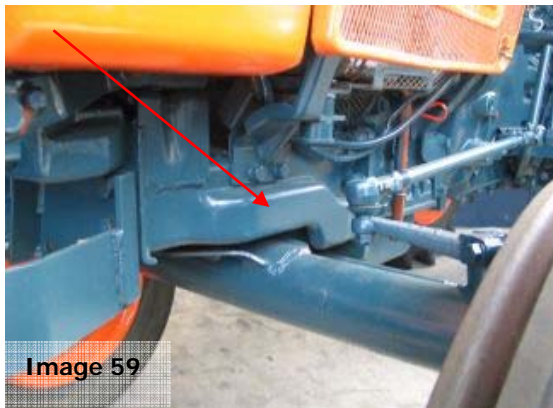
Image 59

These illustrations highlight the outside of a hollow channel (red arrows) that is present on some models and potentially harbour contamination. The following illustrations will highlight the inside access points for flushing.

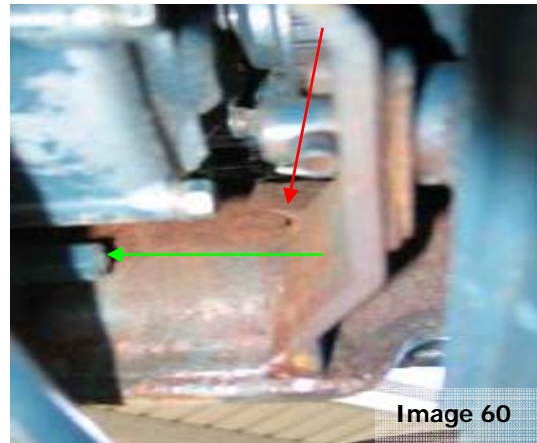
Image 60

Although not visible in these illustrations, the access points to the hollow channels mentioned above are highlighted by the red arrows. The green arrows indicate the direction of the hollow channel.

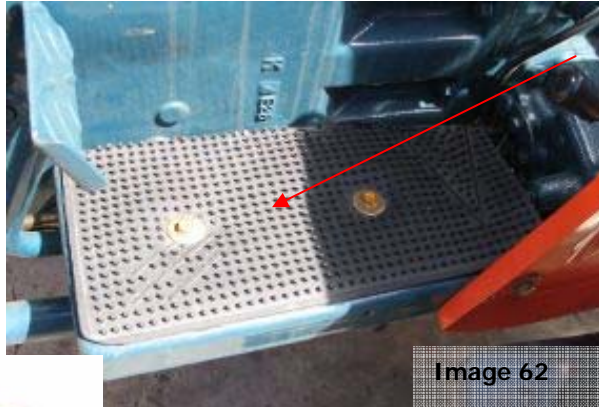
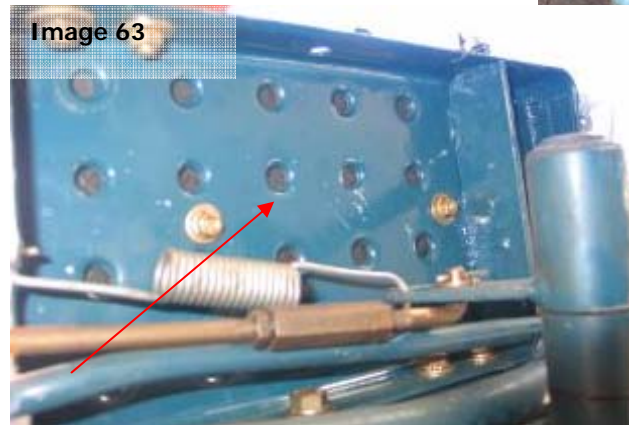
The underside of all rubber mats that may be on mini tractor sidesteps must be cleaned and accessible for inspection.

The underside of the sidestep must also be free of all contamination.

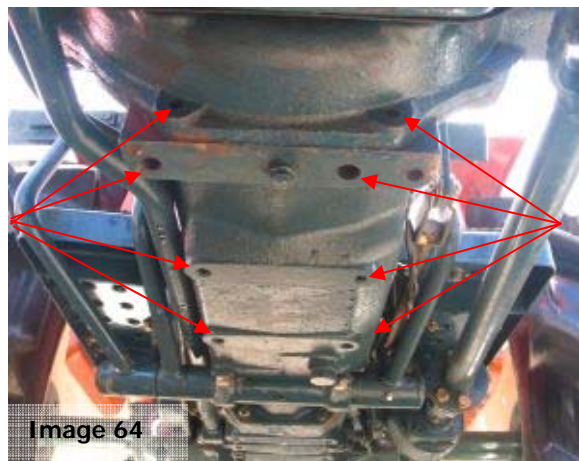
Image 64:

The underside of many mini tractors has numerous countersunk holes (red arrows) which all require cleaning and inspection to verify free of contaminants.

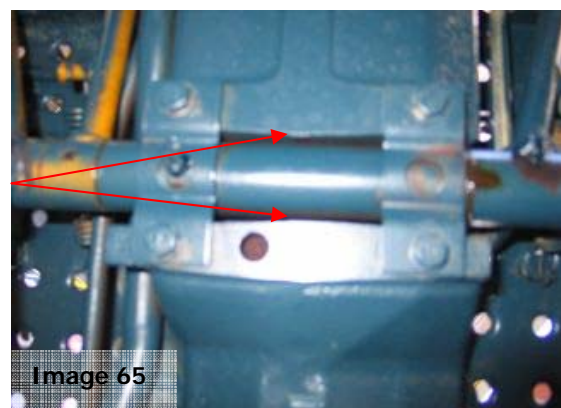
Image 65:

The shaft (red arrows) located halfway along the underbelly will require flushing to verify cleanliness.

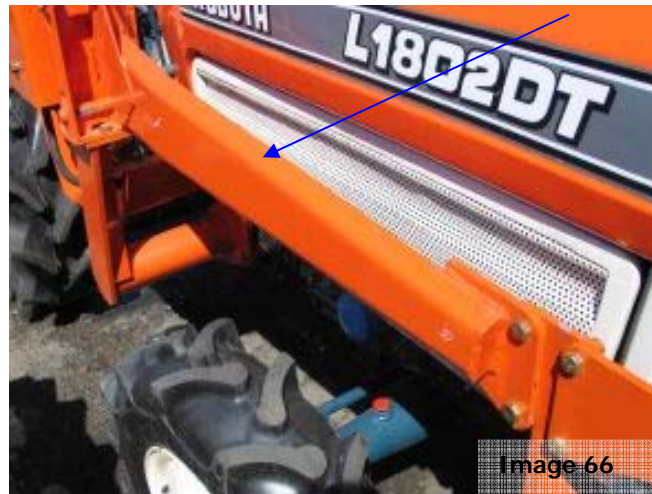
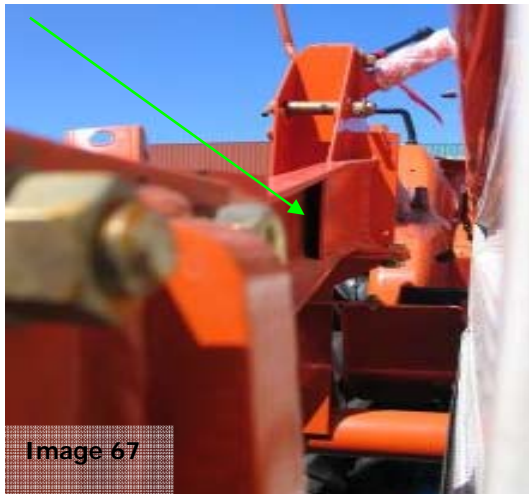
The push arms (blue arrow) may be hollow structures which require internal verification. See next illustration.

On the inside of the push arm, a hollow structure (green arrow) is illustrated and will require verification.

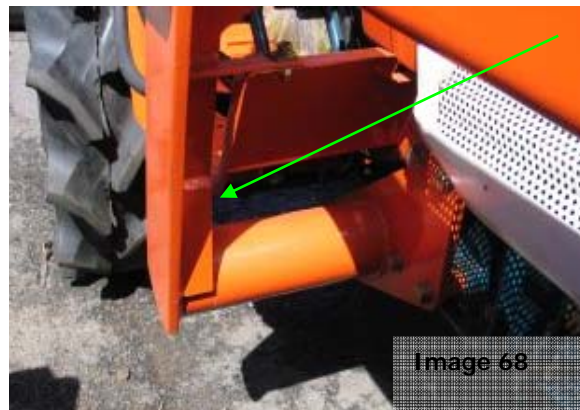
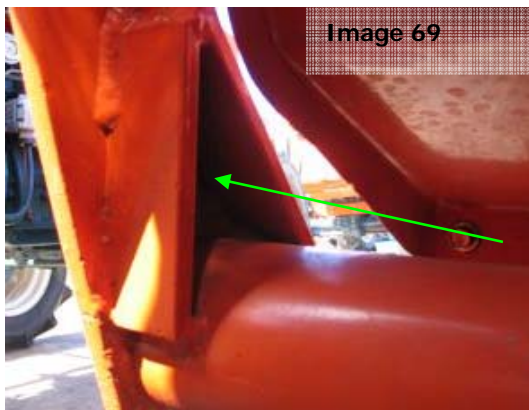
At the base of where the push arms attach to the frame may have open cavities which will be illustrated next.

The open cavity at the base of the push arms which will require verification.

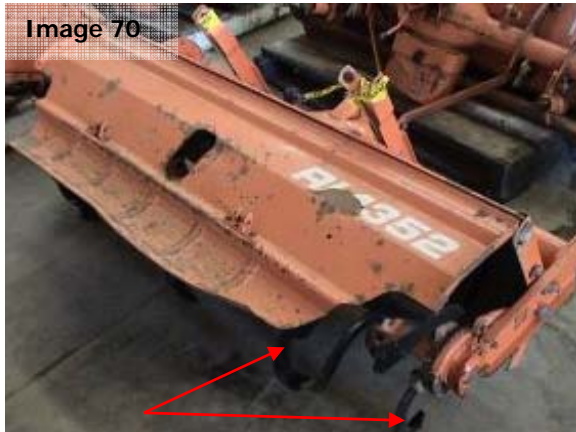
Image 70:

A typical rotary hoe for a mini tractor. All blades (red arrows) must be removed from the tynes for cleaning and inspection. There are numerous cavities and recesses on all surfaces of the rotary hoe and all must be thoroughly cleaned and inspected. Many will require flushing to verify cleanliness.

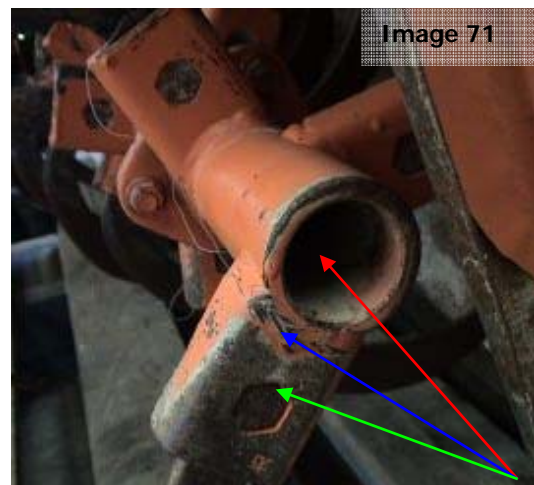
The tyné pockets (green arrow) are hollow (blue arrow) and to verify these, the blades must be removed. Flushing with the blades in place does not suffice. Flush all hollow channels (red arrow) as indicated.

The cutting blades (red arrows) on the rotary hoe. All blades must be removed to verify the internal cleanliness of the tynes (green arrows).

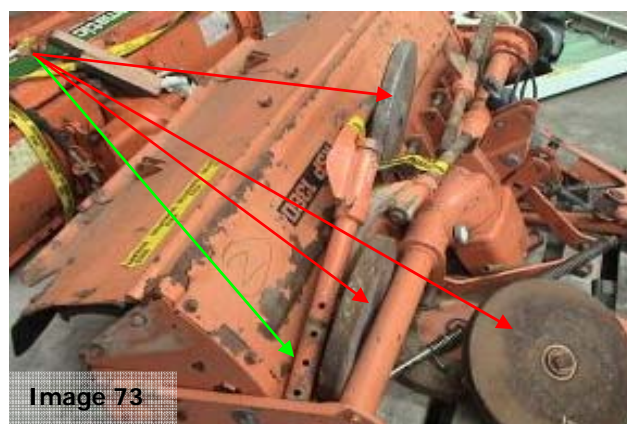
Image 73:

All surfaces of the rotary wheels (red arrows) must be checked for cracks, splits or evidence of repair. These wheels are hollow and will require flushing to verify internal cleanliness if breached. Flush all hollow channels (green arrow) to verify cleanliness.

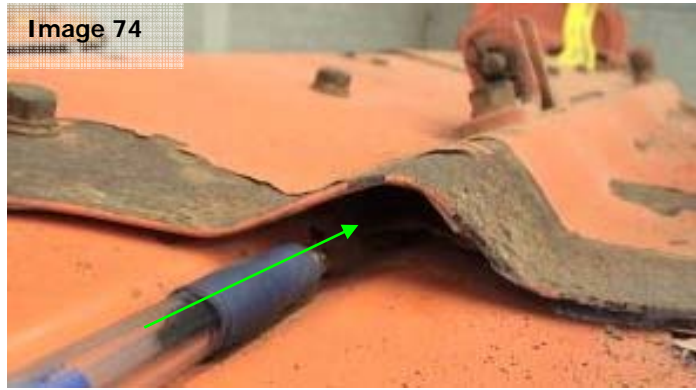
Images 74 & 75:

Examples of the small cavities (green arrows) that are commonly found on rotary hoes. These areas must be cleaned and flushed to verify cleanliness.

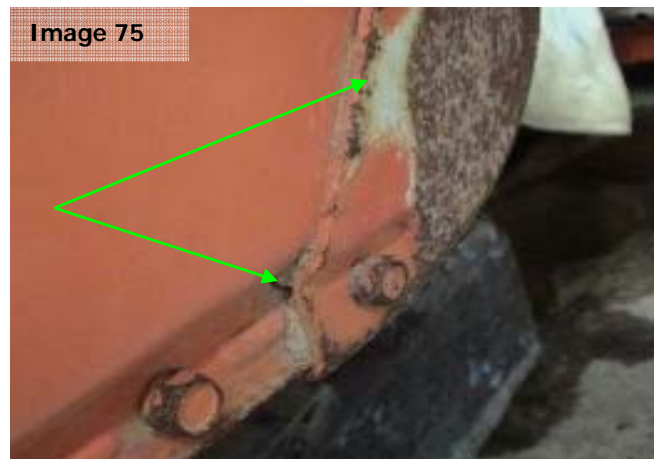
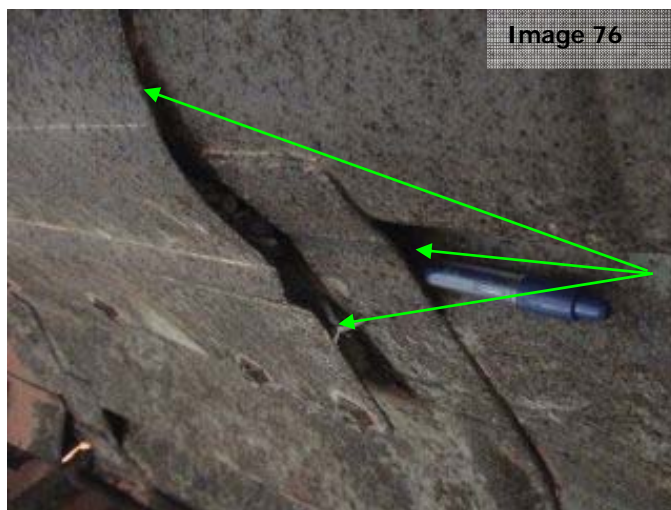
Images 76 & 77:

Examples of the small cavities (green arrows) that are commonly found on rotary hoes. These areas must be cleaned and flushed to verify cleanliness.

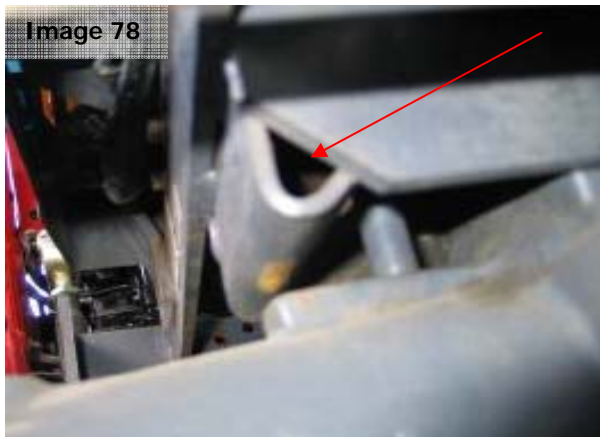
Images 78 & 79:

Hollow channels like those highlighted (red arrows) must be verified internally clean.

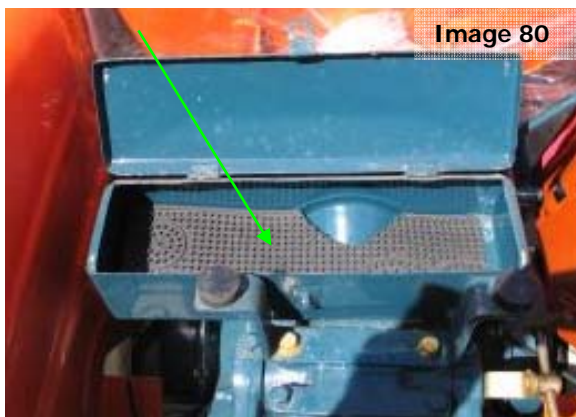
Verify the internal cleanliness of the toolbox, located under or behind the seat.

Check all outer rims for small gussets (red arrows) that will require verification.

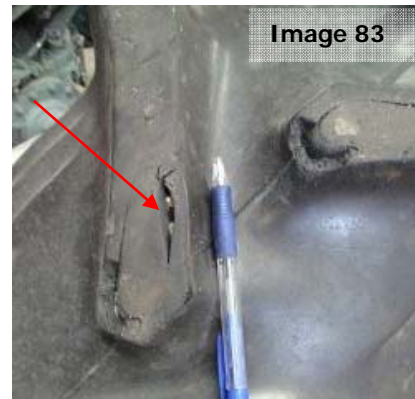
Image 83:

All cracks and splits in tyres must be verified that all are free of contamination.

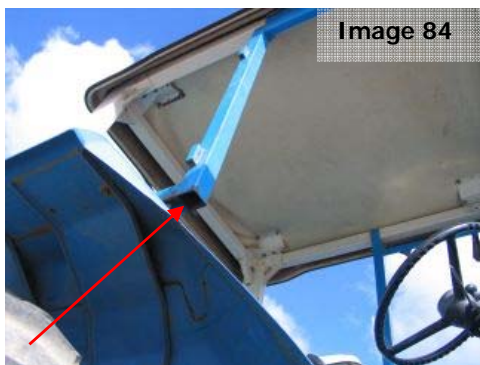
Image 84:

If a cabin is present, check for hollow open-ended framework (red arrow) and flush to verify cleanliness if present.

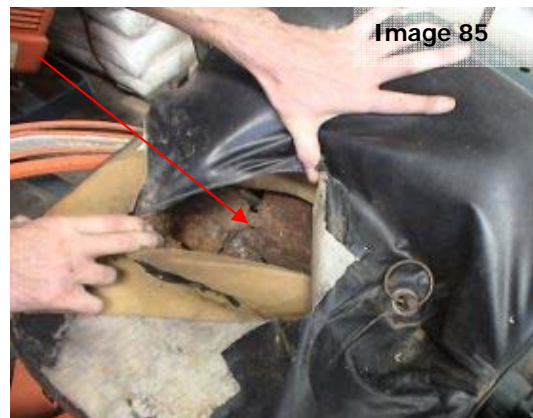
Image 85:

The underside of the seats must be verified clean.

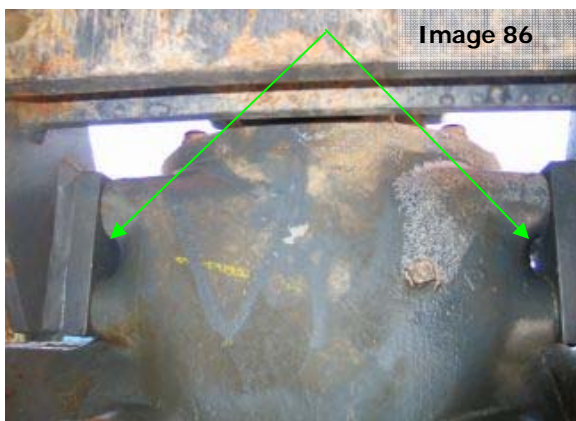
Image 86:

The underside of the axles and differential may also have small recesses (green arrows) that require verification.
