Australian Quarantine and Inspection Service

WHEEL LOADERS

The following cleaning/inspection guide has been segmented to facilitate the process. The segmentation is as follows:

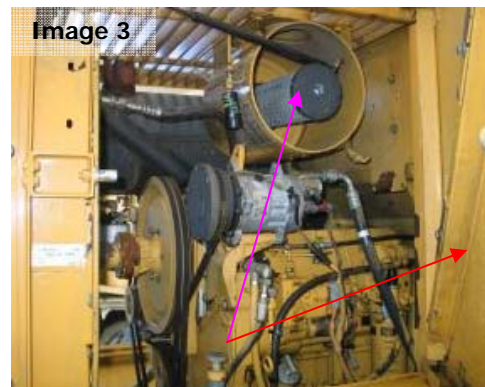
Image 4:

Illustrates the rear of the Wheel Loader and the radiator grill open, exposing the oil cooler and radiator fins (red arrows), which need to be flushed in the presence of the inspecting officer in order to verify cleanliness. Check all internal surfaces of the light covers (blue arrows).

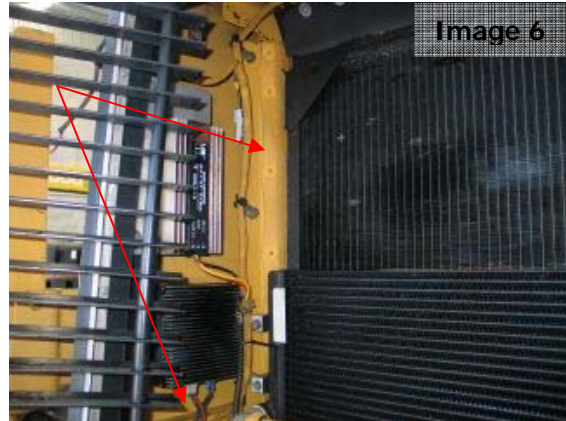
Image 7

This picture illustrates the right hand side of the engine cover near the radiator. The two red arrows highlight open-ended channels that will require flushing to verify cleanliness. Check the outside framework (blue arrow) for open ends or drainage holes. If present, flush to verify clean.

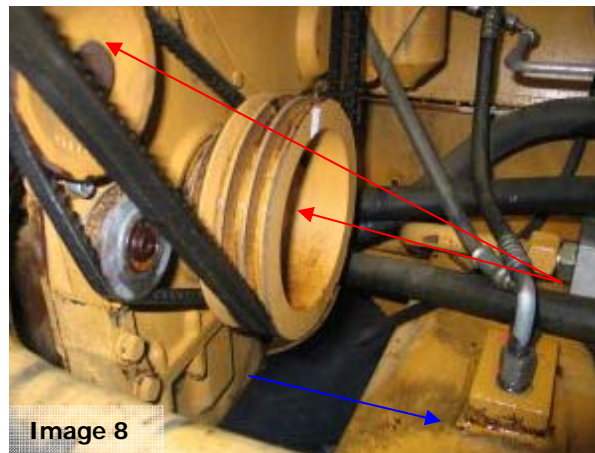
Image 8

At the rear of the engine block are the harmonic balancers or flywheels (red arrows). These are generally concave and can harbour significant amount of contamination. While inspecting these, check the topside of the fuel cell (blue arrow).

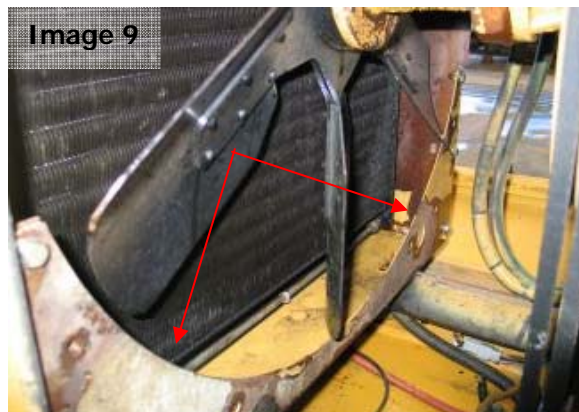
Image 9

The radiator grill has been removed, allowing inspection access into the bottom of the shroud.

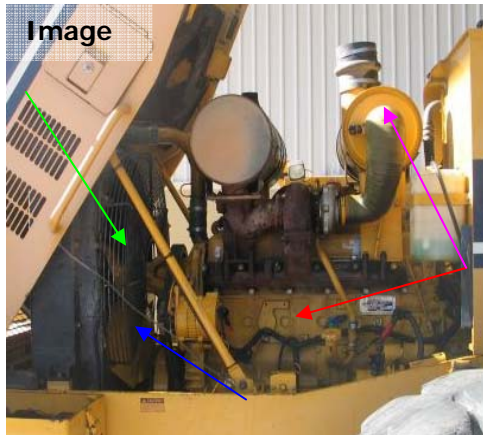
Image 10:

A typical Wheel Loader engine block and radiator. The blue arrow highlights the internal radiator grill, which is preventing inspection access to the inside and bottom of the shroud. The green arrow highlights where the harmonic balancers (flywheels) can be found. The purple arrow highlights the air-filter and the red arrow highlights the side of the engine block. Check between the tappet covers, starter motor and oil filters.

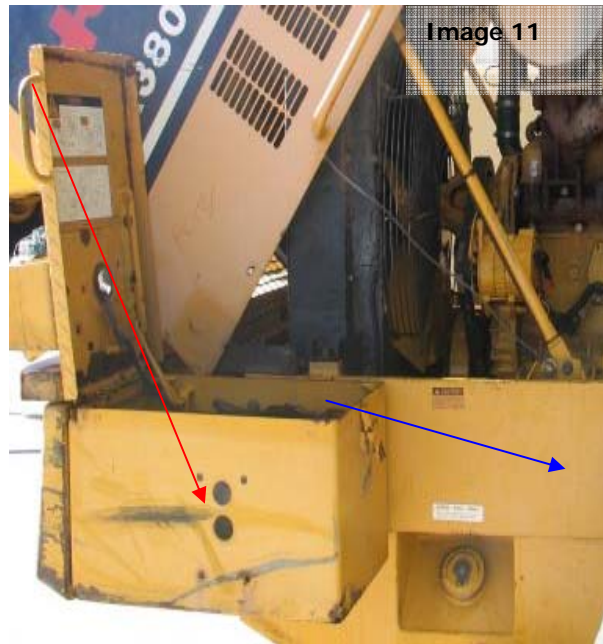
Image 11:

On most models the batteries are located in boxes (red arrows) on either side of the chassis. The batteries need to be loosened from the tie-down points and checked underneath. Check the internal surfaces of the battery box for entrance holes into the hollow chassis rail (blue arrow). These chassis rails, on the larger models are hollow and can be accessed via small holes in the side of the battery box (where the battery cables go) or once the belly plates have been dropped, flush the open holes where the bolts have been removed. If the chassis rail is hollow and open, then it must be flushed in the presence of the inspecting officer to verify cleanliness.

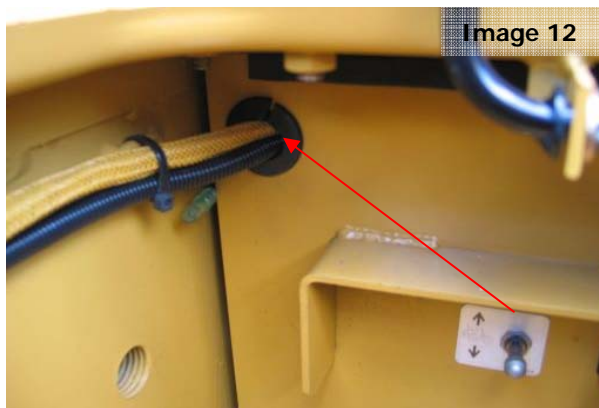
Image 12:

The illustration above shows the small hole that can sometimes be found in the battery box – the cables go through this hole, into the hollow chassis rail.

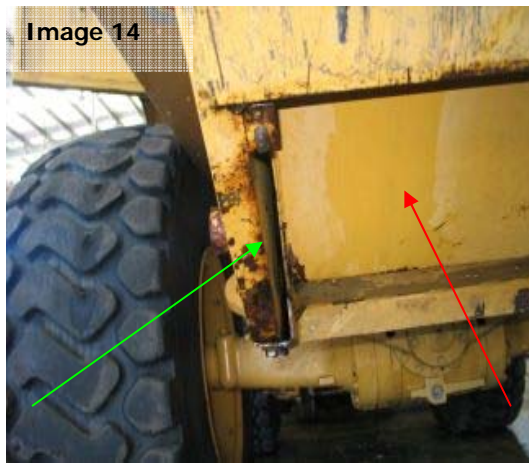
Image 14:

The underside of the fuel cell (red arrow) from the rear. The rear belly plate has been removed, allowing access to the small recess (green arrow) between the fuel cell and the left hand side of the Wheel Loader.

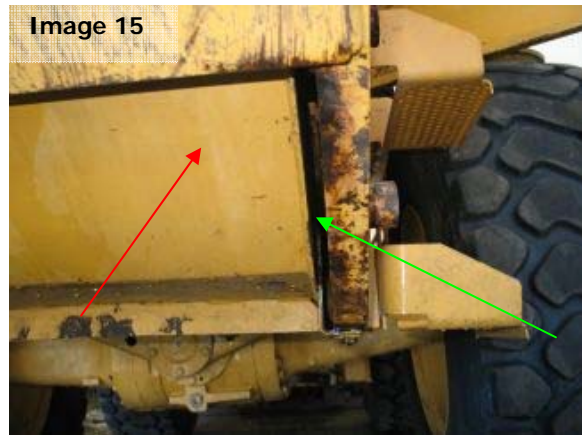
Image 15:

The underside of the fuel cell (red arrow) from the rear. The rear belly plate has been removed, allowing access to the small recess (green arrow) between the fuel cell and the right hand side of the Wheel Loader.

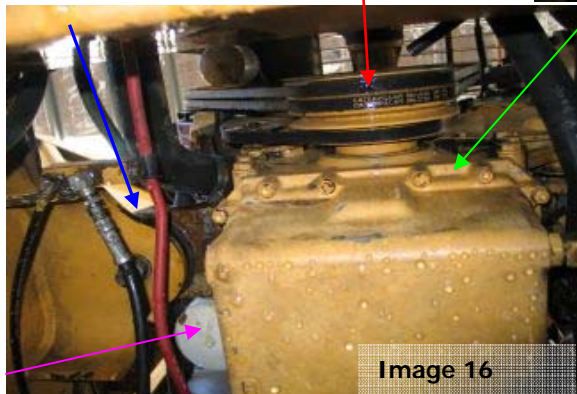
Image 16:

The engine block (sump) from below. The red arrows highlight the harmonic balancer, the blue the engine mounts, the green arrows the lip around the topside of the sump and the purple arrow, highlighting the oil filters.

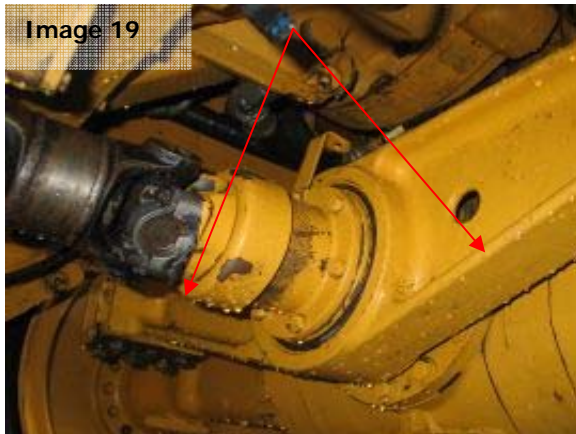
Image 19:

Another example of a sway bar, not hollow like the last example, but does have horizontal ledges (red arrows), both back and front that can harbour contamination.

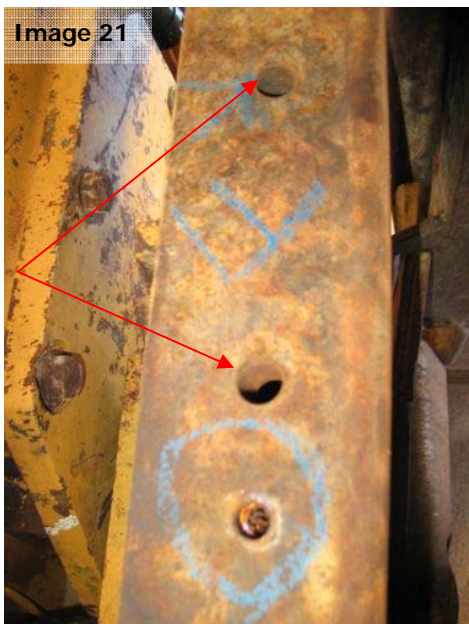
Image 21:

Another example of the belly plate boltholes (red arrows), allowing this hollow chassis rail to be flushed to verify cleanliness.

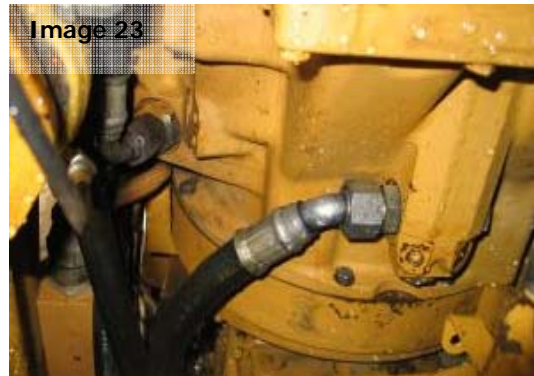
Image 24:

All universal joints must be free of contaminated grease.

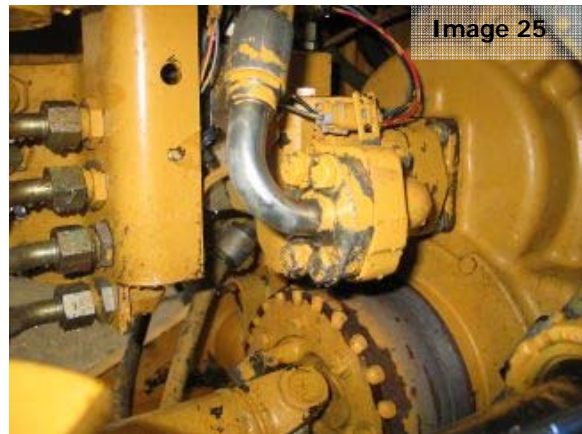
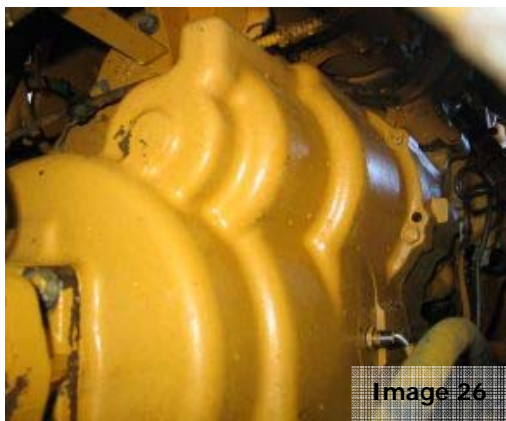
Images 27 & 28:

To enable thorough cleaning and inspection, all non-affixed side panels need to be removed. The hollow, open-ended gussets (green arrows) under the rails need checking.

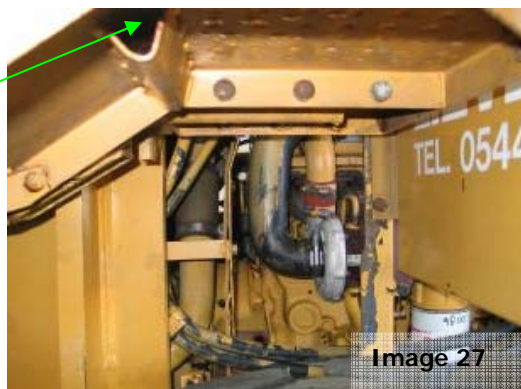
Image 29:

Note that the counterweights have been removed from the rear drawbar (red arrows). The area highlighted by the blue line is hollow and access will be shown next.

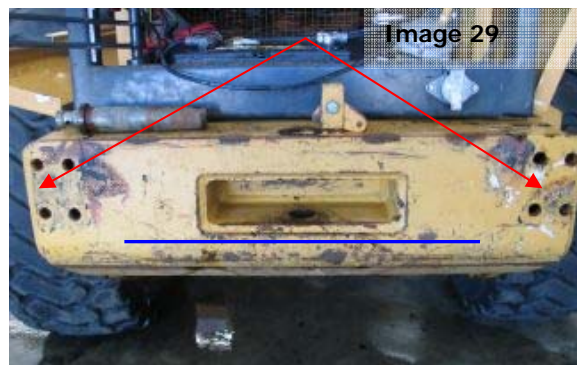
Image 30:

Once the pin is removed from the drawbar (red arrow), on some models this area is hollow and requires flushing to verify cleanliness. Other hollow rear drawbars may have access points elsewhere (drainage holes underside).

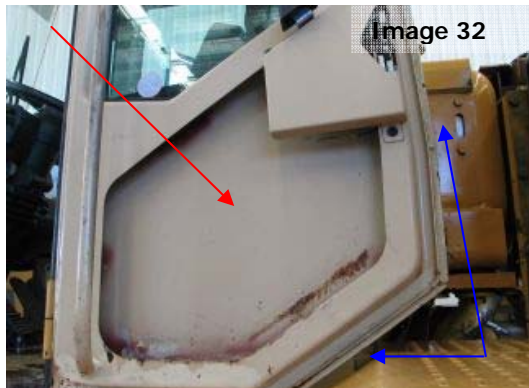
Image 32:

The internal door panelling (red arrow) and door rubbers (blue arrows) have been removed for cleaning and inspection.

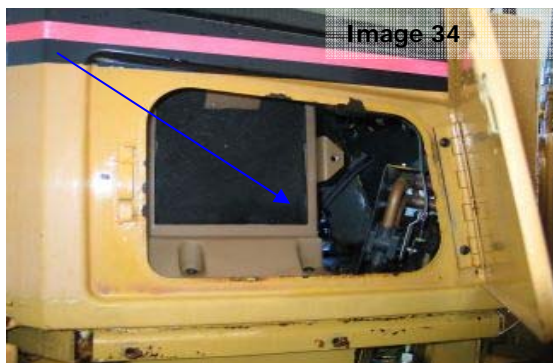
Images 33 & 34:

All non-affixed panelling from outside the cabin has been removed, allowing access for cleaning and inspection.

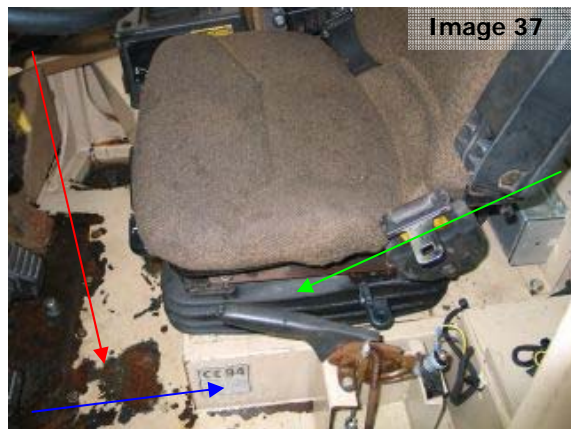
Image 38:

Access will be required to verify that the inside surfaces of the joystick control panels are clean.

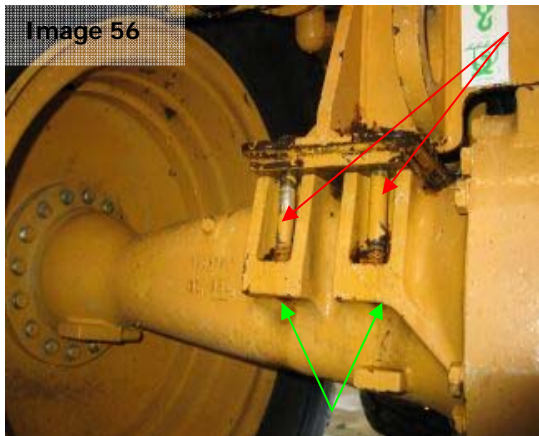
Images 56 & 57:

Each axle on either side of the differential has supports (red arrows) for the housing above. Each of these areas requires thorough cleaning and inspection. Check if bolts are countersunk below (green arrows).

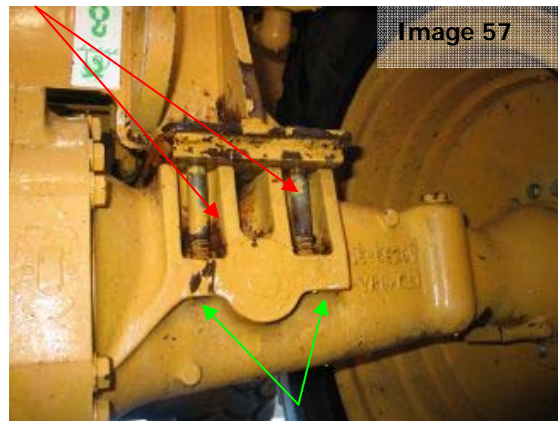
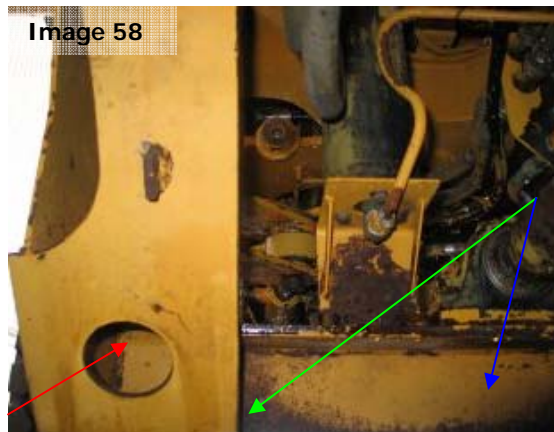
Images 58 & 59:

From the front end, looking back towards the articulated pivot-point, open channels (red arrows) like those illustrated above maybe found on either side of the Wheel Loader. On some models the horizontal structure highlighted below these channels (blue arrows) is hollow and may have drainage points (green arrows).

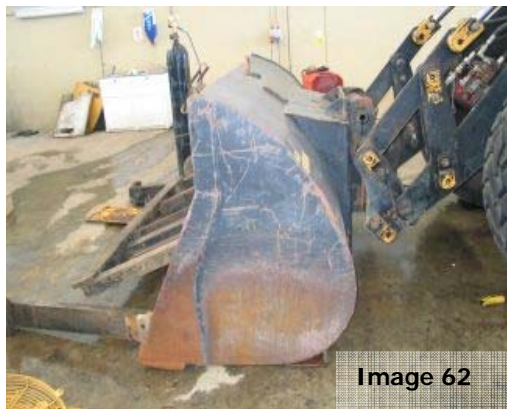
Image 62:

Check all internal and external surfaces of the bucket for any cracks, splits or evidence of repair. All wear plates are to be loosened for flushing, while cutting teeth are to be removed for inspection.

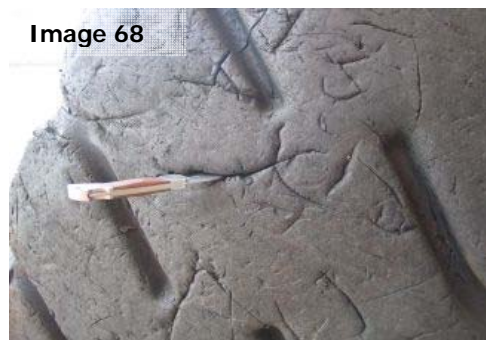
Image 68:

All cracks and splits in tyres must be verified to ensure that all are free of contamination.

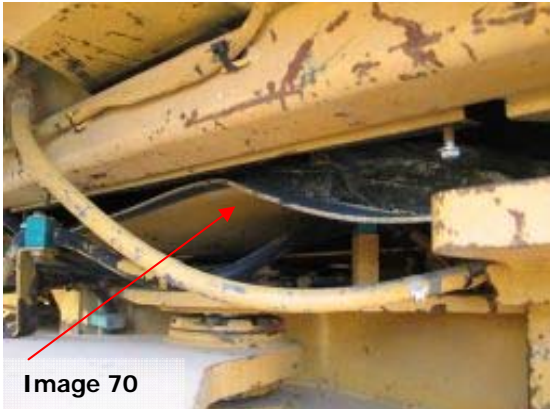
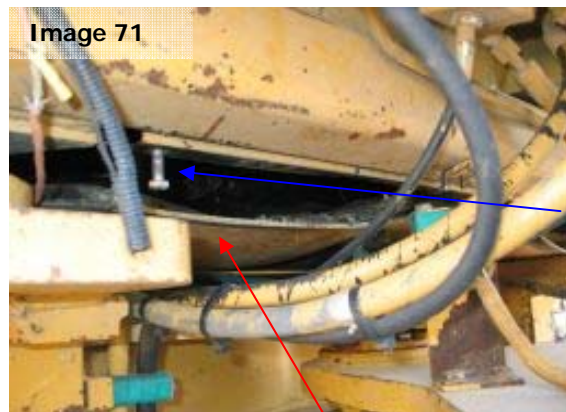
Images 70 & 71:

On some models of Wheel Loaders, under the cabin may be a false floor (red arrows). These are reasonably common and worth illustrating as this area can harbour a significant amount of contamination. The false floors can be made from hard rubber or compressed fibreboard and can be unbolted to allow access for cleaning and inspection.

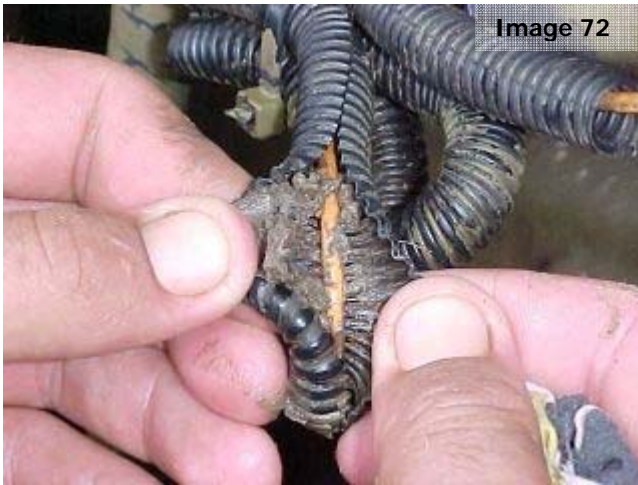
Image 72:
Check all wiring harnesses for internal cleanliness.

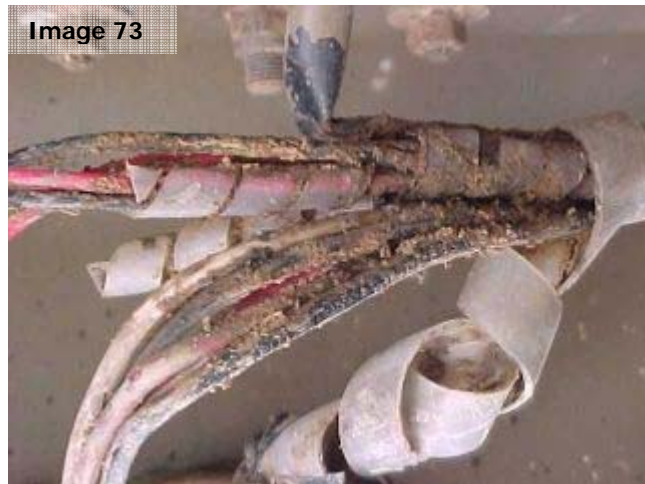
Image 73:
Check all looming around hydraulic hoses for internal cleanliness.

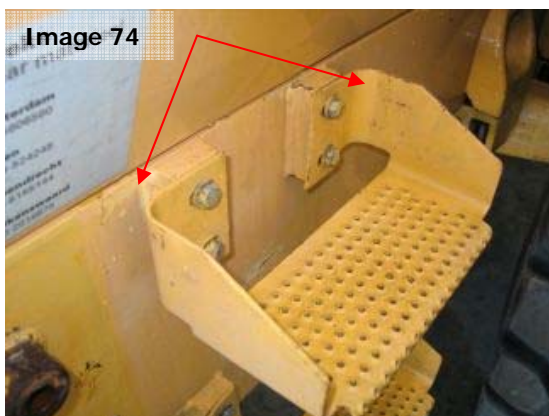
Image 74:
Check all footsteps for cleanliness (including underside).

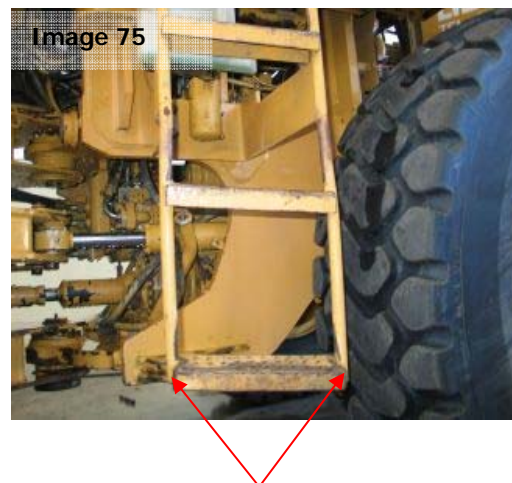
Image 75:
The ladder to the cabin may have open-ended tubing (red arrows) that requires flushing to verify

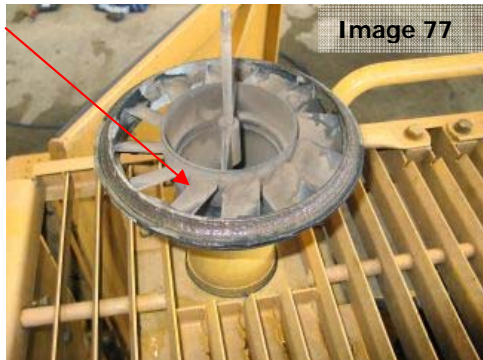
Images 76 & 77:

The pre-cleaner or dust collector. The lid must be removed for cleaning and inspection.

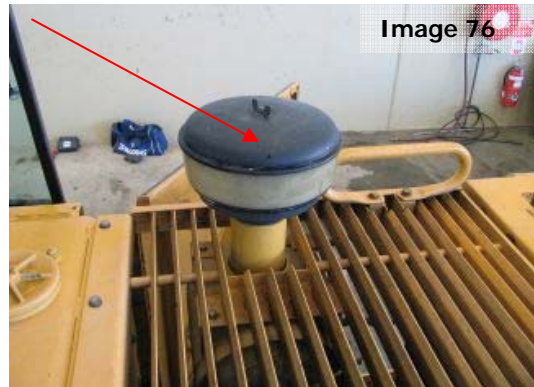
Image 78:

Flush any open-ended piping to verify cleanliness.

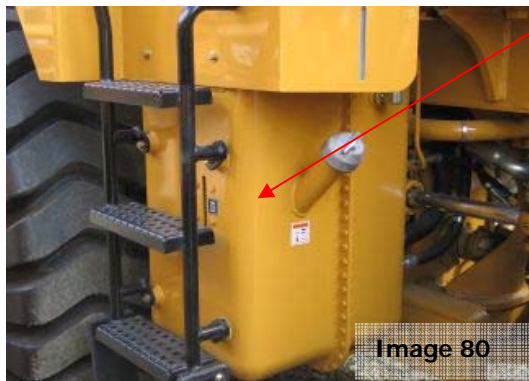
Image 80:

The fuel tank located just below the cabin. All external surfaces must be cleaned and thoroughly inspected – particularly the backside and top.
